# **INDOOR AIR QUALITY ASSESSMENT**

**Penn Brook Elementary School  
68 Elm Street  
Georgetown, MA**

Prepared by:  
Massachusetts Department of Public Health  
Bureau of Environmental Health  
Indoor Air Quality Program  
August 2013

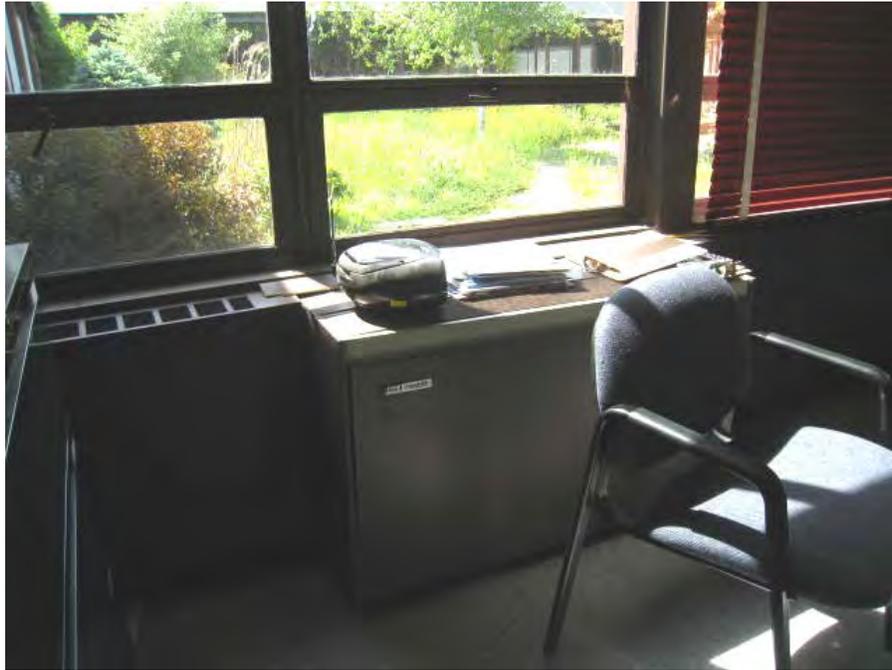
**Picture 1**

Fresh air in classrooms is supplied by unit ventilators (univents) (Picture 1). A univent is designed to draw air from outdoors through a fresh air intake located on the exterior wall of the building (Picture 2). Return air is drawn through an air intake located at the base of each unit where fresh and return air are mixed, filtered, heated or cooled and provided to classrooms through an air diffuser located in the top of the unit ([Figure 1](#)).

**Classroom univent**

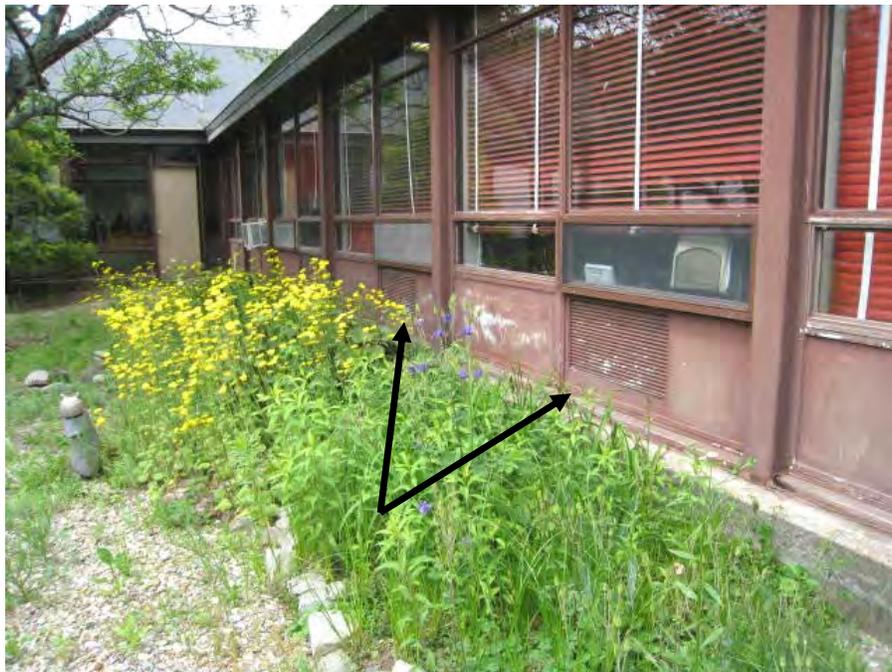
**Picture 2**

**Air intakes for classroom univents (arrows)**

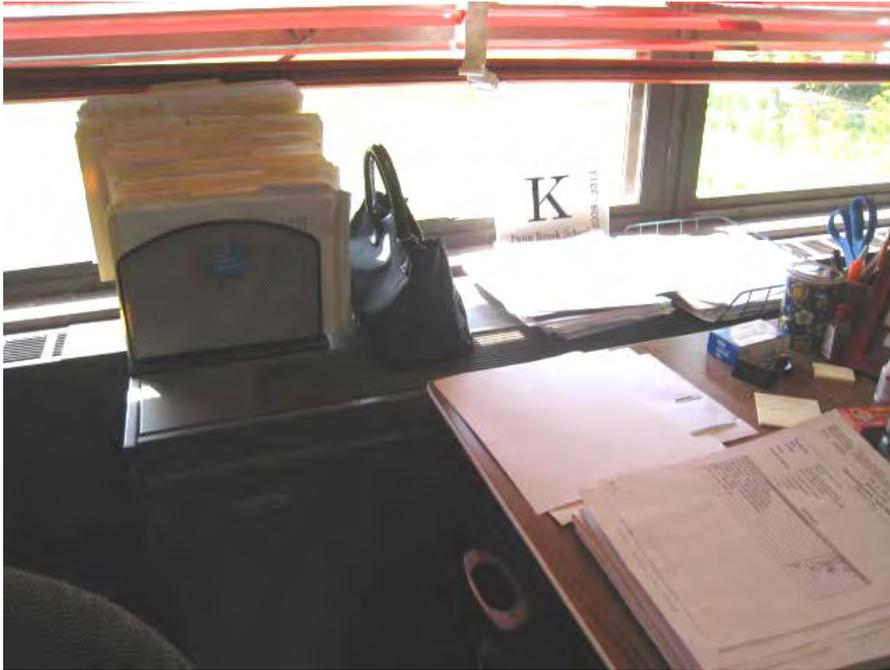
**Picture 3**

Univents were found deactivated or obstructed with classroom items in several areas (Picture 3; Table 1). In order for univents to provide fresh air as designed, intakes/returns must remain free of obstructions. Importantly, these units must remain on and be allowed to operate while rooms are occupied. Mechanical ventilation in some central areas, including the library, the cafeteria and the gym is provided by air-handling units (AHUs) located at/above the ceiling (Picture 4).

**Univent top and front blocked with items**

- **Remove all blockages from univents to ensure adequate airflow. Clean out interiors of univents regularly.**
- **Action:** School maintenance staff report that teachers are regularly informed that univents should remain unobstructed to function properly but that blockage of univents still occurs. Some univents were found blocked during current visit.

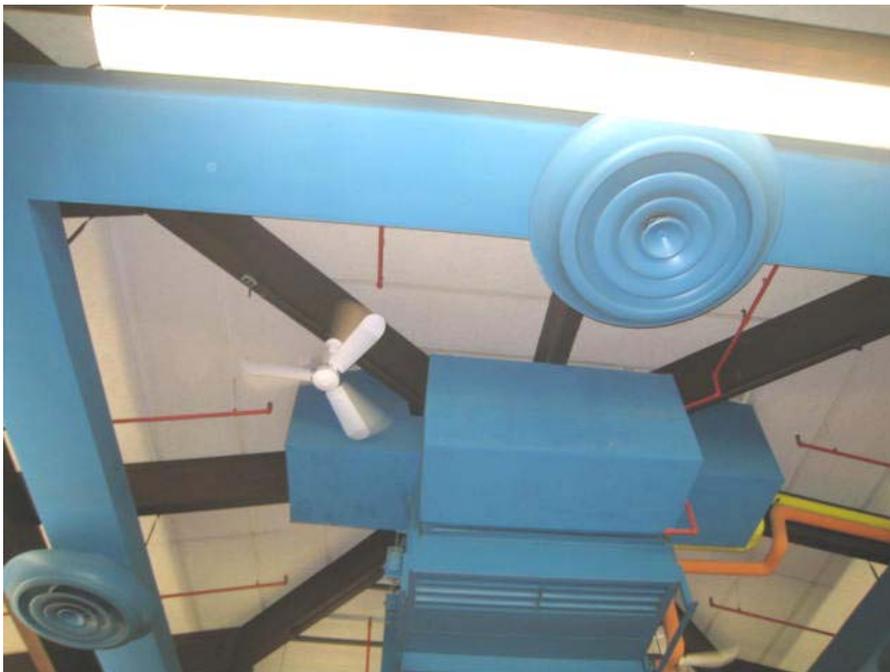
**Picture 4**

Note that the univents/AHUs are original equipment, more than 40 years old. Function of equipment of this age is difficult to maintain, since compatible replacement parts are often unavailable. According to the American Society of Heating, Refrigeration and Air-Conditioning

Engineers (ASHRAE), the service life<sup>1</sup> for a unit heater, hot water or steam is 20 years, assuming routine maintenance of the equipment (ASHRAE, 1991). Despite attempts to maintain this equipment, the operational lifespan has been exceeded. Maintaining the balance of fresh air to exhaust air will become more difficult as the equipment ages and as replacement parts become increasingly difficult to obtain.

**Library supply vents and air handling unit**

1. Examine the feasibility of replacing unit ventilators/AHUs as they are beyond their operational lifespan.
2. Consider adopting a balancing schedule of every 5 years for all mechanical ventilation systems, as recommended by ventilation industrial standards (SMACNA, 1994).
3. Examine the feasibility of installing additional gutters/downspouts and methods of reducing water pooling on exterior walls to prevent moss growth.
4. Have a licensed plumber remove water fixtures that are no longer needed and cap drains.
5. Replace carpeting in the library and any other areas that still have original wall-to-wall carpeting.

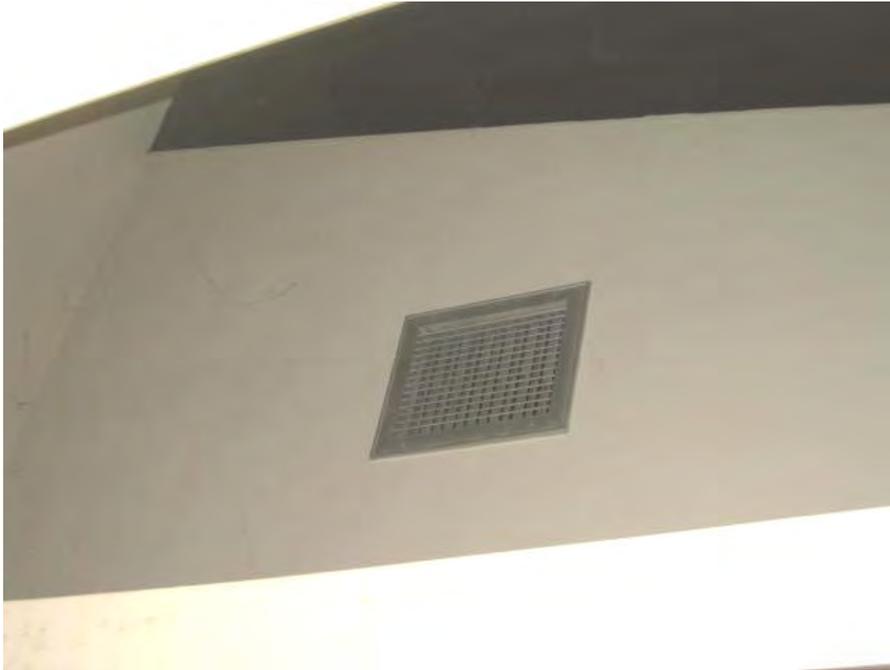
**Picture 5**

Exhaust ventilation is provided by wall-mounted vents ducted to rooftop motors (Picture 5). Some of the vents that were examined had very low or no draw; many of these vents are located near the sloped roof line, high above the classroom area, so function could not be determined during the assessment. School personnel reported that these motors were replaced recently as a part of an energy savings project. It is possible that control settings for some motors are not on an appropriate operating schedule.

**Classroom exhaust vent, high on interior wall below sloped roof**

To maximize air exchange, the MDPH recommends that both supply and exhaust ventilation operate continuously during periods of occupancy. In order to have proper ventilation with a mechanical supply and exhaust system, the systems must be balanced to provide an adequate amount of fresh air to the interior of a room while removing stale air from the room. It is recommended that heating, ventilating and air conditioning (HVAC) systems be re-balanced every five years to ensure adequate air systems function (SMACNA, 1994). The date of last balancing was not available at the time of the current visit; however school maintenance staff reported that an energy-saving project had occurred recently at the school, which may have included balancing.

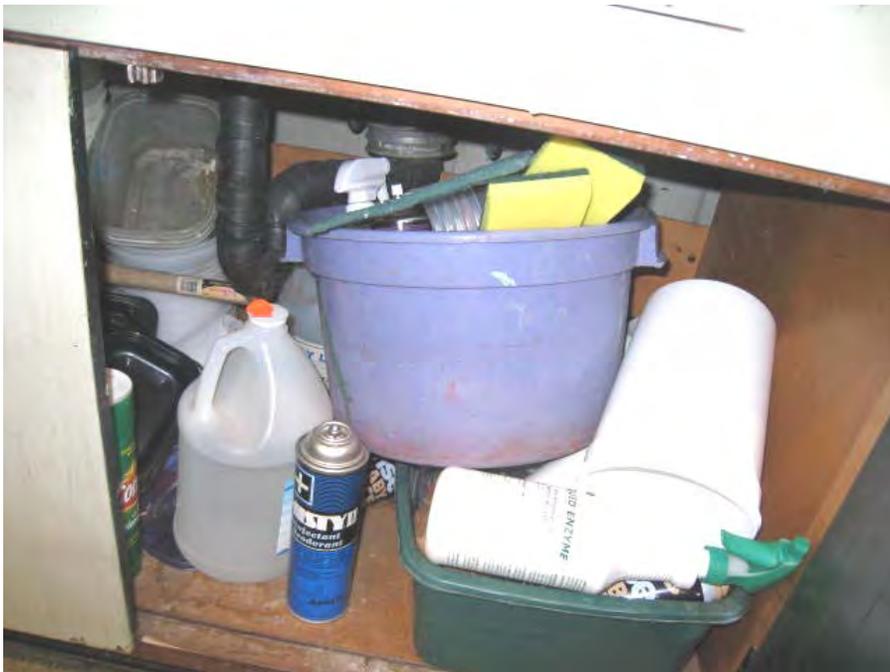
**Picture 6**

No water-damaged ceiling tiles or other building materials were observed at the time of the assessment. Many classrooms contained sinks and some were observed to have porous items stored underneath them (Picture 6). The area underneath the sink is a moist environment and items stored there may be subject to chronic dampness due to leaks and condensation, which may lead to microbial growth. In addition, accumulated items under sinks may make it harder to detect leaks.

**Items and cleaning products stored under sink**

6. Refrain from storing porous items or large amounts of items under sinks.
7. Properly turn off water to sinks and other fixtures that are not in use. Cap the associated drains to prevent sewer gases and moisture entering into occupied areas.

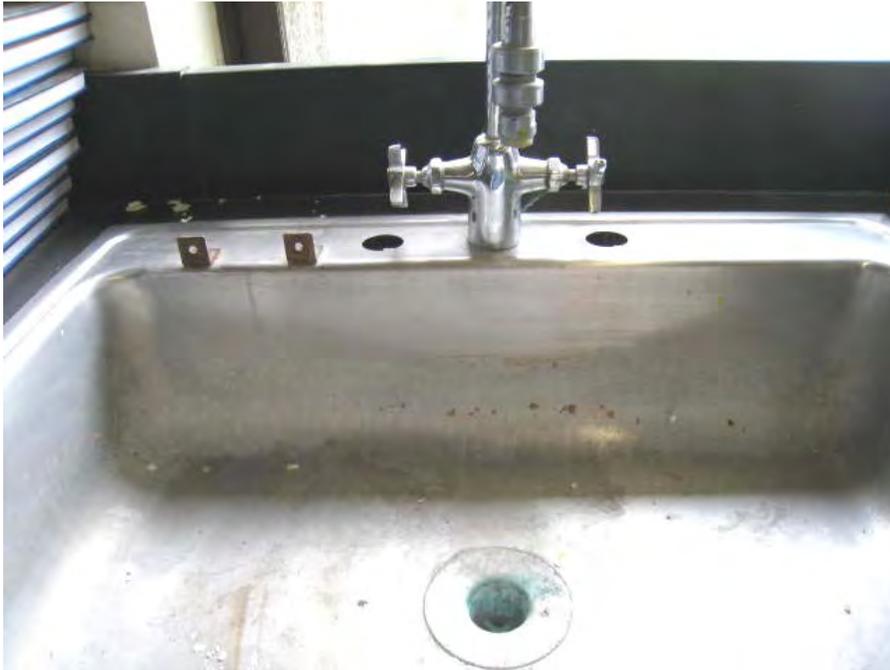
**Picture 7**

The sinks in room 24, originally outfitted as a science room, appeared to be dry and not in use (Picture 7). If the drains in sinks that are not used are not capped/blocked, sewer gases can enter occupied spaces. There are also some water fountains/handwash sinks in hallways and restrooms that may no longer be in use (Picture 8), which also allow for similar sewer gas issues. Water sources that are not in use should be properly shut off to prevent leaks and the associated drains should be blocked or capped.

**Potentially dry sink in former science room**

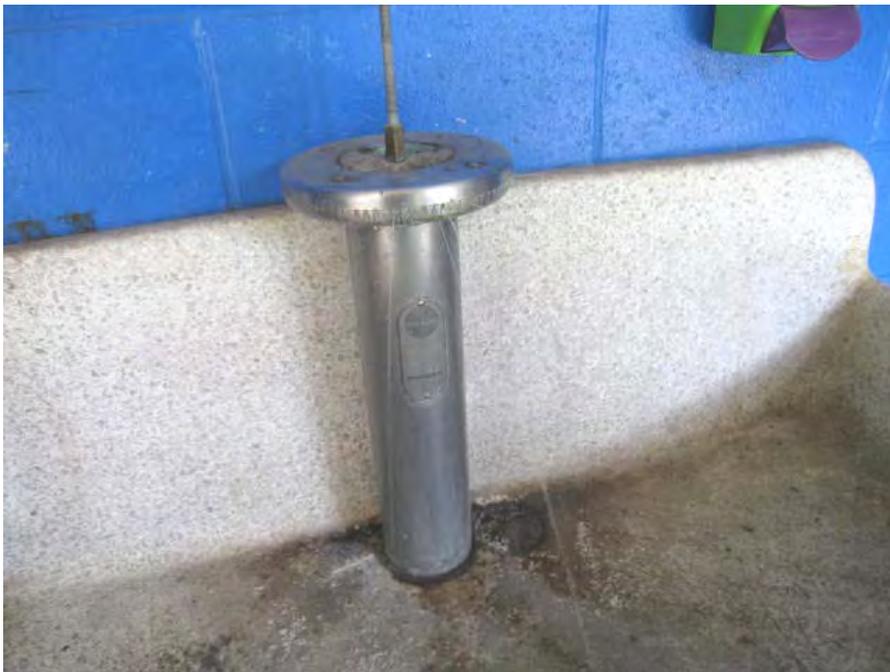
**Picture 8**

**Old-style partially functional sink/fountain in hallway**

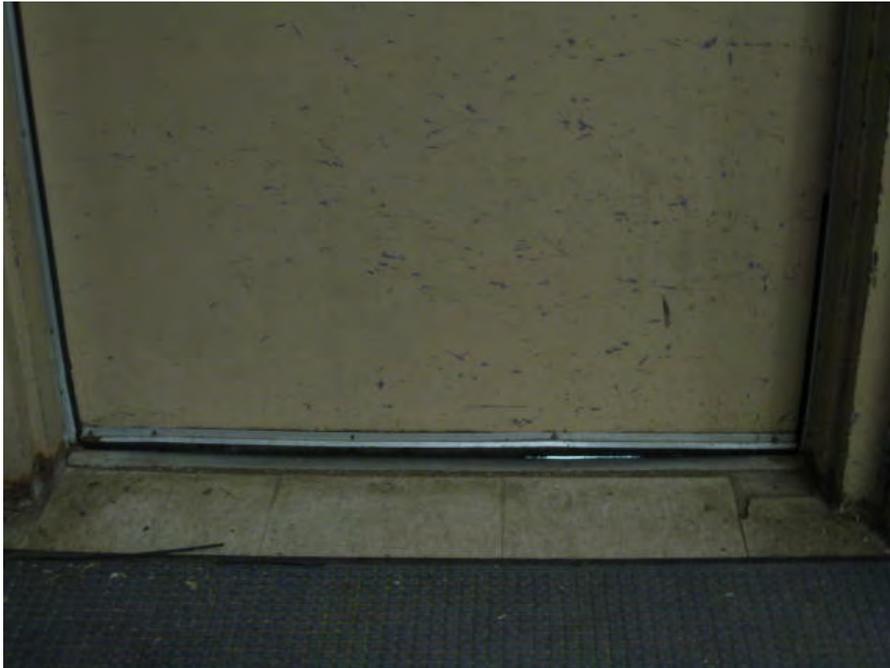
**Picture 9**

- An exterior door to the cafeteria had damaged/missing weather-stripping. Light could be seen penetrating through spaces underneath the door (Picture 9).
- Plants and shrubbery were observed growing in close proximity to the foundation and univent air intakes along both the outside of the building and in interior courtyards, which can allow moisture and pollen to be drawn into the building (Pictures 10 and 11) and cause water damage to the foundation and exterior.
- Crushed/damaged downspouts were observed (Picture 12); and

These conditions can undermine the integrity of the building envelope and provide a means of water entry by capillary action into the building through exterior walls, foundation concrete and masonry (Lstiburek & Brennan, 2001). In addition, these breaches in exterior areas can provide a means of drafts and pest entry into the building.

**Light visible beneath cafeteria door**

10. Replace missing/damaged weather-stripping on exterior doors (e.g., cafeteria) to prevent drafts, moisture infiltration and pest entry. Ensure tightness of doors by monitoring for light penetration and drafts around doorframes.

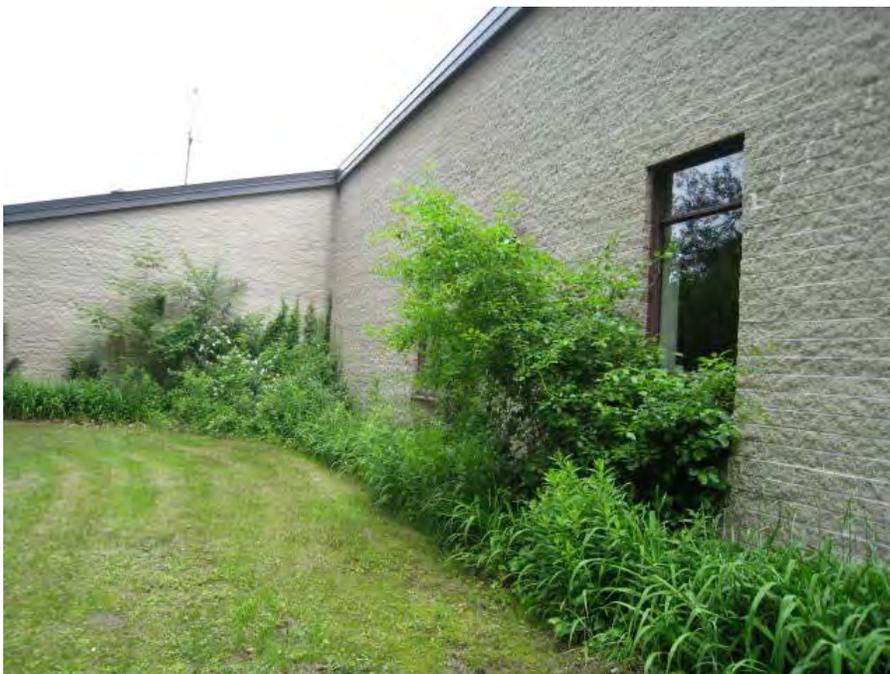
**Picture 10**

**Plants near foundation of building and windows**

8. Ensure plants, trees and shrubs are located at least five feet away from exterior walls/foundation of the building, particularly those in close proximity to univent fresh air intakes.

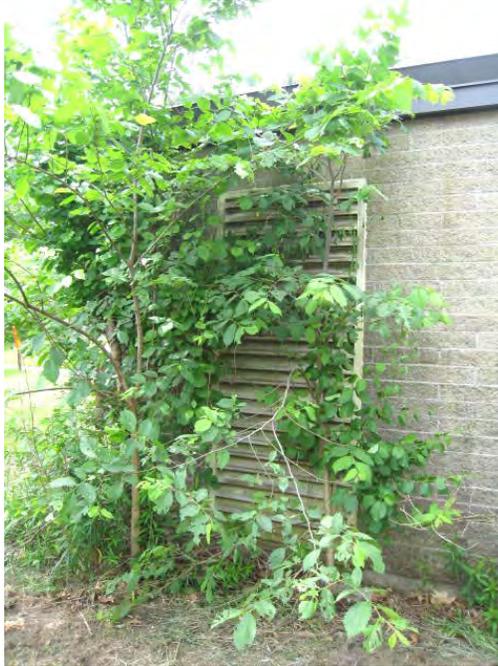
**Picture 11**

**Plants directly adjacent to air intake**

- **Remove plant growths against the exterior wall/foundation of the building to prevent water penetration.**
- **Action:** School staff report that plants are removed and regularly trimmed back from the sides of the building. However, some plants along the sides of the building were observed during the current assessment, including in direct contact with air intakes.

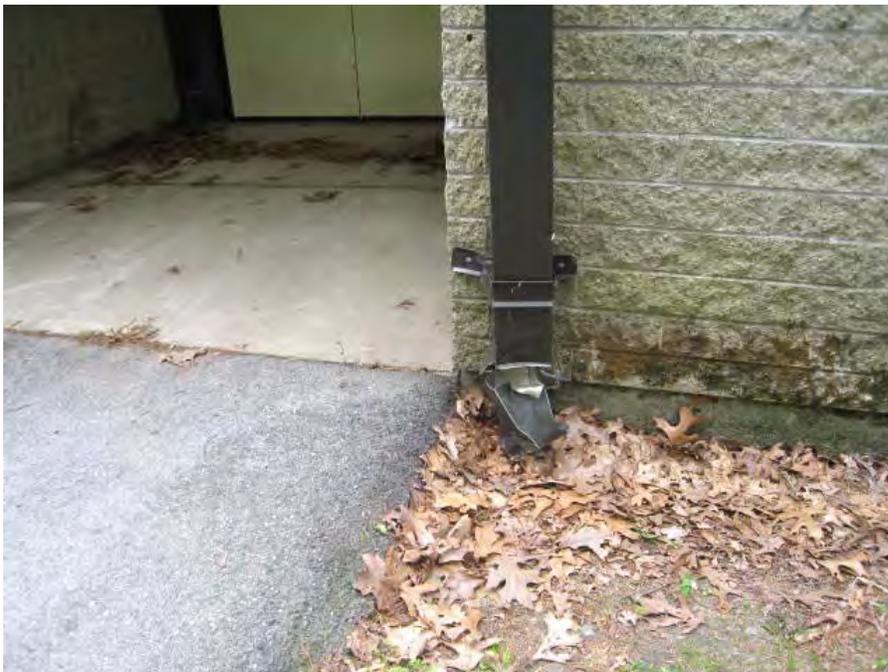
**Picture 12**

**Damaged downspout**

9. Make repairs to existing gutter and downspout systems to drain water away from the building.

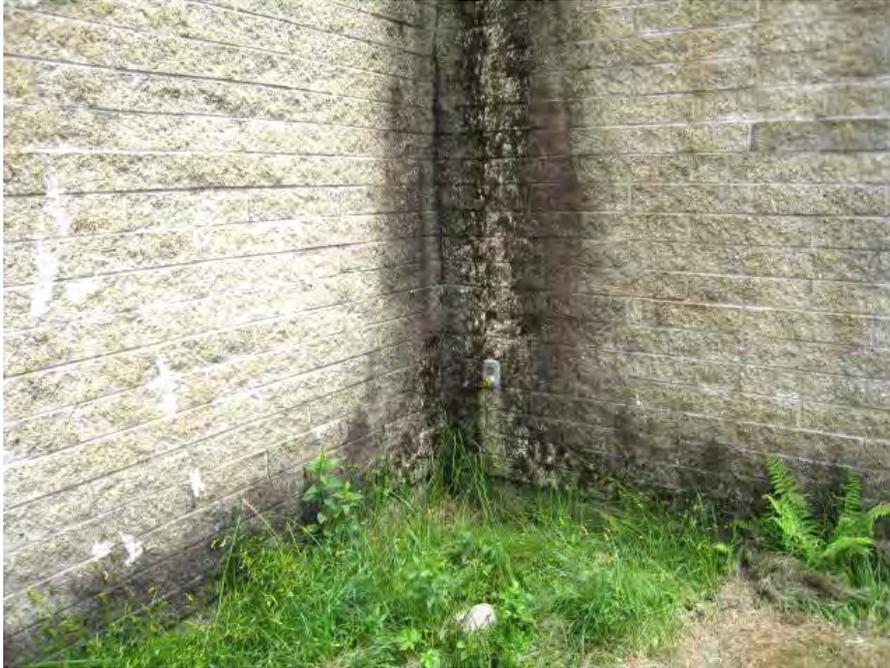
**Picture 13**

- Moss growth on exterior walls was noted, particularly near interior corners indicating chronic dampness, likely due to lack of proper gutters/downspouts and drainage (Picture 13).

**Staining and moss growth along corner/wall indicating chronic dampness**

- **Clean exterior walls and univent air intakes of moss and debris.**
- **Action:** Moss and staining were observed on exterior walls during the current visit in locations indicated in the 2002 report. School staff report that this material is cleaned/removed regularly but reoccurs.

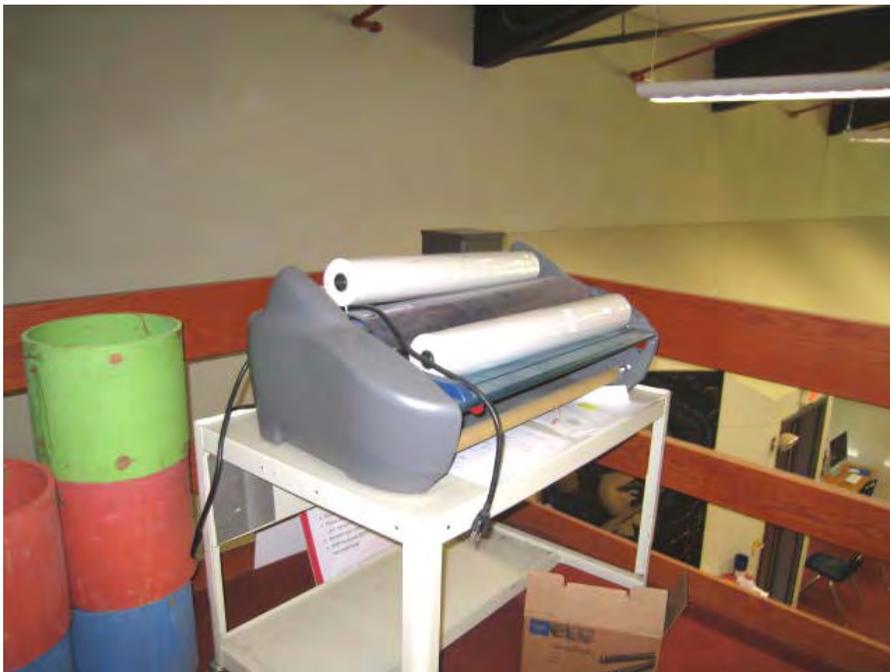
**Picture 14**

Laminators and photocopiers were found in the school (Picture 14). Lamination machines melt plastic and give off odors and VOCs. VOCs and ozone can be produced by photocopiers, particularly if the equipment is older and in frequent use. Ozone is a respiratory irritant (Schmidt Etkin, 1992).

**Laminator and laminator plastic rolls in library area**

- **Action:** A lamination machine was observed in the library loft area which is a less occupied area than the media center; however no local exhaust was present for this machine. School staff report that the laminator is infrequently used.

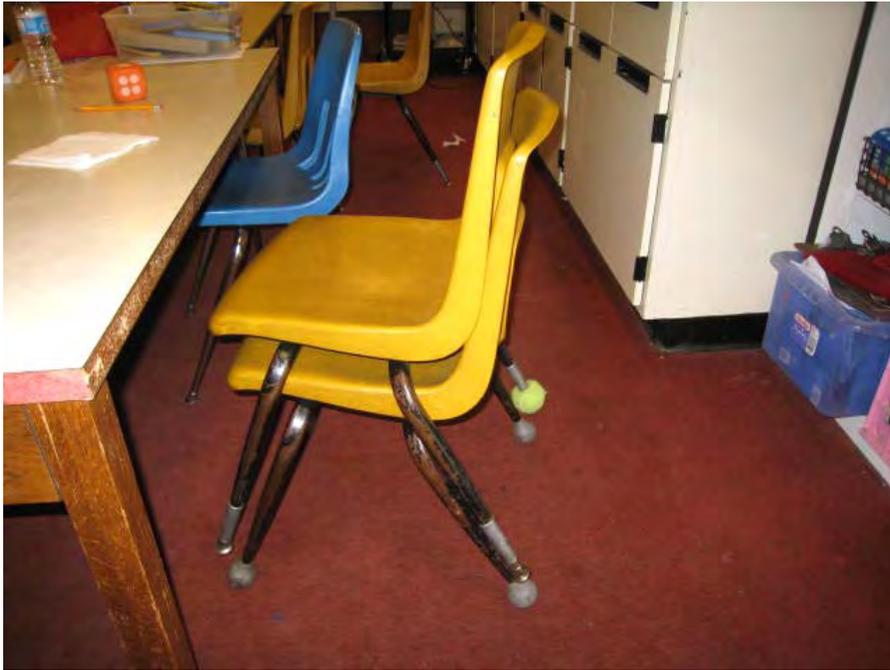
**Picture 15**

In a few areas, tennis balls were found sliced open and placed on chair legs (Picture 15). Tennis balls are made of a number of materials that are a source of respiratory irritants. Constant wearing of tennis balls can produce fibers and off-gas VOCs. Tennis balls are made with a natural rubber latex bladder, which becomes abraded when used as a chair leg pad. Use of tennis

balls in this manner may introduce latex dust into the school environment. Some individuals are highly allergic to latex (e.g. spina bifida patients) (SBAA, 2001). It is recommended that the use of materials containing latex be limited to reduce the potential for symptoms in sensitive individuals (NIOSH, 1997). It was reported that the school has been trying to replace tennis balls with glides, which were also observed in some areas (Picture 15). Latex-free glides should be used for this purpose.

**Chair legs with tennis balls and non-tennis-ball glides**

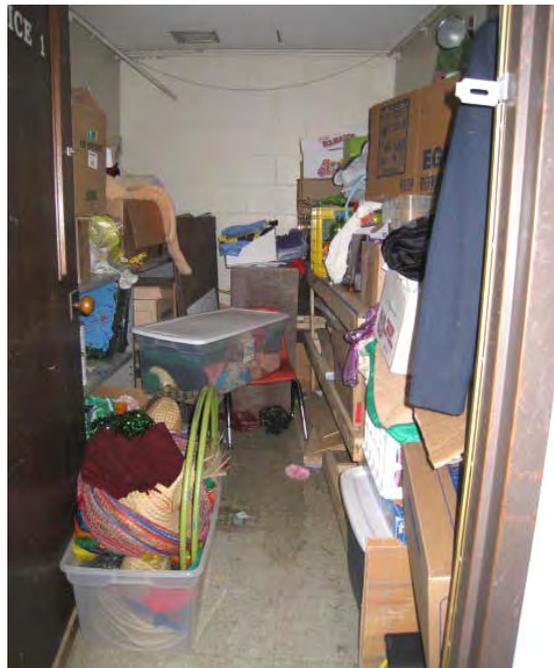
**Picture 16**

Other conditions that can affect IAQ were observed during the assessment. In many classrooms, large numbers of items were on floors, windowsills, tabletops, counters, bookcases and desks, which provide a source for dusts to accumulate. These items (e.g., papers, folders, boxes) make it difficult for custodial staff to clean. Items should be relocated and/or be cleaned periodically to avoid excessive dust build up. In addition, dust and debris can accumulate on flat surfaces (e.g., desktops, shelving and carpets) in occupied areas and subsequently be re-aerosolized causing further irritation. Some storage areas were also observed to be cluttered with items including boxes, musical instruments, papers and books (Picture 16).

**Disorganized storage area**

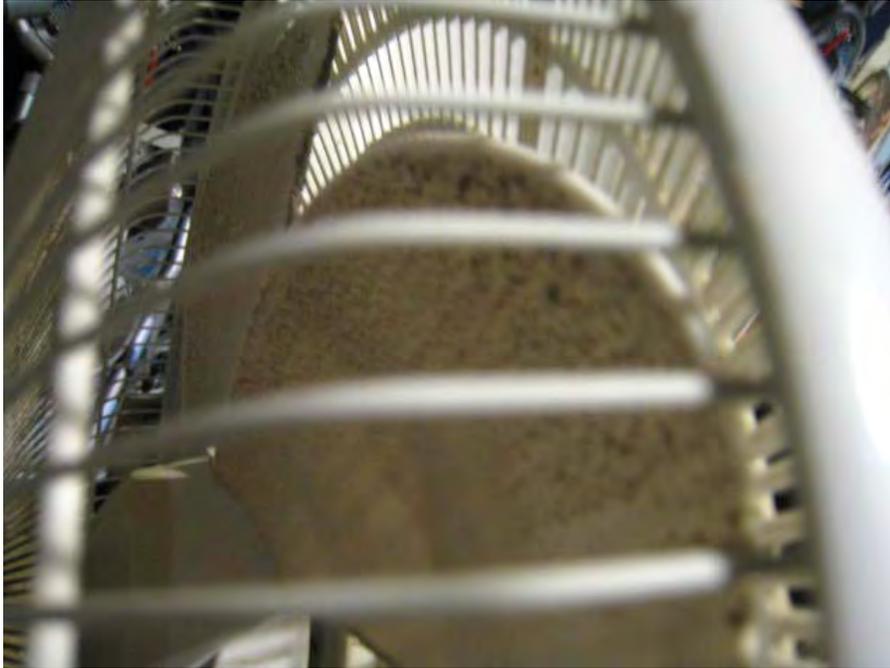
**Picture 17**

A number of personal fans and exhaust vents were observed to have accumulated dust/debris (Picture 17; Table 1). Re-activated diffusers, vents or fans can aerosolize accumulated dust. If exhaust vents are not functioning, backdrafting can occur, which can re-aerosolize dust particles.

**Dusty blades on personal fan**

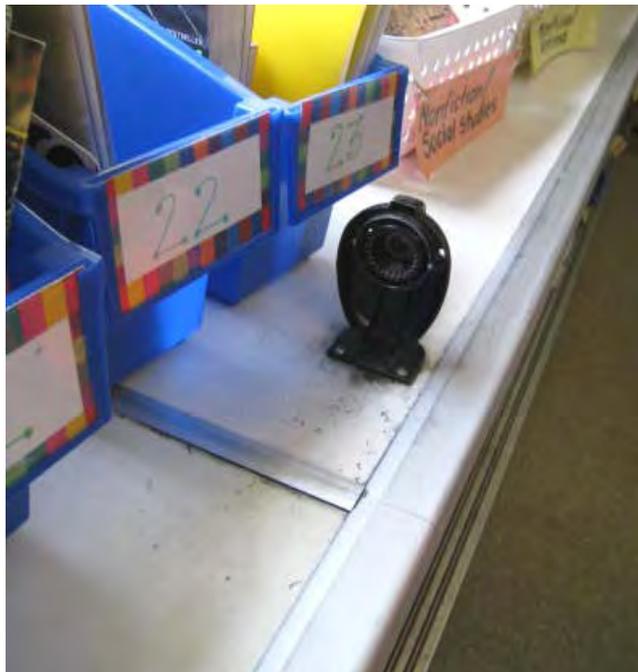
**Picture 18**

In addition to blockages and dust observed in/around univents, other debris occluding/on univents could become aerosolized. For example, a pencil sharper was observed on a univent (Picture 18). Pencil shavings that settle on/into the univent can be aerosolized when the univent

**Pencil sharpener and shavings on univent cabinet**

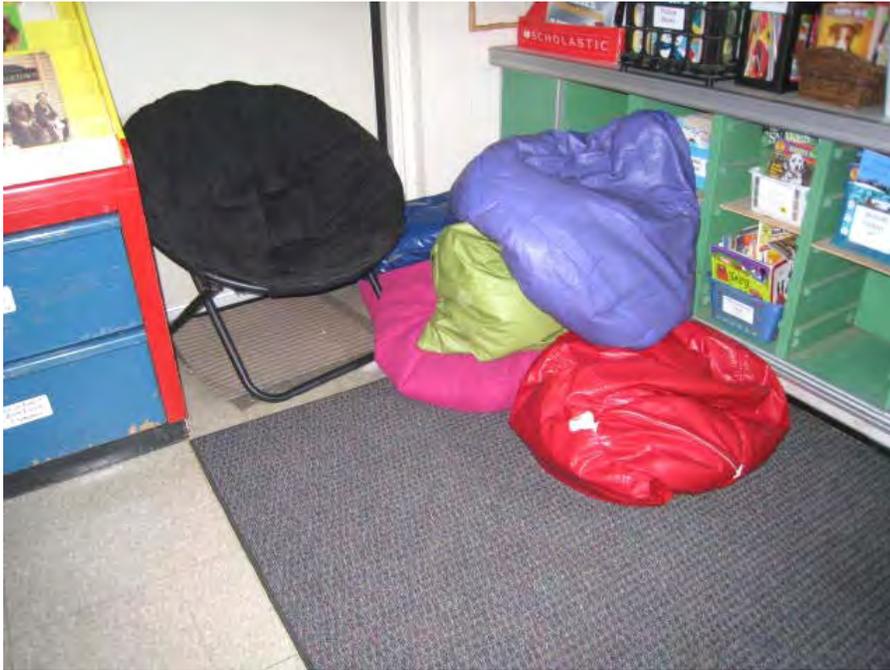
**Picture 19**

Most classrooms had area rugs (Pictures 19 and 20; Table 1) many of which were observed to be dirty/dusty or debris-covered. School maintenance staff reports that these carpets are brought in at the beginning of each school year and that janitorial budgets do not cover regular cleaning or shampooing of them. Carpets can be subject to moistening and microbial growth, and can harbor dust mites, molds and other allergens. The Institute of Inspection, Cleaning and Restoration Certification (IICRC), recommends that carpeting be cleaned annually (or semi-annually in soiled high traffic areas) (IICRC, 2005). In addition, wall-to-wall carpeting in the library was observed to be worn, and is reportedly original to the building. Since the average lifespan of a carpet in schools is approximately eleven years, consideration should be given to removing/replacing the wall-to-wall carpeting (Bishop, 2002).

Upholstered furniture was also observed (Pictures 19 and 20). Upholstery and plush toys are covered with fabrics that may be exposed to human skin. This type of contact can leave oils, perspiration, hair and skin cells. Dust mites feed upon human skin cells and excrete waste products that contain allergens. In addition, if relative humidity levels increase above 60 percent, dust mites tend to proliferate (US EPA, 1992). In order to remove dust mites and other pollutants, frequent vacuuming of upholstered furniture is recommended (Berry, 1994). It is also recommended that upholstered furniture (if present in schools), be professionally cleaned on an annual basis. If an excessively dusty environment exists due to outdoor conditions or indoor activities (e.g., renovations), cleaning frequency should be increased (every six months) (IICRC, 2000).

**Area rug, cloth-covered chair, and beanbag chairs**

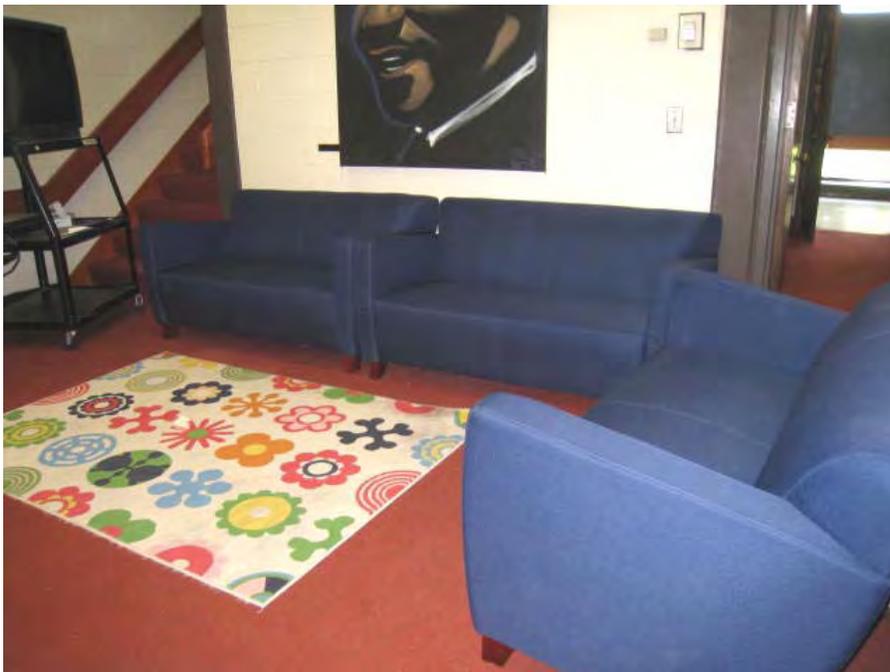
**Picture 20**

**Area rug on carpet and upholstered couches in library**
