# **INDOOR AIR QUALITY ASSESSMENT**

**North Elementary School  
580 Whetstone Hill Road  
Somerset, MA**

Prepared by:  
The Massachusetts Department of Public Health  
Bureau of Environmental Health  
Indoor Air Quality Program  
April 2013

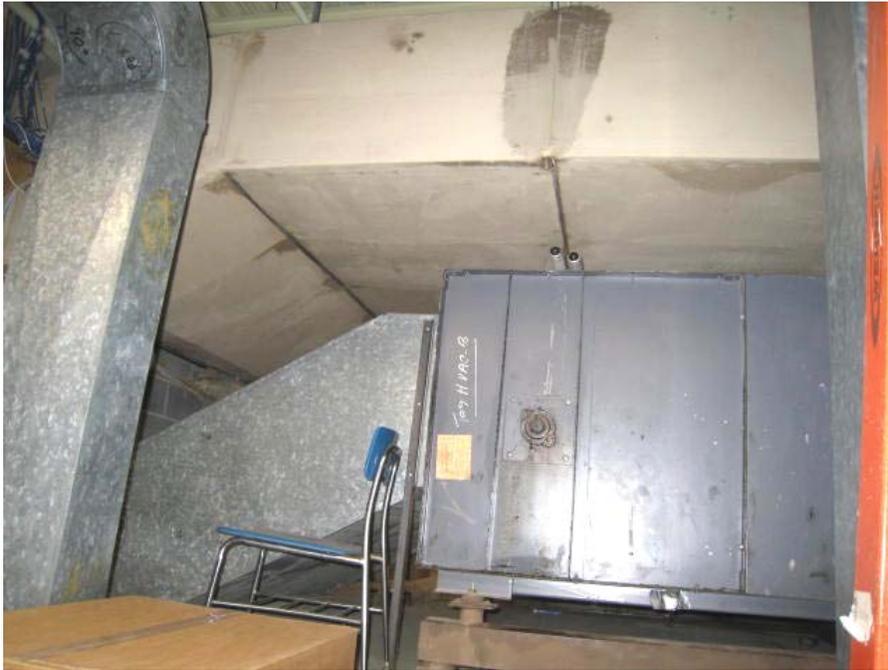
**Picture 1**

handling units (AHUs) located in a penthouse and in mechanical rooms (Picture 1). AHUs draw air in from outside through fresh air intakes. Air is filtered, heated and/or cooled by the AHU before it is distributed to occupied areas via ceiling-mounted air diffusers (Picture 2). Exhaust air is drawn into wall or ceiling-mounted vents and returned back to the AHUs via ductwork (Picture 3). Some of the return vents were partially obstructed by classroom items, which can inhibit airflow.

**Air handling unit in mechanical room**

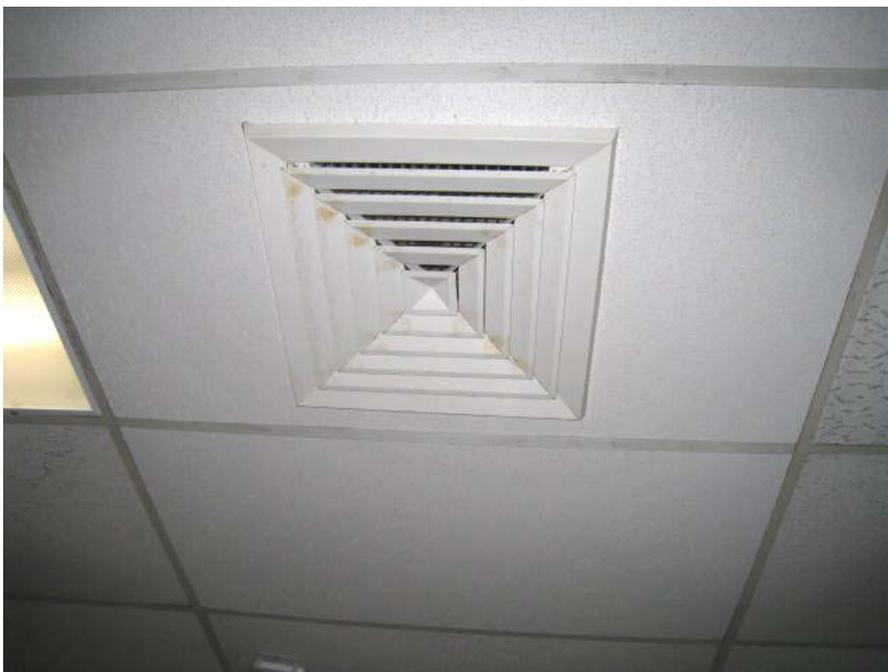
**Picture 2**

**Ceiling-mounted supply diffuser**

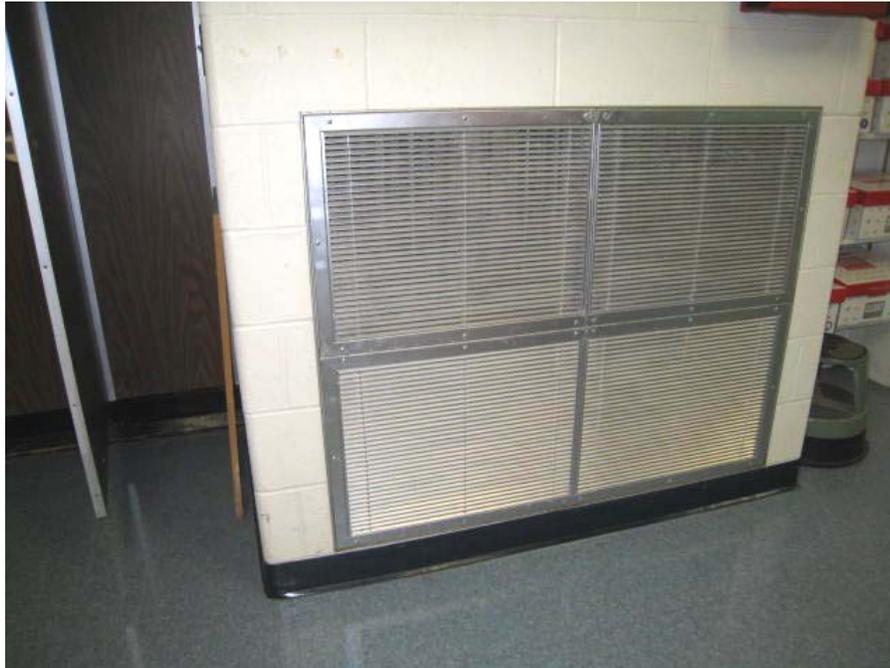
**Picture 3**

**Wall-mounted exhaust/return vent**

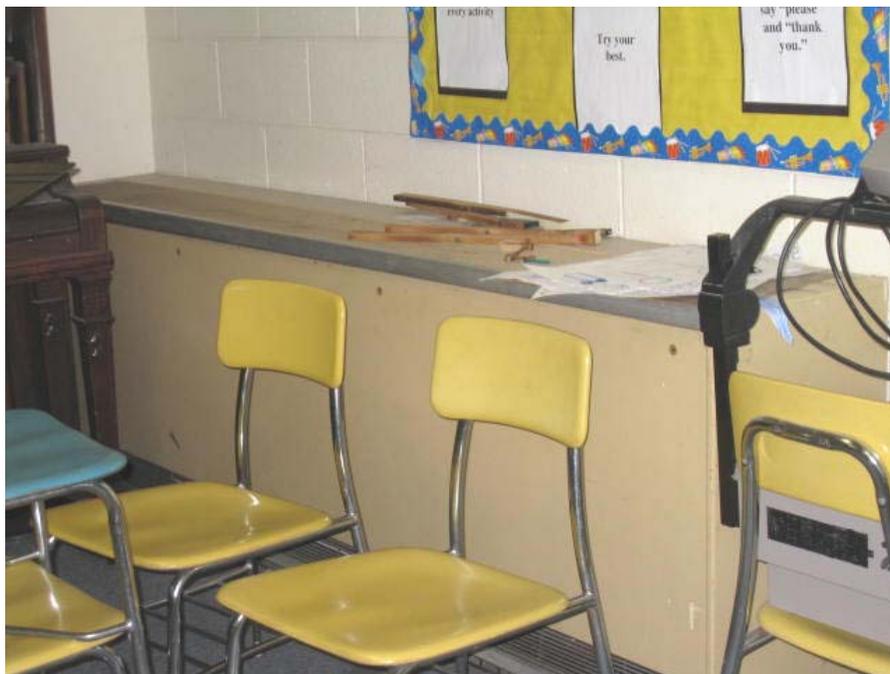
**Picture 4**

Fresh air in six classrooms is supplied by unit ventilator (univent) systems (Picture 4). A univent draws air from the outdoors through a fresh air intake located on the exterior wall of the building (Picture 5) and returns air through an air intake located at the base of the unit. Fresh and return air are mixed, filtered, heated and provided to classrooms through an air diffuser located in the top of the unit ([Figure 1](#)). Univents have fan settings of “low” and “high”. Several of the univents were found deactivated or obstructed by classroom items at the time of assessment. In order to provide fresh air as designed, univents must be operating and free of obstructions. Classrooms with univents are typically outfitted with a corresponding exhaust vent (usually on an opposite wall) to remove stale air and pollutants. Exhaust vents could not be identified in these rooms. Without adequate supply/exhaust ventilation, excess heat and normally-occurring environmental pollutants can build up leading to indoor air/comfort complaints.

**Classroom unit ventilator (univent)**

3. Adjust the percentage of fresh air supplied to and/or exhausted by the HVAC system to improve air exchange.
4. Remove all blockages from univents (top and front) to ensure adequate airflow.

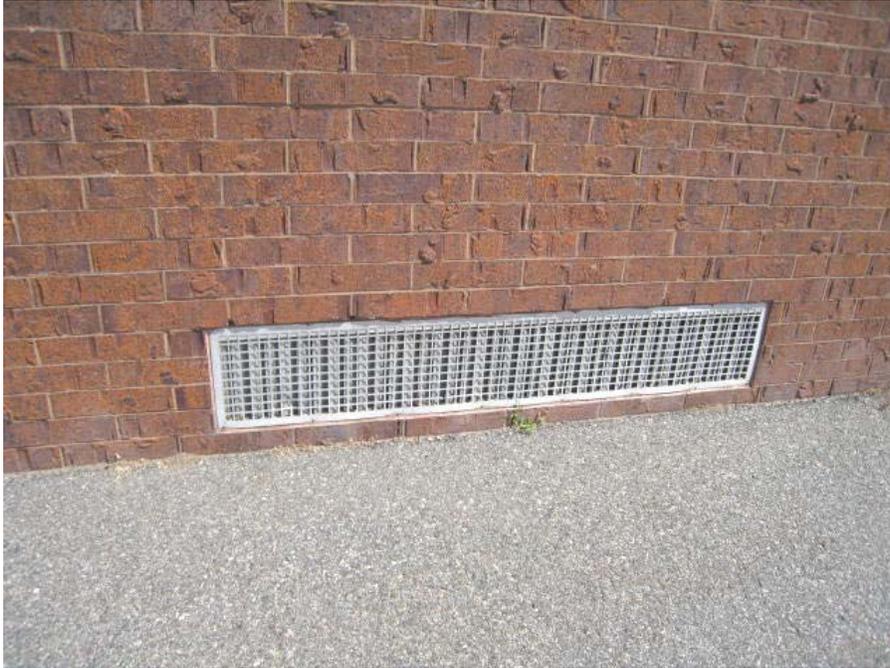
**Picture 5**

**Univent fresh air intake**

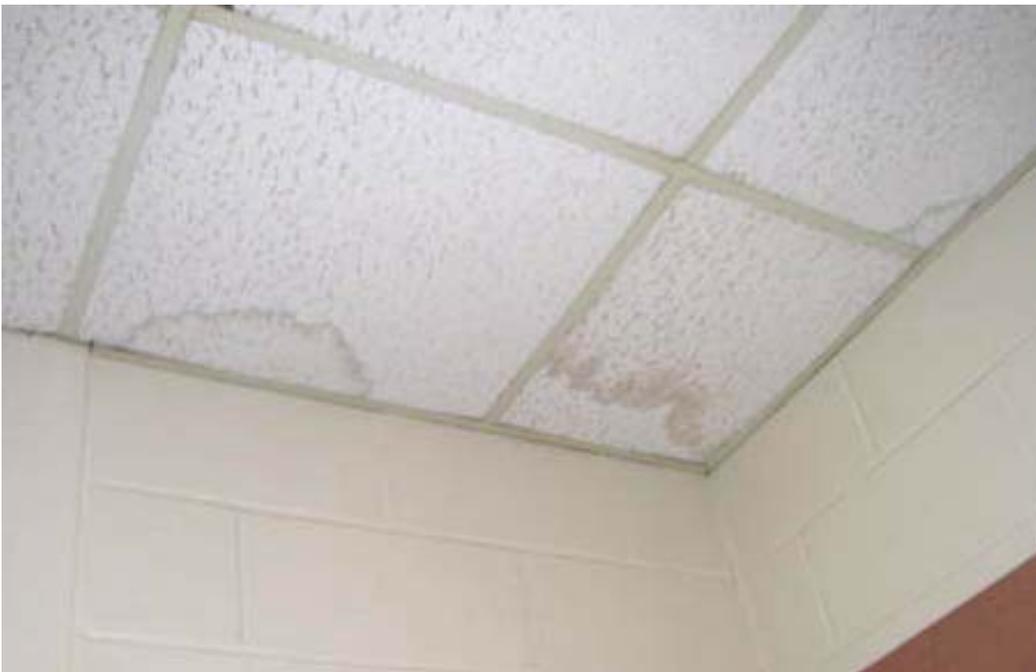
**Picture 6**

A few areas throughout the school had water-damaged ceiling tiles (Table 1; Picture 6). In some cases, ceiling tiles were of the inter-locking type, which are often difficult to replace and may require destruction of the ceiling/substrate or removal of large areas (Picture 7). Water-damaged ceiling tiles can provide a source of mold growth and should be replaced after a water leak is discovered and repaired.

**Water-damaged ceiling tiles**

10. Ensure all roof/plumbing leaks are repaired and replace water-damaged ceiling tiles. Examine the area above and around water-damaged areas for mold growth. Disinfect areas with an appropriate antimicrobial as needed.

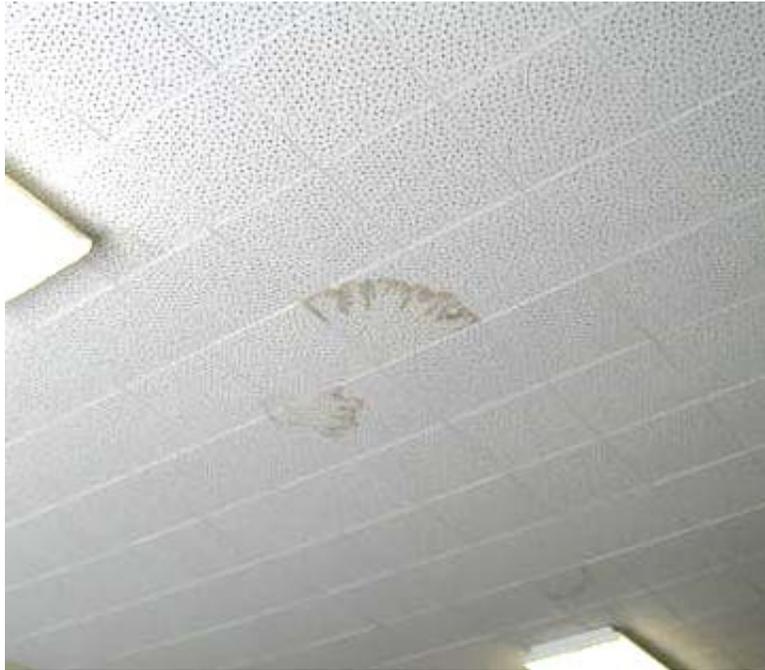
**Picture 7**

**Water-damaged interlocking ceiling tiles**

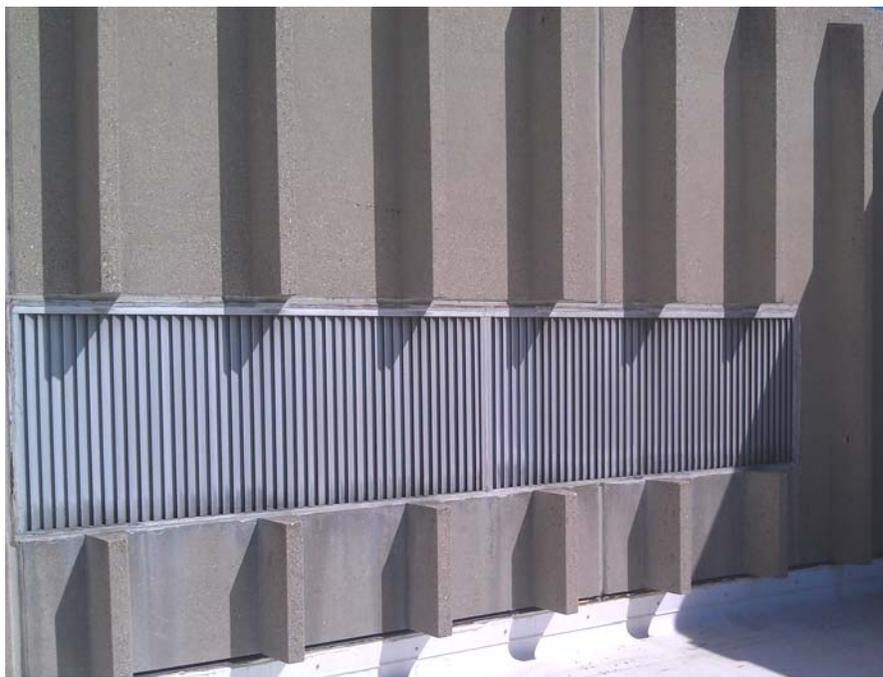
**Picture 8**

Staff reported an intermittent leak against the interior wall near the reading room. Mr. Campos reported that this leak periodically occurs during heavy, wind-driven rain events and that ceiling tiles are changed after the leaks are reported. The leak is attributed to water intrusion through an air intake for an AHU (Picture 8). Water enters through the fresh air intake and then drains against the interior cement block wall, where it pools on the floor, and ultimately into the classroom area through breaches around the supply ductwork (Picture 9). Please note, missing flashing was observed around ductwork, likely resulting in the reported leaks (Picture 10).

**AHU fresh air intake**

12. Contact HVAC/building engineer/roofing contractor to determine best methods to eliminate/reduce water penetration through intake vents on roof.
13. Ensure plants are equipped with non-porous drip pans. Avoid over-watering and examine drip pans periodically for mold growth. Disinfect with an appropriate antimicrobial where necessary.

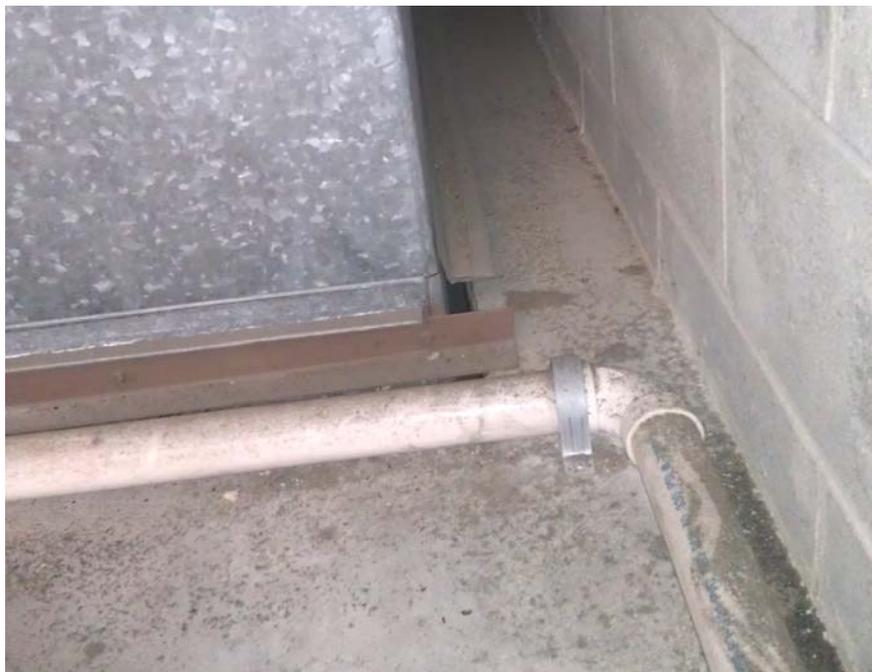
**Picture 10**

**Missing flashing around ductwork, which results in leakage to classroom**

11. Replace missing flashing observed (Picture 10). Consider supplementing with additional sealing products (i.e. silicone) as an additional measure to prevent water leakage into occupant areas.

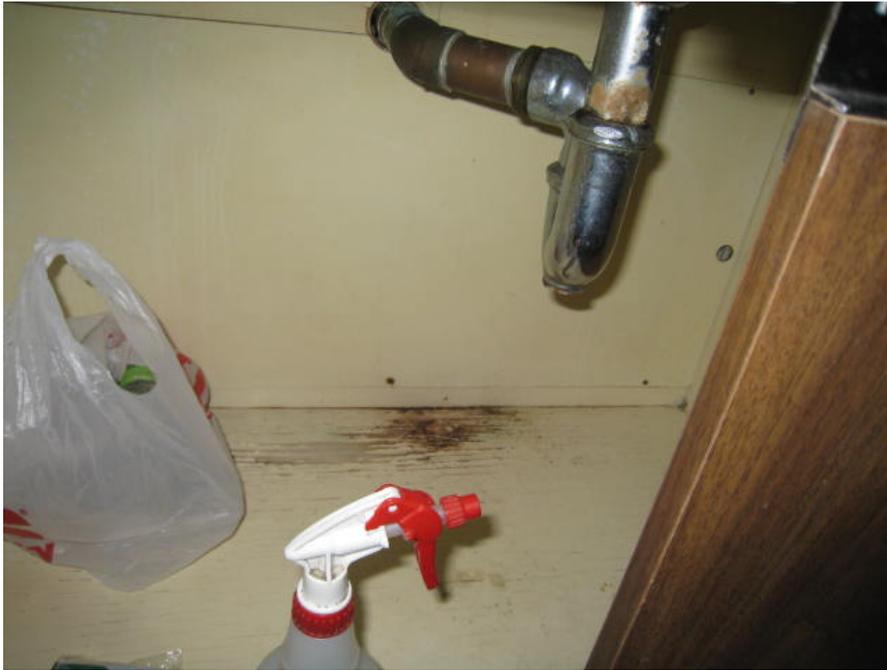
**Picture 11**

The cabinets under sinks were examined and many had evidence of past water leakage or condensation (Picture 11). Cabinets were also found to contain items, including porous materials such as paper or cardboard (Picture 12). The area under sinks is often a moist environment. Porous items stored there are subject to water damage and/or mold growth. In addition, the storage of large amounts of materials there can prevent detection of leaks which can damage the wood of the cabinets themselves.

**Water-damaged wood under sink**

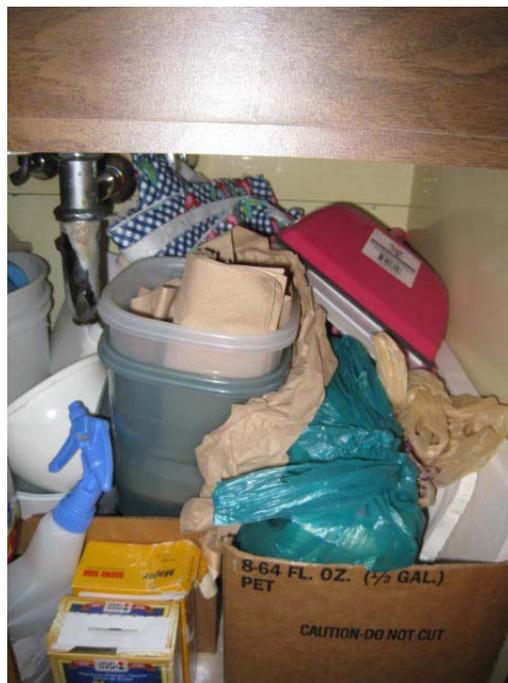
**Picture 12**

**Porous items stored under sink**

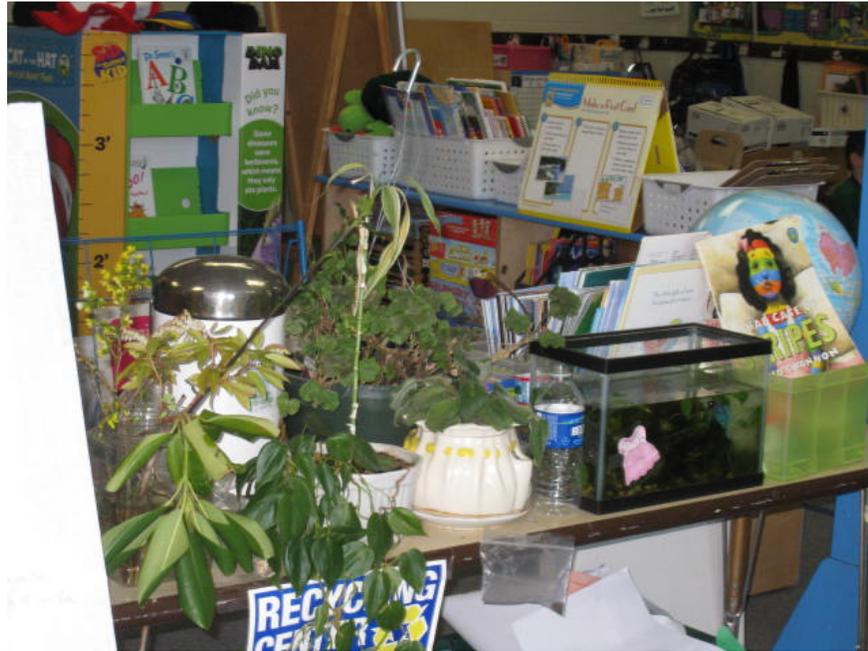
**Picture 13**

**Aquarium in classroom**

14. Clean and maintain aquariums and terrariums to prevent mold growth and associated odors.
15. Reactivate/repair exhaust vent in copy room to help reduce excess heat and odors.

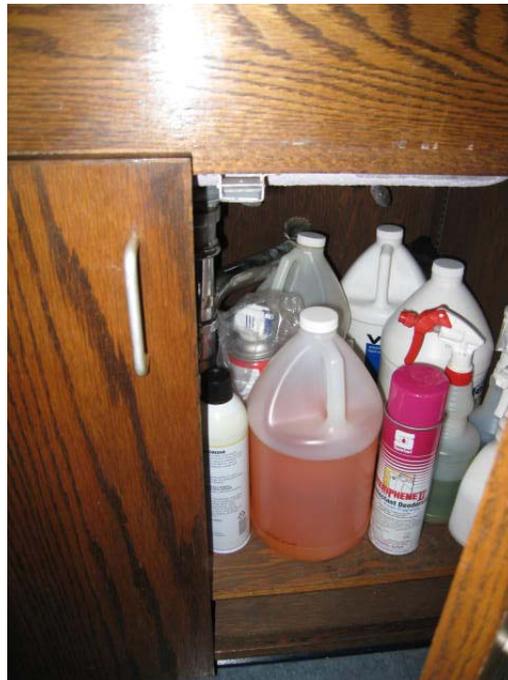
**Picture 14**

Cleaning products and air fresheners were found in several rooms (Picture 14; Table 1). Cleaning products contain chemicals that can be irritating to the eyes, nose and throat of sensitive individuals. These products should be properly labeled and stored in an area inaccessible to children. Additionally, an MSDS should be available at a central location for each product in the event of an emergency. Consideration should be given to providing teaching staff with school issued cleaning products and supplies to ensure that MSDS information is available for all products used at the school. Air fresheners also contain VOCs that can be irritating to the eyes, nose and throat of sensitive individuals. Many air fresheners contain 1,4-dichlorobenzene, a VOC which may cause reductions in lung function (NIH, 2006). Deodorant materials do not remove materials causing odors, but rather mask odors which may be present in the area.

**Cleaning products under sink**
