INDOOR AIR QUALITY ASSESSMENT

**Mass Health Enrollment Center
Tewksbury Hospital Campus, Halls 1 and 2
367 East Street
Tewksbury, Massachusetts**

Prepared by:
Massachusetts Department of Public Health
Bureau of Environmental Health
Indoor Air Quality Program
October 2013

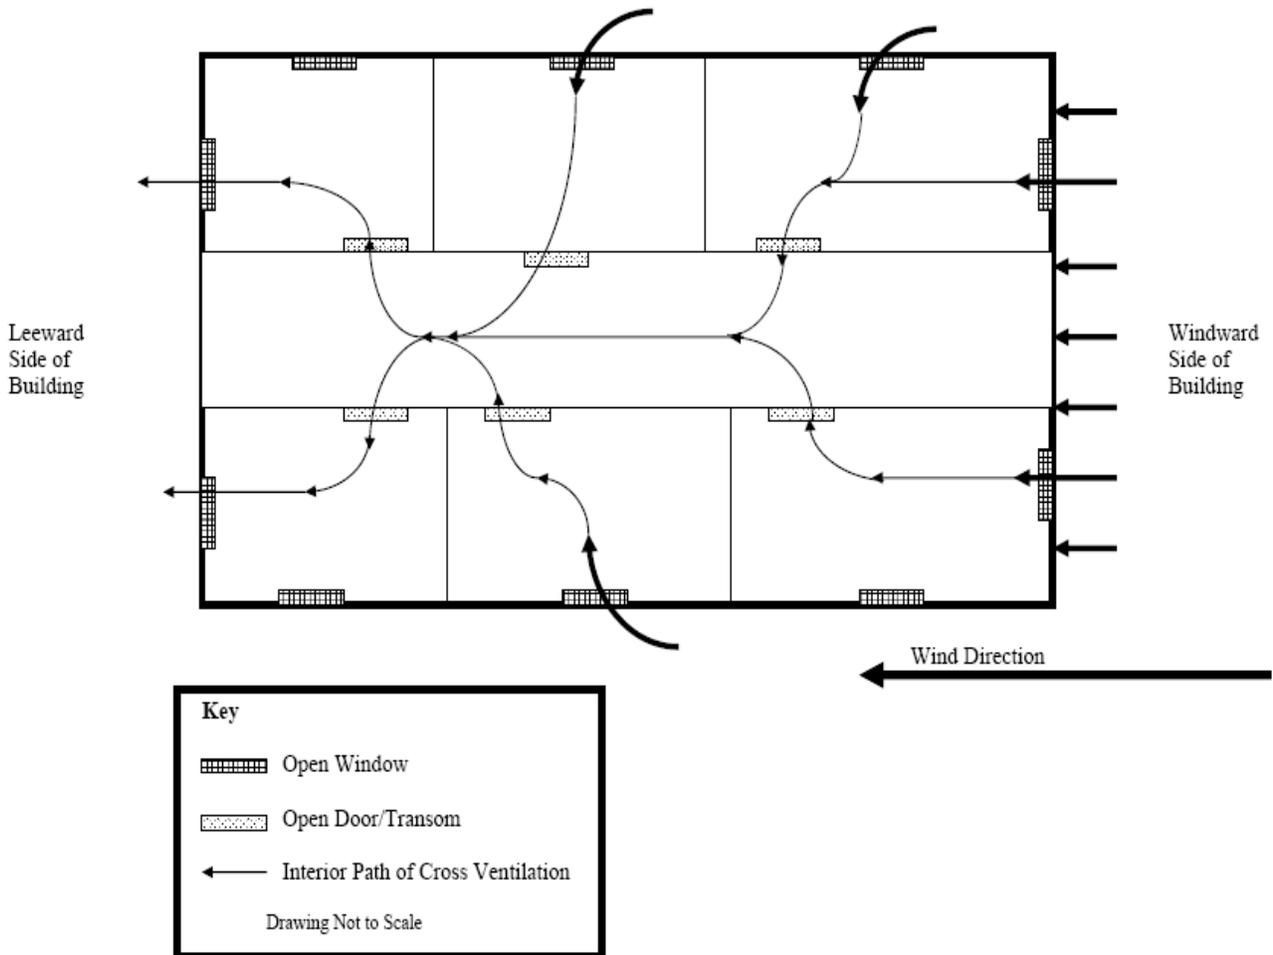
Figure 1

Cross Ventilation in a Building Using Open Windows and Doors/Transoms

1. Operate window AC units for cooling/fresh air when they are installed and use operable windows to provide air exchange. Keep windows closed in rooms where ACs are operating in cooling mode. Ensure that windows are closed tightly at the end of each workday to prevent security issues and the freezing of pipes during cold weather.

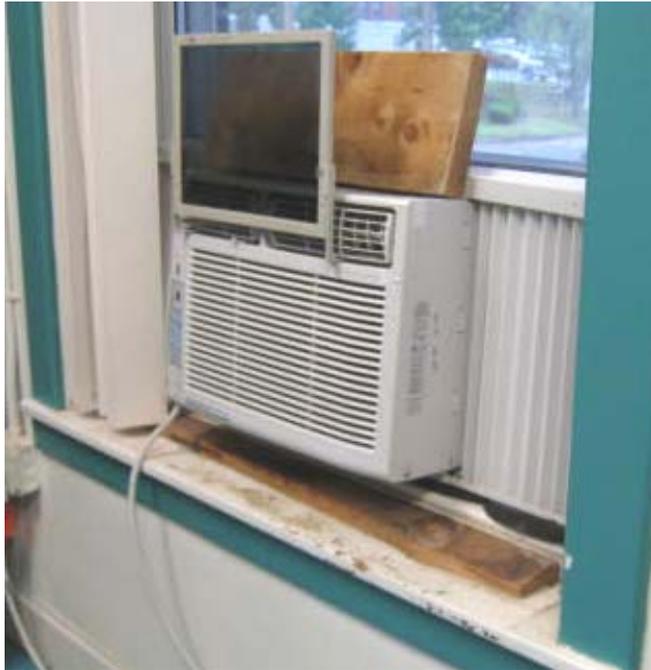
Picture 1

The MHEC offices have no mechanical ventilation systems and use windows to introduce fresh air. Window air conditioners (ACs) were installed in most offices and were operating on the day of assessment (Picture 1; Table 1). When cooling is not called for, window AC units can be operated to provide limited outside air through the “fan only” setting. In some locations, the window AC units were not activated in either cooling or “fan only” settings (Table 1) and windows were closed, therefore no means of providing fresh air was occurring at the time of assessment.

In a few locations, strips of foam used to seal around the window ACs were found to be moist from the driving rain and high humidity conditions outside (Picture 1). If these porous materials remain wet, microbial growth can occur. Adjacent wood and wall materials can also become moist due to contact with the foam material, which wicks the moisture from outside. The US Environmental Protection Agency (US EPA) and the American Conference of Governmental Industrial Hygienists (ACGIH) recommend that porous materials be dried with fans and heating within 24 to 48 hours of becoming wet (US EPA, 2001; ACGIH, 1989). If not dried within this time frame, mold growth may occur. Once mold has colonized porous materials, they are difficult to clean and should be removed/discarded.

Window air conditioner; note stained wood, and foam (foam was moist)

3. Seal around air conditioners with water-resistant materials. If materials used to seal around air conditioners become moist due to rain infiltration, ensure they can dry thoroughly or replace.

9. Avoid the use of scented products including air fresheners.
10. Clean window AC filters on a regular basis in accordance to the manufacturer's instruction, including prior to first use during the cooling season and before storage at the end of the summer. Ensure window AC units are stored in an area free from mold, dust and other contaminants when not in use.

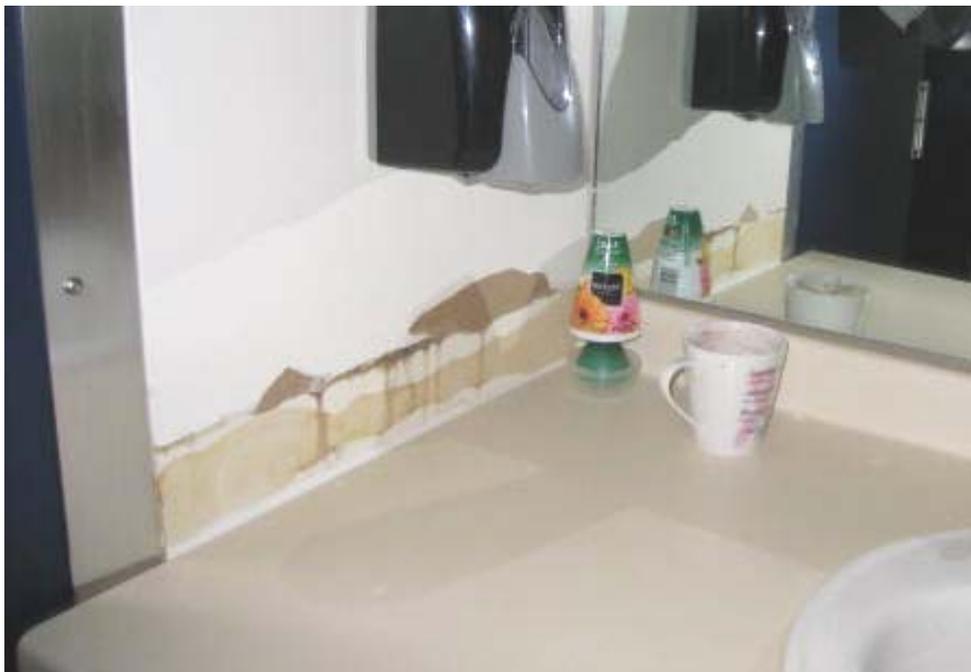
Picture 2

A few areas had water-stained ceiling tiles (Table 1), which are evidence of historic roof or plumbing leaks. Water-damaged ceiling tiles can provide a source of microbial growth and should be replaced after a water leak is discovered and repaired. In the ladies room, coving appeared to be peeling next to the sink, possibly from water damage due to overflow or chronic high humidity (Picture 2).

Missing coving in ladies room sink area; note also pop-up air freshener

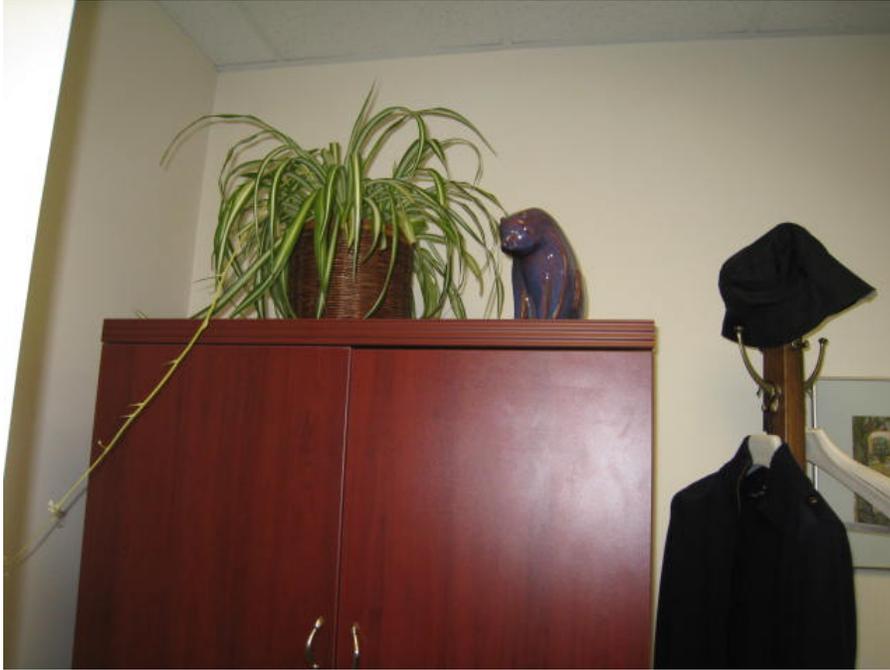
Picture 3

Plants and cut flowers were observed in some areas (Table 1; Picture 3). Plants should be properly maintained and equipped with drip pans. Cut flower vases should be cleaned and the water changed regularly to prevent microbial growth and odors from stagnant water. Plants and vases should also not be placed on porous materials, since water damage to porous materials may lead to microbial growth.

Plant in an office

6. Ensure plants and cut flowers are well maintained to prevent spills/leaks, stagnant odors and the aerosolization of pollen, dirt and mold.
7. Continue with paperless office procedures to the greatest extent possible to reduce the need for printing. Use the higher-capacity printers/copiers located outside of offices for large jobs as often as possible. Locate printers away from occupants to the greatest extent possible. Maintain printers in accordance with manufacturer's instructions.

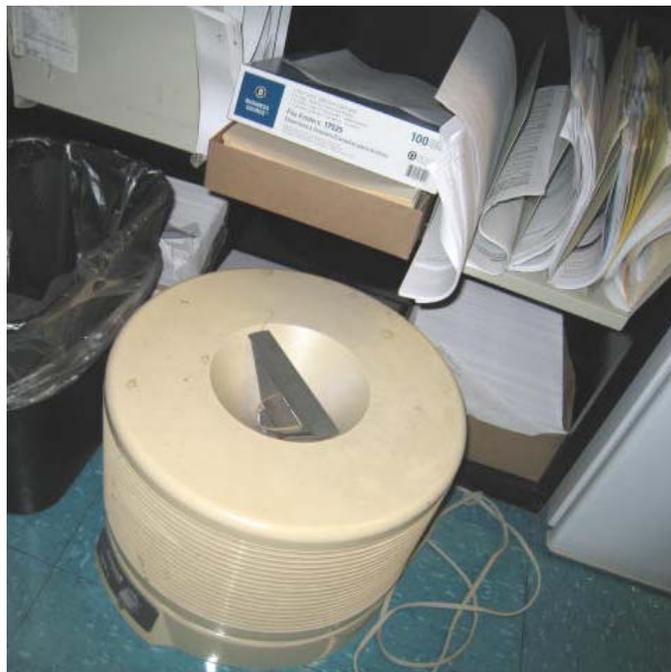
Picture 4

In some offices, items (papers, books, personal items) were found on desks and the floor (Pictures 4 and 7). These items make it difficult for custodial staff to clean. Items should be reduced, relocated and/or be cleaned periodically to avoid excessive dust build up. In addition, these materials can accumulate on flat surfaces (e.g., desktops, shelving and carpets) in occupied

HEPA filter unit, note also papers/boxes on table and floor

11. Clean and maintain HEPA filters in accordance with manufacturer's instructions.
12. Clean personal fans of dust/debris on a regular basis.
13. Ensure all food-preparation equipment is kept clean and well-maintained to prevent the production of smoke/odors and the attracting of pests. Regularly clean refrigerators.

16. Clean fluorescent light fixture shown in Picture 6. Examine nearby areas for missing/damaged window screens, and/or other penetrations/sources of flies.
17. Relocate or consider reducing the amount of materials stored in offices and common areas to allow for more thorough cleaning.
18. Refer to resource manuals and other related indoor air quality documents for further building-wide evaluations and advice on maintaining public buildings. Copies of these materials are located on the MDPH's website: <http://mass.gov/dph/iaq>.

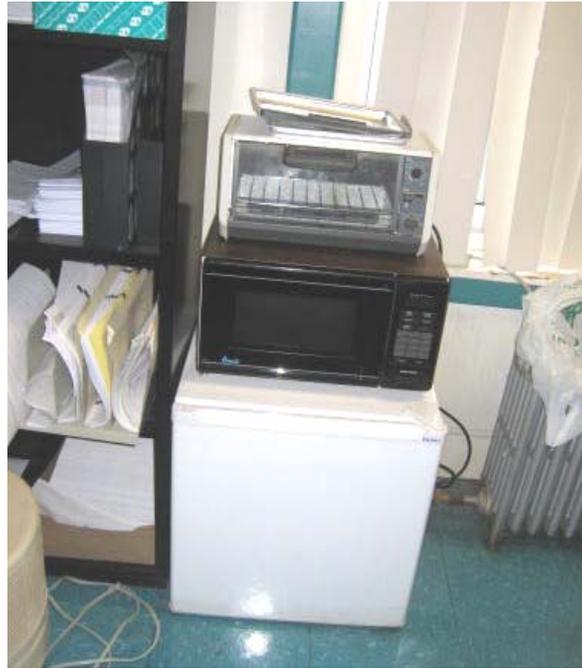
Picture 5

Food-preparation equipment including microwaves, toaster ovens, coffee makers, and refrigerators were observed in many offices (Table 1; Picture 5). The use of this equipment can provide a source of particulates and odors, particularly if the equipment is not kept clean. Food/debris remaining on heating elements can burn the next time the items are used, producing smoke and odors. In addition, crumbs remaining on food-preparation equipment can be

attractive to pests. Refrigerators in particular can be a source of moisture and, if not cleaned out and washed inside regularly, can be a source of mold and unpleasant odors.

Refrigerator, microwave and toaster oven in office

14. Consider removing food-preparation equipment from occupied areas and use in central location (e.g., kitchen/breakroom).
15. Refer to the recommendations from the 2005 report (Appendix A) for further investigation and cleaning to determine and remediate the source of odors in room 108 concentrating on drains/pipes in walls. Continue to use the room infrequently or not at all until the source can be determined.

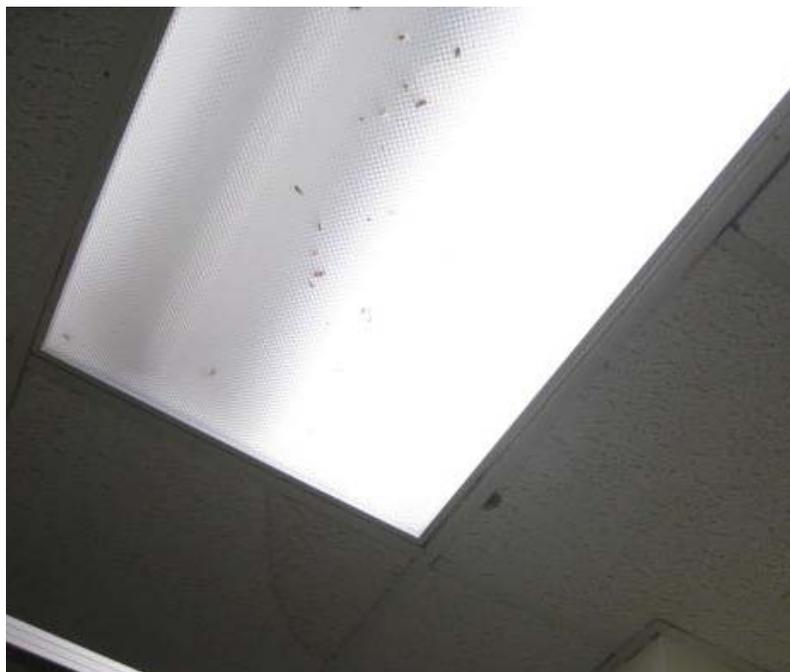
Picture 6

A fluorescent light fixture was observed to have numerous flies under the cover (Picture 6). Light fixtures should be cleaned regularly to remove debris that can become aerosolized. The presence of so many dead flies in this area suggests that window screens are missing/damaged or the edges around air conditioners may not be properly sealed.

Flies under fluorescent light cover

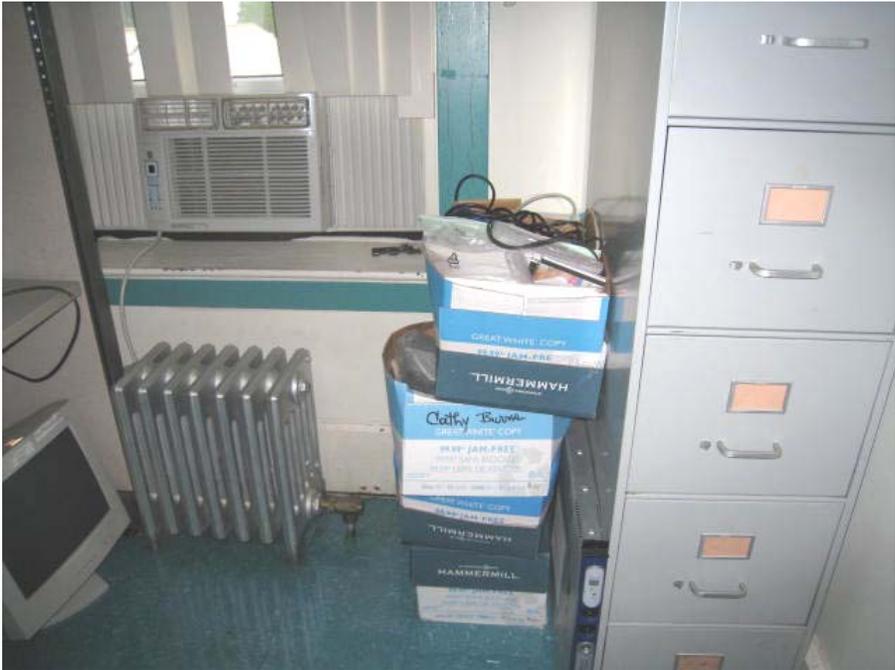
Picture 7

Boxes/items on floor
