INDOOR AIR QUALITY ASSESSMENT

**Belmont Light
40 Prince Street
Belmont, MA**

Prepared by:
Massachusetts Department of Public Health
Bureau of Environmental Health
Indoor Air Quality Program
July 2014

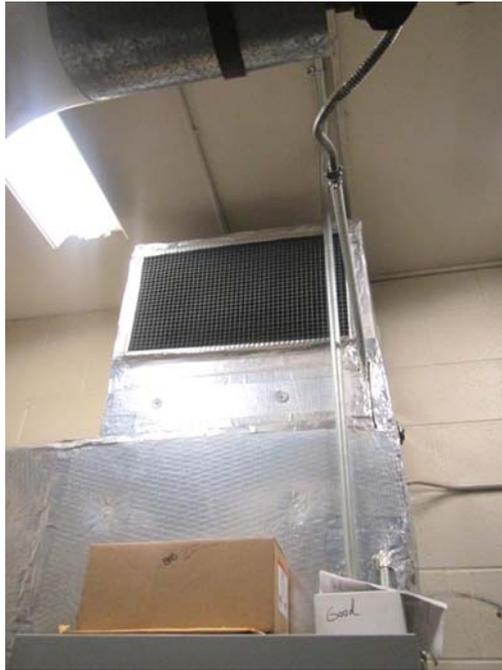
Picture 1

It can be seen that carbon dioxide levels were below 800 parts per million (ppm) in 20 out of 21 areas tested, indicating adequate air exchange in the majority of areas surveyed at the time of assessment (Table 1). Fresh air is provided by an air handling unit (AHU) located in the mechanical room (Picture 1). This AHU has a single fresh air supply vent located on the outside wall at the rear of the building (Picture 2). Once air is filtered, it is heated or cooled and delivered to occupied areas via ceiling-mounted fan coil units (Picture 3) ducted to supply diffusers (Picture 4). Return air is drawn into a ceiling plenum via vents (Picture 5) and ducted back to the AHU located in the utility room.

Air handling unit in mechanical room

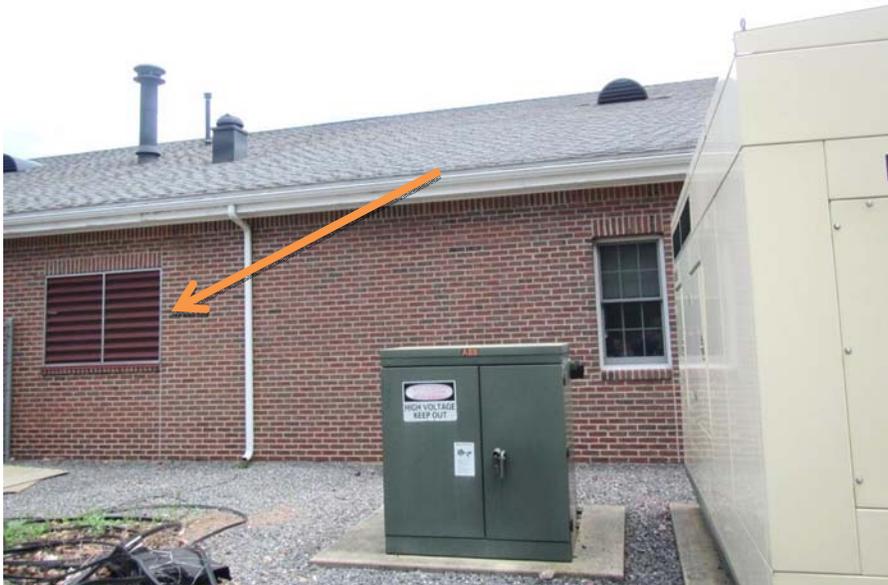
Picture 2

BEH/IAQ staff observed the sole fresh air intake vent in the rear of the building. It was reported that office staff have complained of vehicle exhaust odors in the past. This intake vent is in close proximity to a parking lot area (Picture 10) used by tree trimming vehicles under contract with BL. M.G.L. chapter 90 section 16A prohibits the unnecessary operation of the engine of a motor vehicle for a foreseeable time in excess of five minutes (MGL, 1996). It is strongly recommended a buffer zone be created around this fresh air intake vent to prevent the draw of vehicle exhaust into the ventilation system of the building. This may be achieved by installing anti-idling signs in combination with physical barriers.

It was also noted that the fresh air intake vent is close to the main backup generator for the facility. It was reported that this generator is tested once weekly (Tuesday) as part of a regular maintenance schedule. MDPH recommends either scheduling the generator testing when the building is unoccupied or extending the exhaust above and/or away from the fresh air intake.

Fresh air intake vent

3. Develop a plan to prevent vehicle exhaust from being entrained into the fresh air intake.
4. Perform weekly generator testing during a time when building is unoccupied or consider ducting generator exhaust away from fresh air intake.

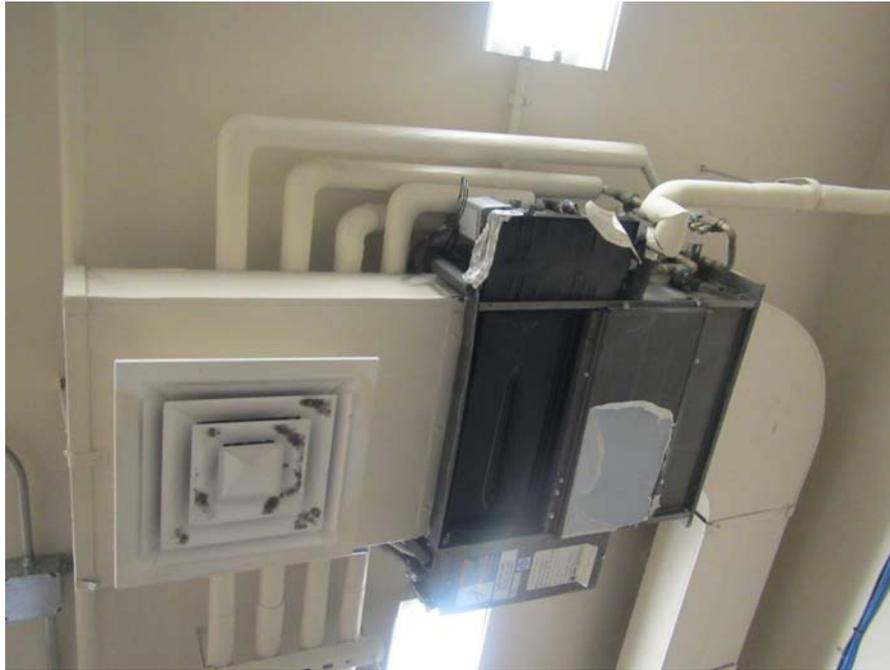
Picture 3

Dust was observed collected on air supply diffusers in a few areas (Picture 3). Dust that has collected on diffusers can be re-aerosolized when HVAC equipment is reactivated. Dust can be irritating to the eyes, nose and respiratory tract.

Fan coil unit with dust collected on supply diffuser

5. Clean supply diffusers and return vents on a regular basis.
6. Consider adopting a balancing schedule of every 5 years for all mechanical ventilation systems, as recommended by ventilation industrial standards (SMACNA, 1994).

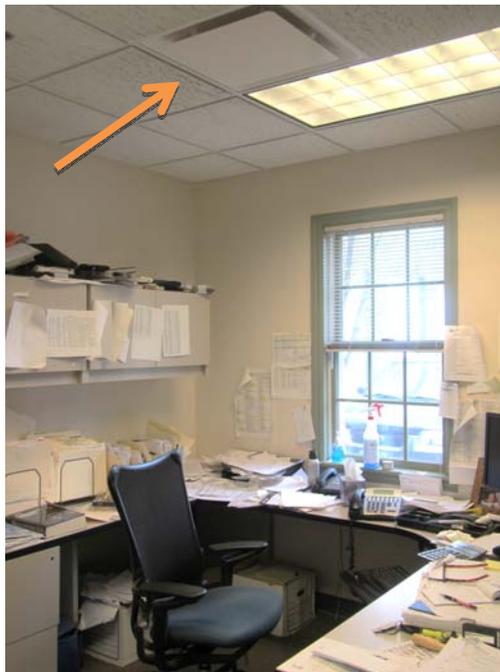
Picture 4

Some staff reported symptoms such as eye and respiratory irritation during the heating season. BEH/IAQ staff examined the workspaces of these staff and observed air diffusers were located directly above the desks of these individuals (Picture 4). Heating or cooling removes moisture from air. As a result, air that is supplied through air diffusers is typically lower in humidity. As mentioned, the sensation of dryness and irritation is common in a low relative humidity environment. Relocating air diffusers or redirecting air towards a wall may reduce occupant irritant symptoms.

In some offices, a large number of items were on flat surfaces (e.g., floors, windowsills, tabletops), which provide a source for dusts to accumulate. These items (e.g., papers, folders, boxes) make it difficult for areas to be cleaned. Items should be relocated and/or be cleaned periodically to avoid excessive dust build up. In addition, dust and debris can accumulate on flat surfaces (e.g., desktops, shelving and carpets) in occupied areas and subsequently be re-aerosolized causing further irritation.

**Supply air diffuser located directly above occupant's seat,
note amount of items on desk**

1. Redirect or relocate supply air diffusers to prevent direct impact on individuals.
2. Set thermostats to the fan “on” position to provide continuous air circulation/filtration during business hours.

15. Relocate or consider reducing the amount of stored materials in offices to allow for more thorough cleaning. Move items off floors when possible. Clean items regularly with a wet cloth or sponge to prevent excessive dust build-up.

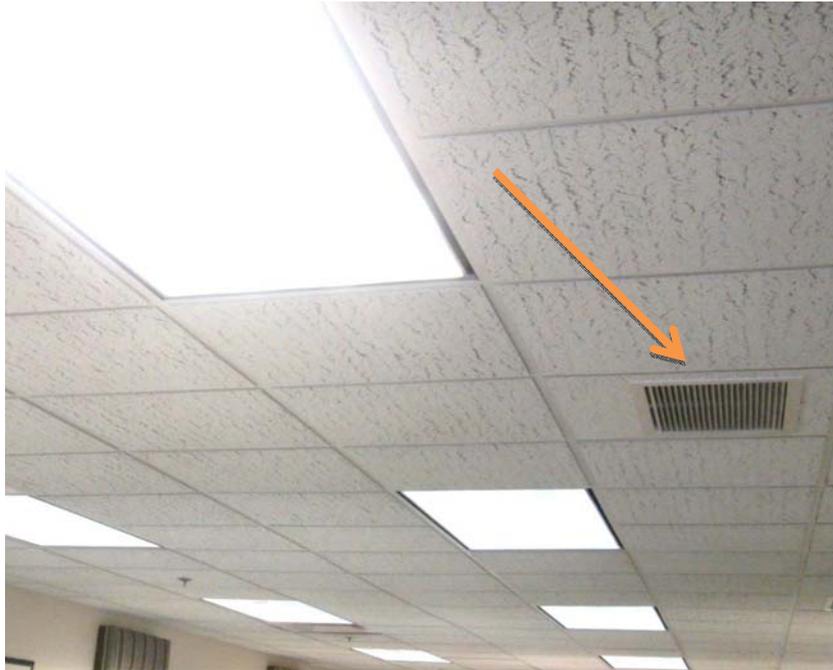
Picture 5

Return air grate

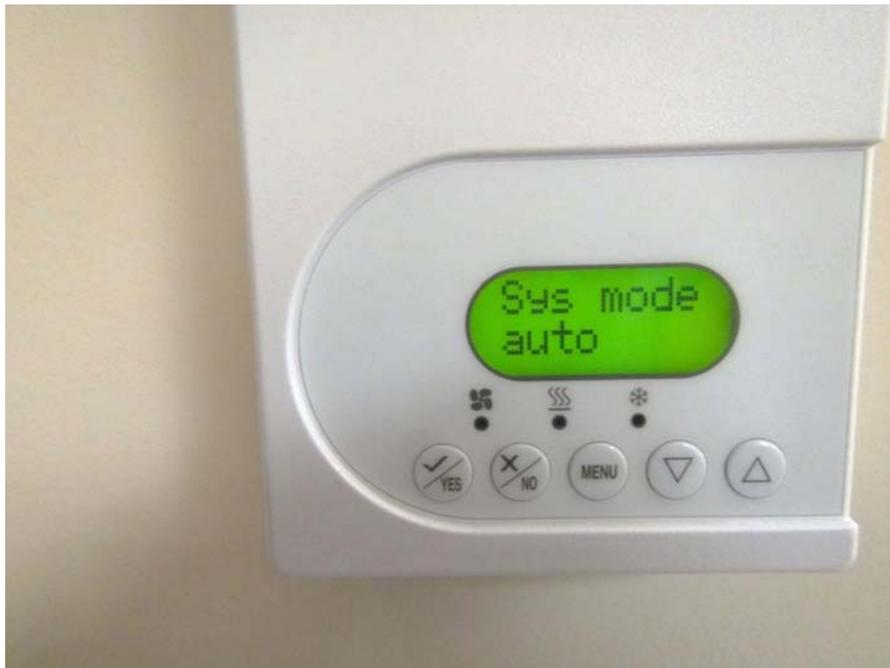
Picture 6

The heating, ventilation, and air conditioning (HVAC) system is controlled by digital thermostats. Thermostats examined had a fan switch with two settings, *on* and *auto*. When the fan is set to *on*, the system provides a continuous source of air circulation and filtration. The *automatic* setting on the thermostat activates the HVAC system at a pre-set temperature. Once the pre-set temperature is reached, the HVAC system is deactivated. Therefore, no mechanical ventilation is provided until the thermostat re-activates the system. At the time of assessment, all thermostat fan settings were in the “auto” position (Picture 6). As mentioned, this thermostat setting can limit airflow. The MDPH typically recommends that thermostats be set to the fan *on*

setting during occupied hours to provide continuous air circulation. The fan “auto” setting can lead to IAQ/comfort complaints due to lack of air exchange.

Thermostat fan set to "auto" mode

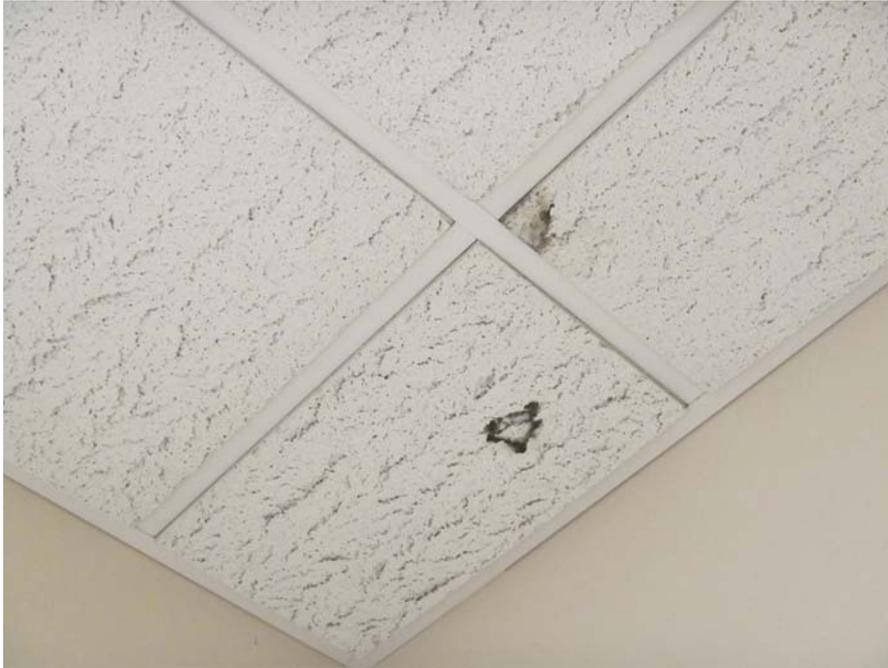
Picture 7

In order for building materials to support mold growth, a source of water exposure is necessary. BEH/IAQ staff noted two ceiling tiles with some water staining (Picture 7). Water-damaged ceiling tiles can provide a source of mold and should be replaced after a water leak is discovered and repaired. These areas should be monitored to ensure that leaks have been abated.

Water-damaged ceiling tiles

8. Replace any water-damaged ceiling tiles when a leak is discovered and repaired. Staff should be encouraged to report building leaks to management for prompt remediation.

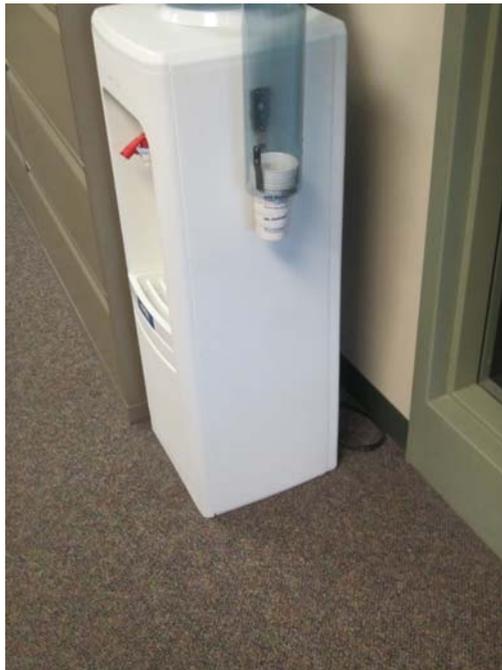
Picture 8

Water coolers and a small refrigerator were observed in carpeted areas (Picture 8). Spills or leaks from this equipment can moisten carpet and lead to microbial growth and degradation of

the carpet. MDPH recommends placing rubber or plastic trays beneath this equipment to protect the carpet from any leaks.

Water cooler on carpet

13. Place refrigerators and water dispensing equipment in non-carpeted areas or consider using a waterproof mat to contain spills or leaks.
14. Ensure refrigerators are cleaned out regularly. Clean moldy gaskets with a mild detergent or antimicrobial agent, if cannot be adequately cleaned consider replacing.

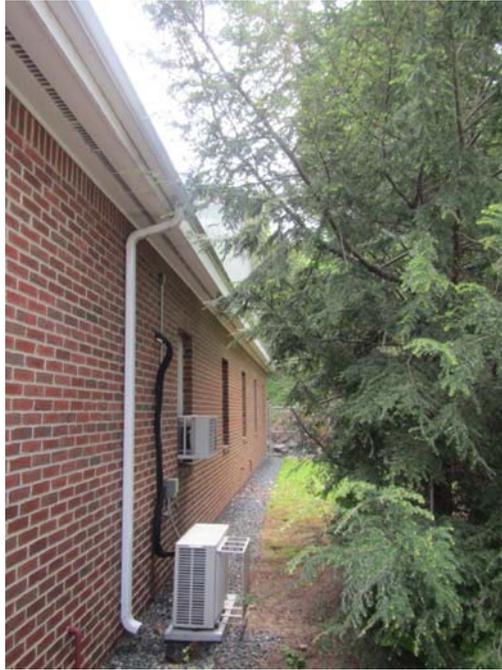
Picture 9

BEH/IAQ staff noted a tree in close proximity to the rear of the building (Picture 9). It is important to keep all vegetation away from building since it may allow for moisture, pests, and pollen to enter the building.

Small tree growing close to building

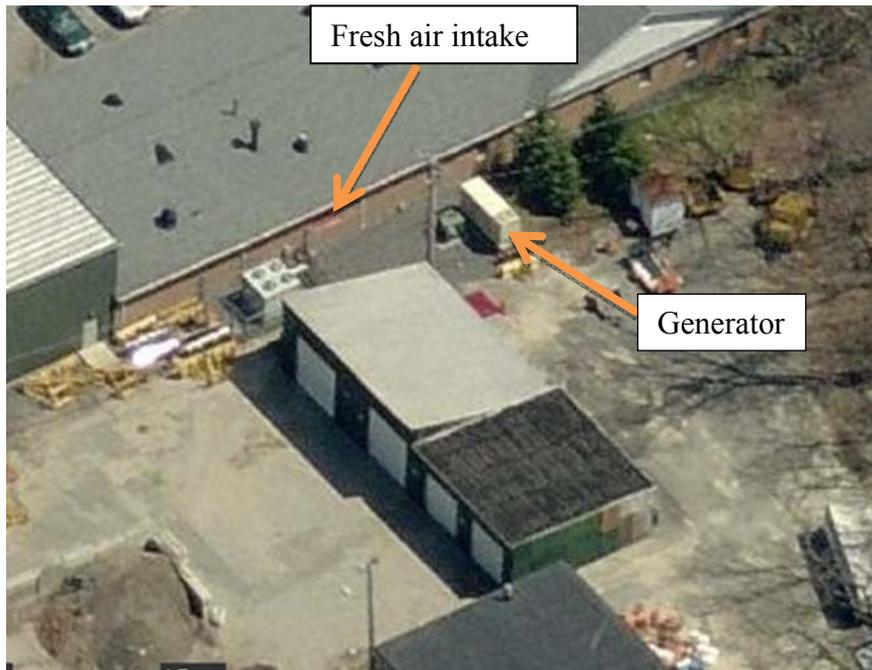
Picture 10

Parking area utilized by construction vehicles near fresh air intake
