INDOOR AIR QUALITY/MOLD ASSESSMENT

**Soldiers' Home in Chelsea
Quigley Building
100 Summit Ave
Chelsea, MA 02150**

Prepared by:
Massachusetts Department of Public Health
Bureau of Environmental Health
Indoor Air Quality Program
December 2014

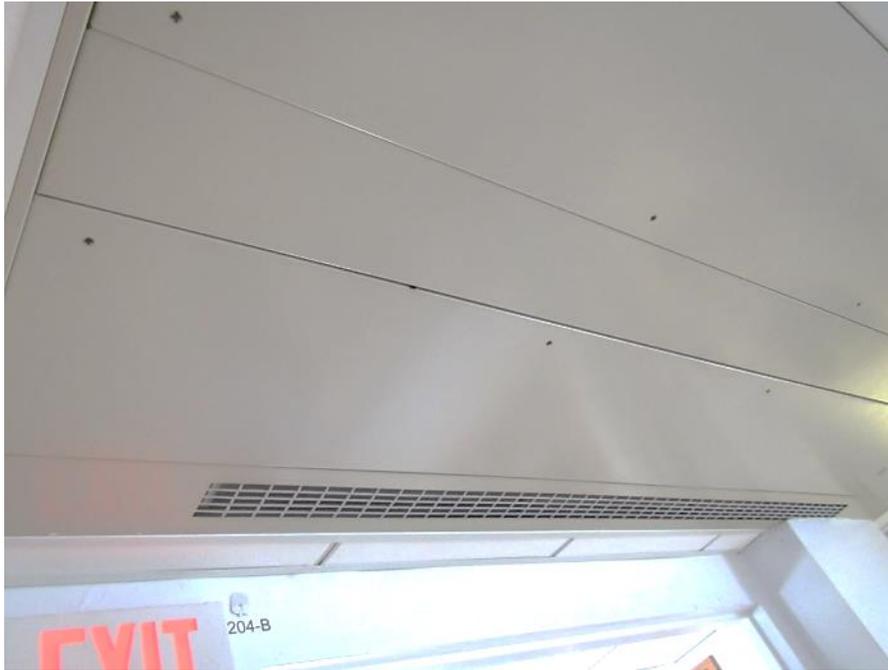
Picture 1

It can be seen that carbon dioxide levels were below 800 parts per million (ppm) in all areas tested, indicating adequate air exchange at the time of the assessment (Table 1). Ceiling-mounted air-handling units (AHUs) provide conditioned fresh air to patient wings (Picture 1). Fresh air and air returned from the occupant space are mixed, filtered, heated or cooled, and provided to the occupant space via air diffusers (Picture 2).

Air-handling unit (AHU) in patient wing

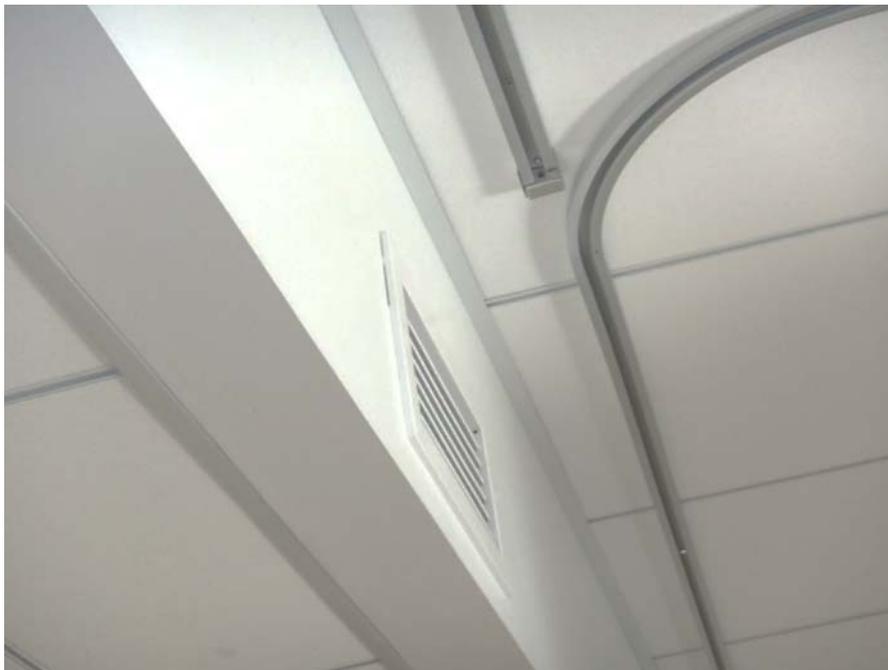
Picture 2

Fresh air diffuser in patient wing

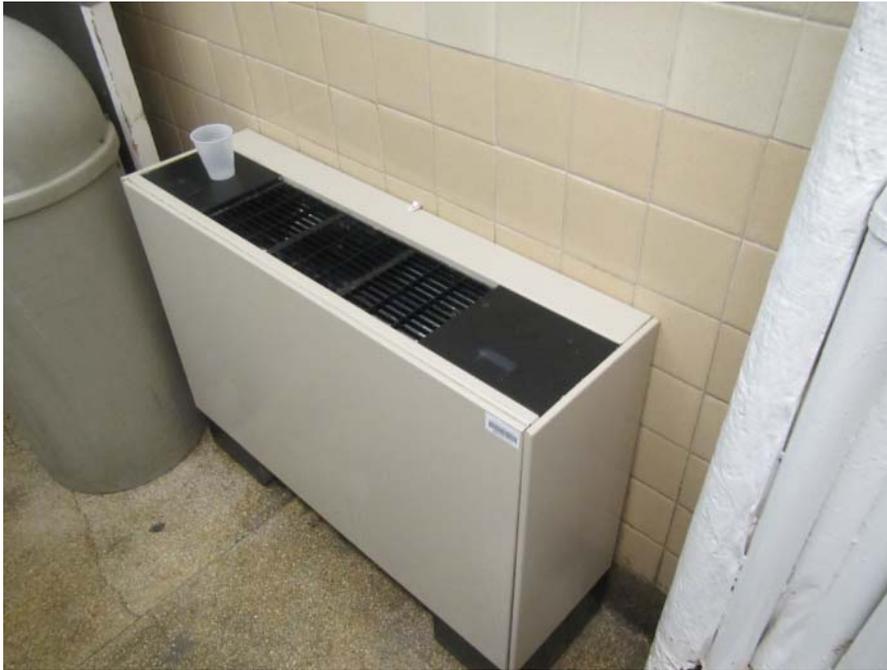
Picture 3

Conditioned air to offices, storage areas and patient rooms in the main portion of the building is provided by wall-mounted fan-coil units (FCUs). Air from a room is drawn through a return vent located at the base of the FCU; air is then filtered, conditioned (e.g., heated or cooled), and provided to the room through an air diffuser located at the top of the unit (Picture 3; Figure 1). The purpose of FCUs is to provide conditioned air. These units do not introduce fresh air, which is necessary to dilute normally occurring indoor pollutants. The use of openable windows is the sole means of providing fresh air to these areas of building.

Fan coil unit (FCU)

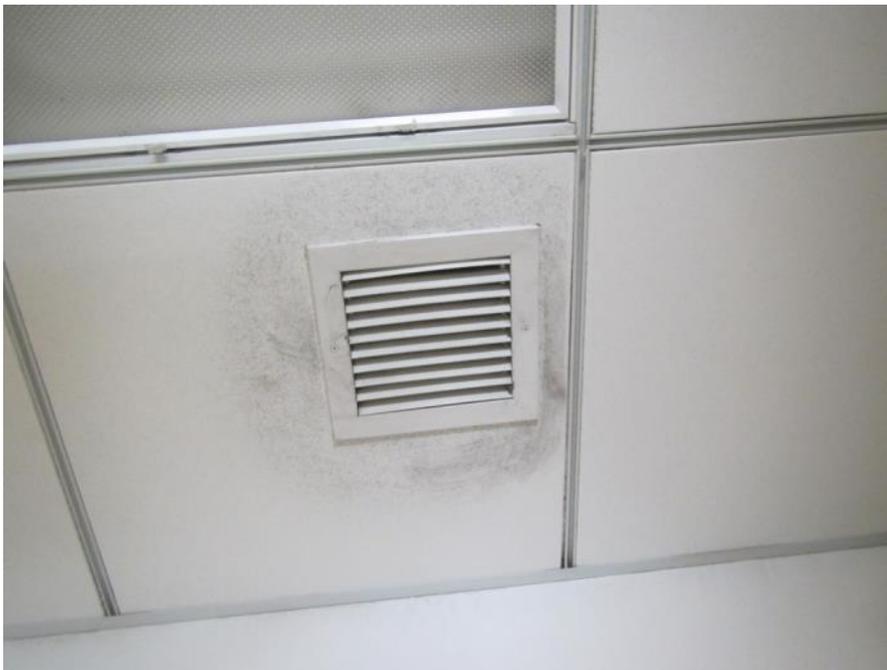
Picture 4

Ceiling-mounted return vents (Picture 4) are located in storage rooms off of offices and in common rooms. These return vents are ducted to penthouse exhaust fans that remove stale air and airborne materials from the building. Please note, at the time of the assessment, a strong draw of air was observed from the exhaust vents located in the office storage rooms. The doors

Occupants reported concerns of mold in the storage rooms. Dust and fine debris was observed around exhaust vents (Picture 4). As previously discussed, a strong draw of air was noted in the storage rooms. The debris observed around the exhaust vent is likely the result of the strong draw of air. Such debris typically consists of human skin cells, dirt, and mold spores. Since there is no active water source, these mold spores will remain dormant. At the time of the assessment, MDPH/BEH staff recommended cleaning vents and conducting a thorough cleaning of the storage closets.

Return vent in storage room

3. Ensure storage rooms are cleaned regularly to prevent buildup of dust and debris.
4. Ensure FCUs are free of items placed on top or in front of the unit.

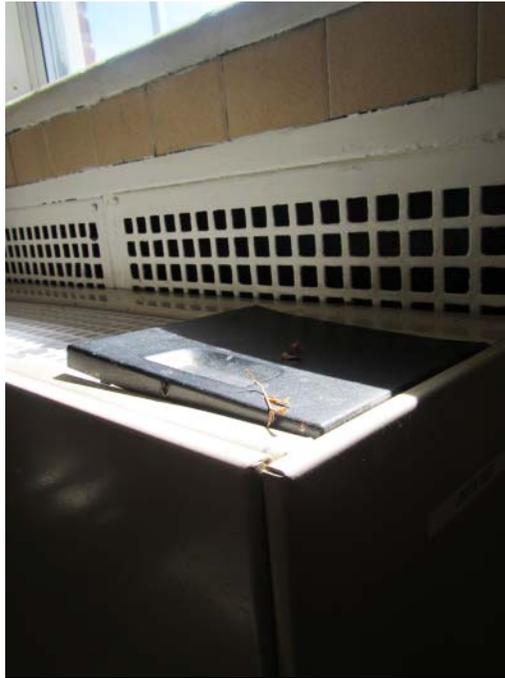
Picture 5

At the time of the assessment, BEH/IAQ staff examined the condition of FCUs in offices and common areas including the interior of FCUs in a few locations. In the majority of areas assessed, plant debris and other materials were observed within the FCUs (Picture 5). BEH/IAQ staff also observed items and plants on top and in front of the FCUs (Picture 6). Materials placed above or in close proximity to the FCU can fall in through the supply registers onto the coils. When the FCU is operating, these materials can be re-distributed to the occupied space. Plants

Plant debris on FCU

According to Mr. Maniatis and Mr. Kraft, the Facilities Management and Support Services Program recently implemented a program that includes cleaning and maintenance, which should help prevent aerosolization of debris that has collected within the FCUs. However, staff should also remain vigilant and remove items located directly on, in front of, or hanging above the FCUs.

7. Ensure plants have drip pans and avoid over-watering. Examine drip pans periodically for mold growth. Disinfect with an appropriate antimicrobial where necessary. Do not place plants on or adjacent to FCUs and other ventilation equipment.

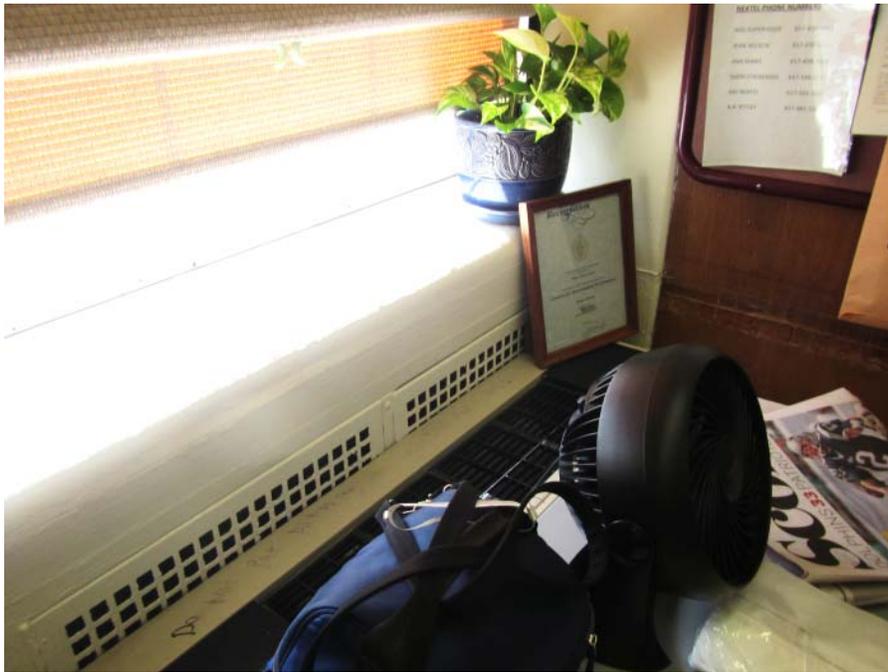
Picture 6

can be a source of pollen and mold, which can be respiratory irritants to some individuals. Plants should be properly maintained and equipped with non-porous drip pans. Plants should also be located *away* from ventilation sources to prevent the entrainment and/or aerosolization of dirt, pollen or mold.

Plants near FCU, items placed in front of FCU

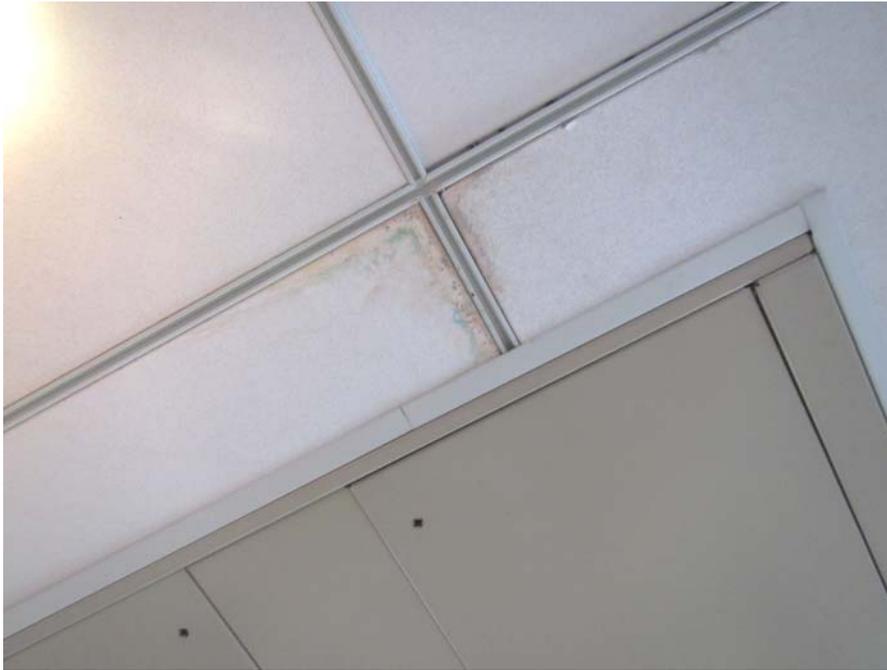
Picture 7

Water-damaged ceiling tiles were observed in some locations in the building. Of note are water-damaged ceiling tiles in the East Wing (Picture 7). These stained ceiling tiles are in close proximity to the AHU that provides conditioned air to the space. It is likely that condensation is forming on the metal frame supporting the ceiling tile. This may occur when warm, moist air rises and comes in contact with the metal frame, which is cooled by conditioned air supplied by the AHU. Over time, ceiling tiles can become wet and serve as a source for mold growth.

Water-damaged ceiling tile, note staining around metal ceiling tile supports

5. Replace water-damaged ceiling tiles as staining becomes apparent.
6. For buildings in New England, periods of low relative humidity during the winter are often unavoidable. Therefore, scrupulous cleaning practices should be adopted to minimize common indoor air contaminants whose irritant effects can be enhanced when the relative humidity is low. To control dusts, a high efficiency particulate arrestance (HEPA) filter equipped vacuum cleaner in conjunction with wet wiping of all surfaces is recommended. Avoid the use of feather dusters. Drinking water during the day can help ease some symptoms associated with a dry environment (throat and sinus irritations).

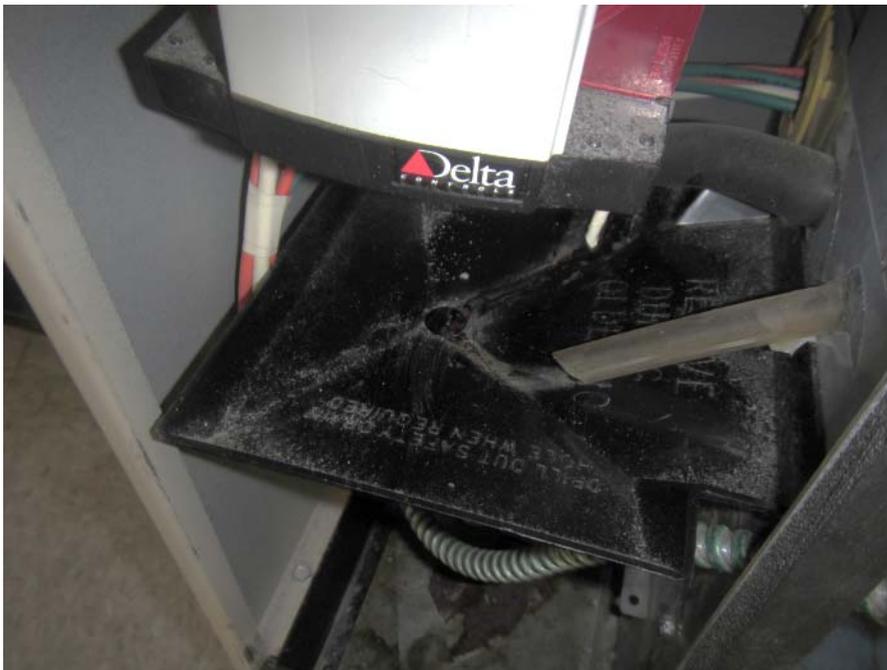
Picture 8

At the time of assessment, BEH staff inspected interior components of an FCU. Debris was observed within the FCU and in the condensation drip pan (Picture 8). Cabinets should be

Debris in condensate drip pan

1. Continue with plans to conduct scheduled maintenance and cleaning of HVAC equipment, including regular filter changes.

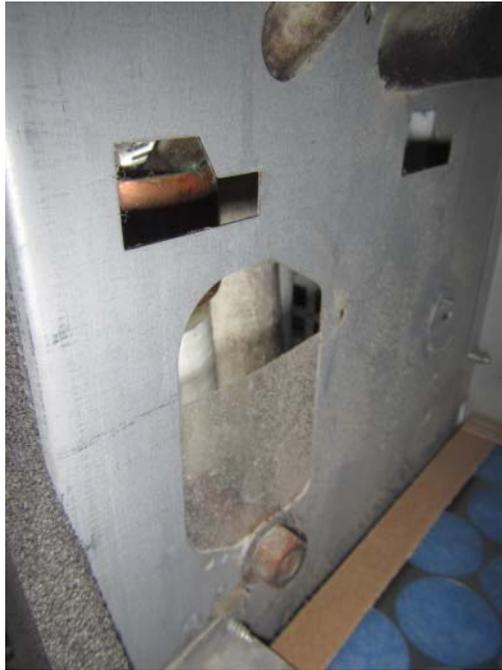
Picture 9

free and clean of debris. BEH/IAQ staff also observed spaces in the floor around pipes in the FCU cabinet and holes/breaches in the FCU cabinet wall (Pictures 9 and 10). These breaches can allow odors, moisture, and pests from the crawlspace to enter occupied areas. These breaches should be sealed properly to prevent these issues.

Holes in cabinet wall allowing draw of air outside the filter

2. Seal holes/breaches where pipes from univents and sinks penetrate into the crawlspace or wall cavity with appropriate fire-rated sealant to prevent movement of odors/particles from wall cavities and subfloor areas.

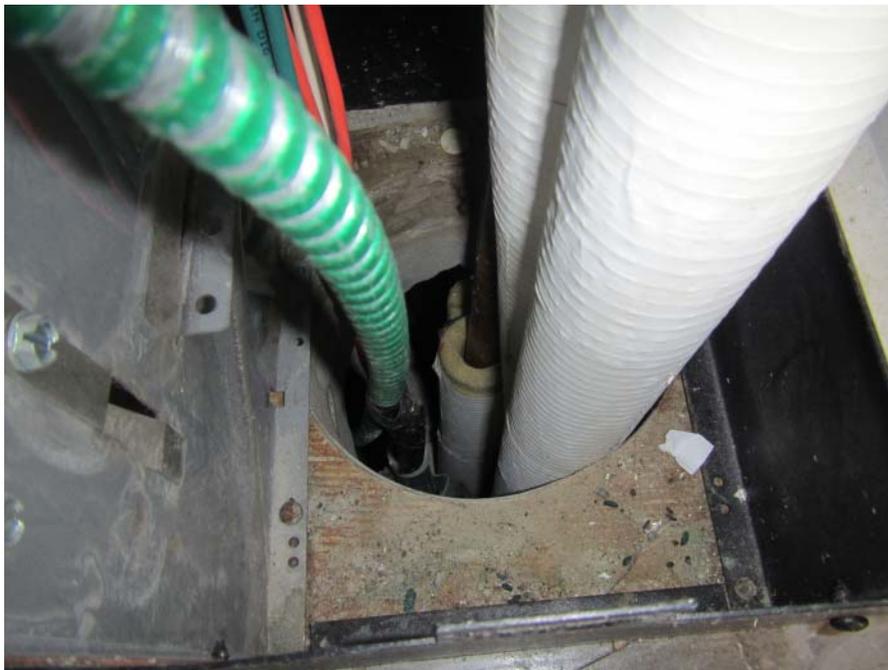
Picture 10

Breaches around pipes in FCU cabinet
