# **INDOOR AIR QUALITY ASSESSMENT**

**Holyoke City Hall  
536 Dwight Street  
Holyoke, Massachusetts**

Prepared by:  
Massachusetts Department of Public Health  
Bureau of Environmental Health  
Indoor Air Quality Program  
October 2014

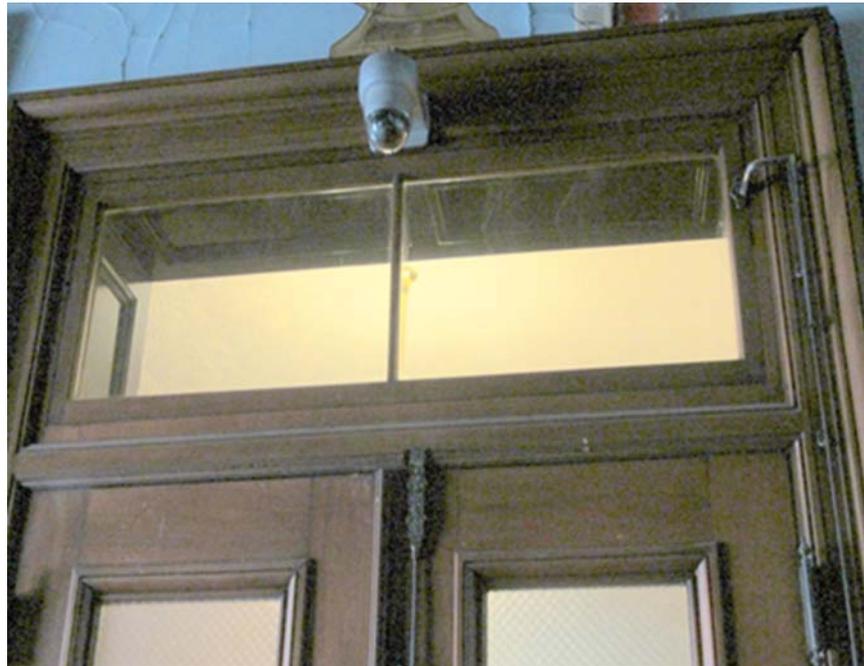
**Picture 1**

Mechanical ventilation is not available in most areas of the building. The HCH was originally designed with a natural/gravity system heated by steam radiators with fresh air provided through openable windows. In addition to openable windows, the building has hinged windows located above hallway doors. These hinged windows or transoms (Picture 1) enable occupants to close hallway doors while maintaining a pathway for airflow into the rooms. This design allows for airflow to enter an open window, pass through a room, through the open transom to the hallway and subsequently pass through the open transom and window on the opposite side of the room on the leeward side (opposite the windward side) ([Figure 1](#)). This system fails if the windows or transoms are closed ([Figure 2](#)). Most windows in the building were found closed at the time of the assessment and many transoms were found

closed/permanently sealed. Without a means for air exchange via windows or a mechanical supply and exhaust system, normally occurring indoor environmental pollutants can build up, leading to indoor air quality/comfort complaints.

**Transom over office door**

5. Open windows (weather permitting) to temper rooms and provide fresh outside air. Care should be taken to ensure windows are properly closed at night and weekends during winter months to avoid the freezing of pipes and potential flooding. In addition, keep windows closed during hot, humid weather to maintain indoor temperatures and to avoid condensation problems when air conditioning is activated.

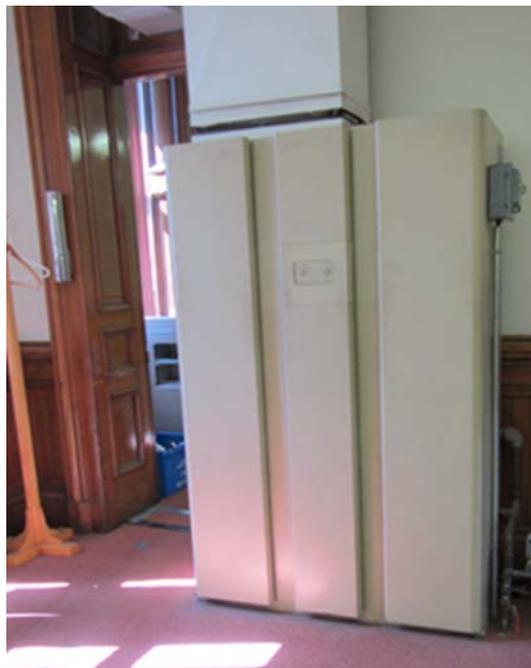
**Picture 2**

Most offices have window air-conditioners (WAC, Table 1) which provide conditioned air in warm weather and can provide limited air exchange. The Treasurer and Parks and Recreation offices have wall-mounted air-handling units (AHU) located in the office spaces (Picture 2). These AHUs do not provide fresh air but cool air and deliver it to occupied spaces via ducted supply vents (Picture 3). The City Council Chambers has a dedicated system for air-conditioning (Table 1). An AHU located in a closet space draws in fresh, outdoor air through air intakes located on the exterior of the building. The AHU delivers conditioned air via ducted supply vents and air is returned back to the AHU via ducted exhaust vents. Mr. Kras reported that all filters in air-conditioning units are cleaned and or replaced as needed twice each year.

**Wall-mounted AHU in Treasurer's office**

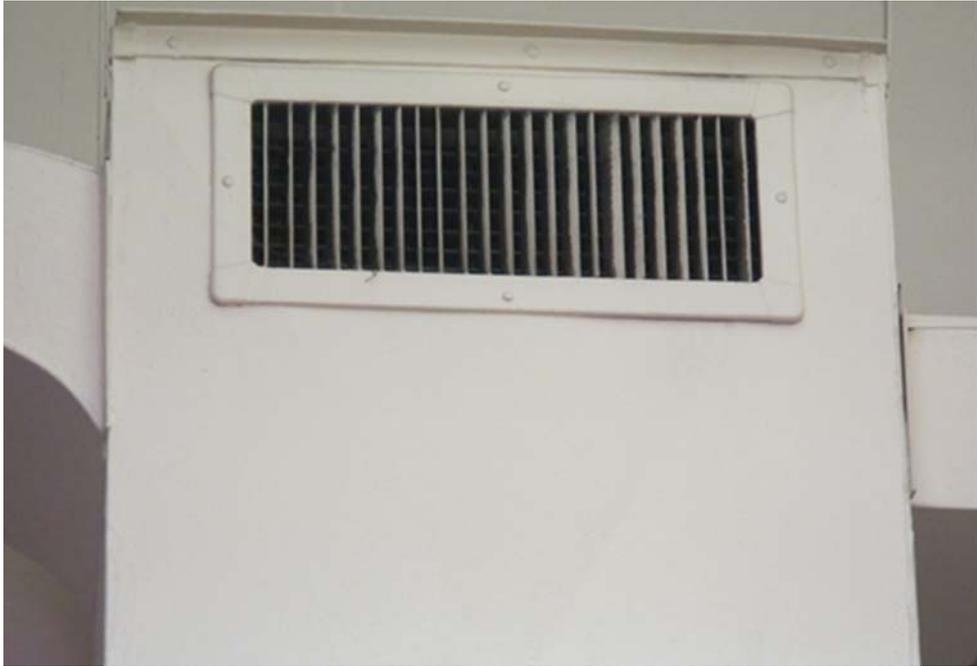
**Picture 3**

**Supply vent in Treasurer's Office**

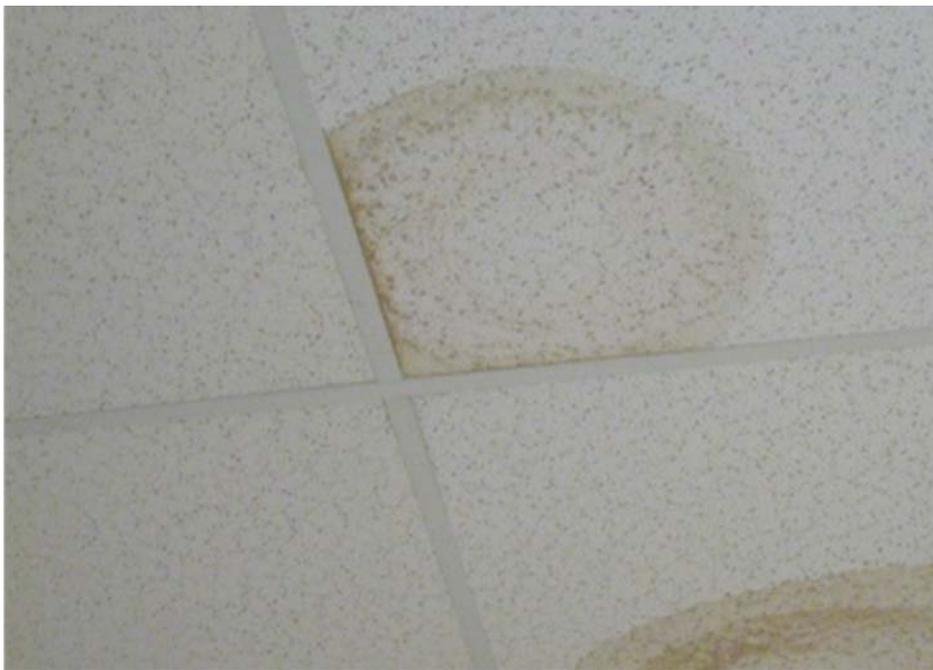
**Picture 4**

Several rooms in the building had water-damaged ceiling tiles (Table 1; Picture 4), which may stem from roof leaks, plumbing leaks and/or condensation from WAC components (Table

1). If repeatedly moistened, ceiling tiles can be a medium on which mold can grow. Water-damaged tiles should be replaced after a water leak is discovered and repaired.

**Water-damaged ceiling tiles**

9. Remove water-damaged ceiling tiles and examine for source of water. Monitor for future leaks. After necessary repairs are made, replace any water-damaged ceiling tiles with new ones.

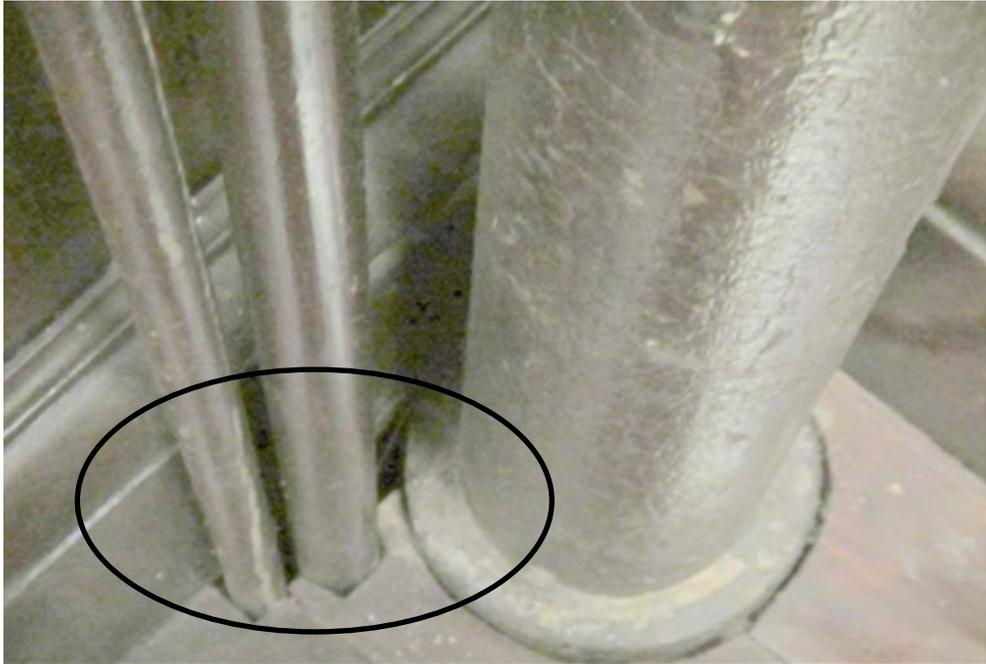
**Picture 5**

Other gaps/breaches were noted in the floor and ceiling of the space around sewer and plumbing pipes (Picture 5). BEH/IAQ staff noted that a sewer drain pipe that terminated in the space appeared not to be capped/sealed. These conditions could allow the migration of odors from the sub-basement into occupied spaces in the basement level and first floor of the building. As mentioned previously, the former restroom door on the exterior of the building had a damaged sweep and weather stripping, which would allow for the outdoor air to pressurize this space to force odors into the wall and floor cavities, particularly during northwesterly wind conditions. Exterior doors can also serve as a source of water entry into the building as well as a pathway for insects, rodents and other pests into the building.

**Hole/gaps around sewer drain and plumbing pipes in abandoned restroom**

1. Facilities management should work with a licensed plumbing firm to ensure all abandoned sewer drain pipes in former restrooms are capped/sealed and make repairs on active plumbing as needed.
2. Seal holes/spaces and other penetrations in the ceilings and floors around plumbing and utility pipes in the abandoned restrooms with an expandable, fire rated sealing compound.

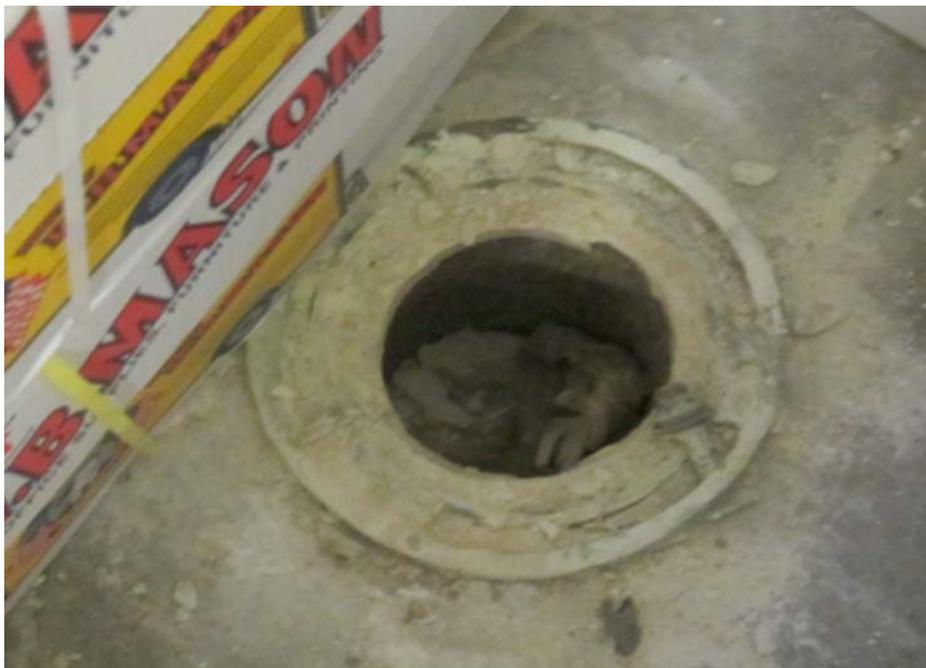
**Picture 6**

The Election Room is a basement level space that was formerly an interior restroom. It is currently used as storage space. Strong sewer/musty odors were noted in the space. Abandoned sewer drain pipes in the floor were found opened or filled with plastic, and appeared to be uncapped (Pictures 6 and 7). A floor drain was also observed in the space (Picture 8). Drains are typically designed with traps to prevent sewer odors/gases from penetrating into occupied spaces. When water is poured into a trap, an air-tight seal is created by the water in the U-bend section of the pipe. These drains must have water poured into them to maintain the integrity of the seal. Without water, the sewer is open to the room and sewer odors can occur. Given that the drain is no longer needed it should be permanently capped/sealed. In addition, holes and breaches were observed in the floor and ceiling of the room from abandoned plumbing and utility pipes (Picture 9). Breaches were also observed around plumbing and utility pipes in occupied offices on the basement and first floor levels.

**Uncapped sewer drain in storage room floor**

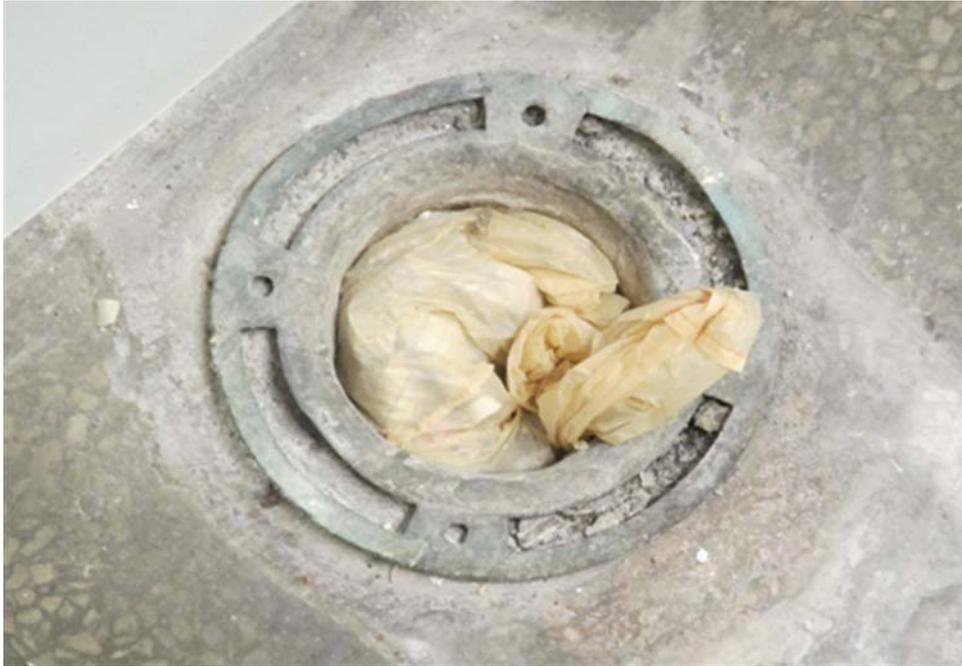
**Picture 7**

**Sewer drain filled with plastic**

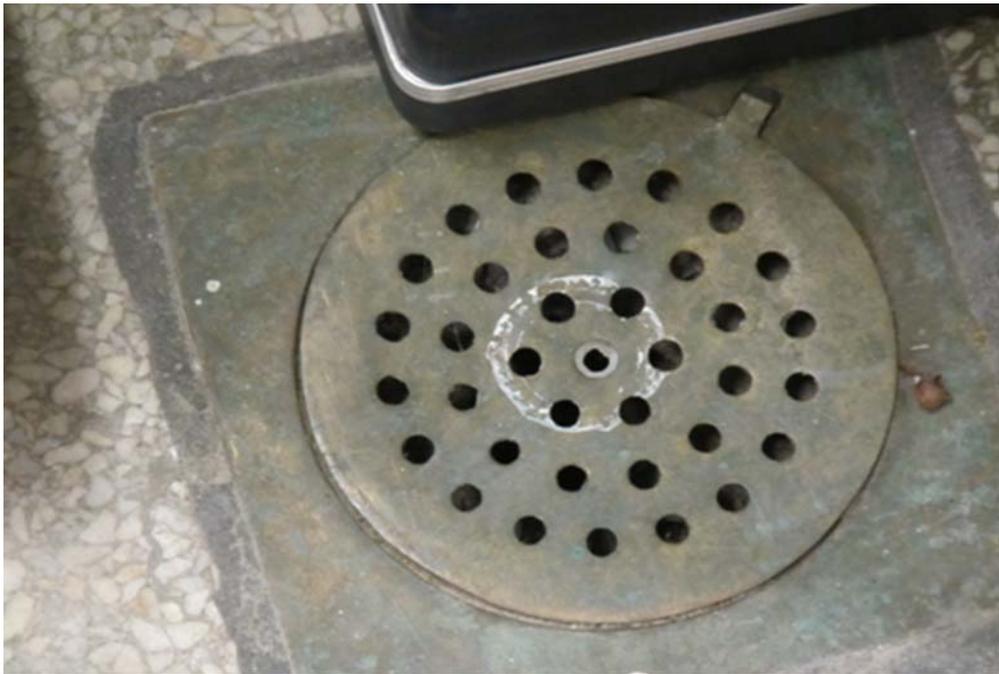
**Picture 8**

**Open floor drain in storage room**

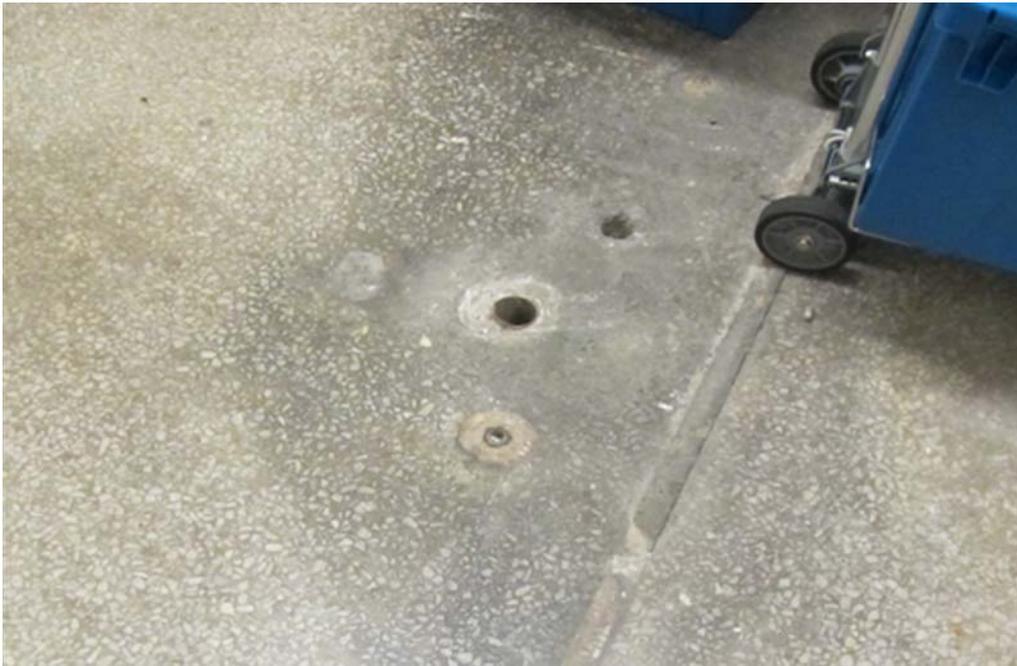
**Picture 9**

**Open plumbing/utility holes in the storage room floor**

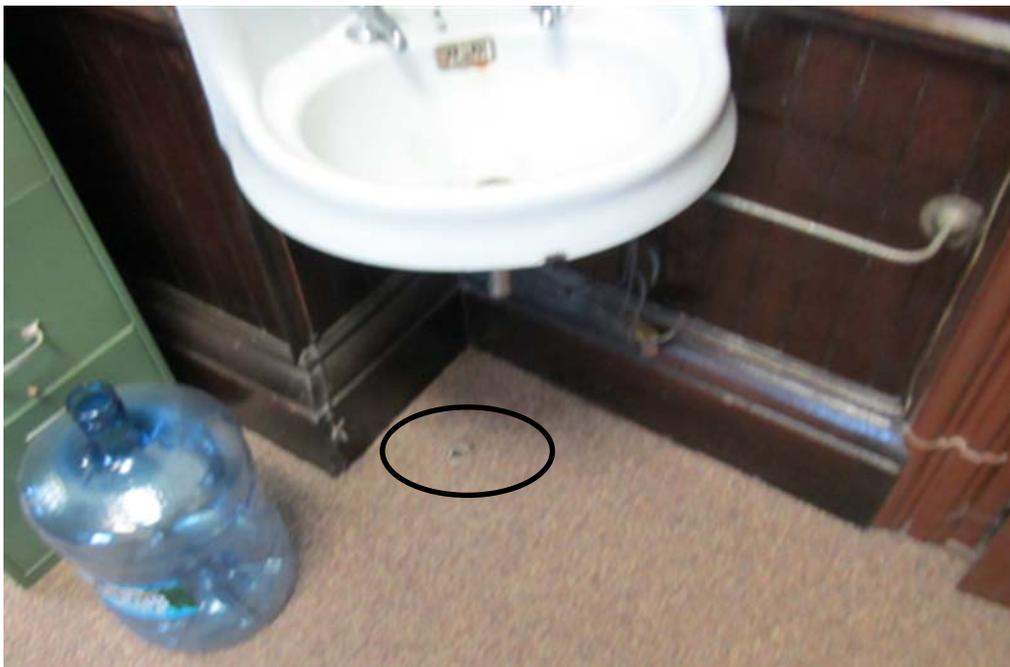
**Picture 10**

As mentioned previously, a sewer/musty odor was detected in the City Messenger's office (Room 10). BEH/IAQ located a sink that had a cut/open drain pipe with a hole in the floor (Picture 10). Another possible source of odors may be the seal on the toilet adjacent to this office. If the wax seal holding the toilet to the floor is not airtight, sewer gas odors can be drawn from underneath the toilet. BEH/IAQ noted that the wax ring/sealant appeared to be degraded and should be replaced.

**Hole in floor below cut sink drain**

3. Examine all occupied office spaces for spaces/breaches around plumbing and utility pipes and seal with an expandable, fire-rated sealing compound.
4. Repair the toilet and replace the wax ring in Room 10 restroom.
