INDOOR AIR QUALITY ASSESSMENT

**Bristol County Mosquito Control Program
140 North Walker Street
Taunton, Massachusetts**

Prepared by:
Massachusetts Department of Public Health
Bureau of Environmental Health
Indoor Air Quality Program
October 2014

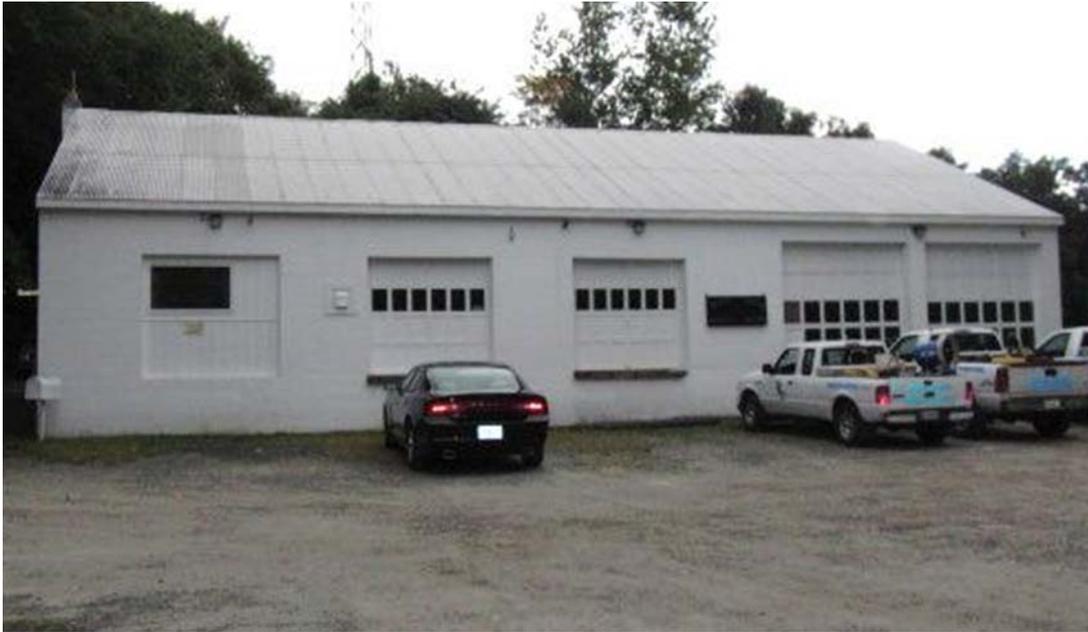
Picture 1

The BCMCP is located in a one-story, 1950s era cinder block and metal roof building. The BCMCP has reportedly occupied the building for 35 to 40 years. The structure appears to have originally been built as a 5-bay garage. At some point, the northernmost bay garage door was sealed and converted into office space (Picture 1). The interior of this office contains wall-to-wall carpet installation, wooden paneling, and openable windows. Several of the windows have been rendered inoperable due to either the installation of plexi-glass or the installation of window-mounted air conditioners. The space contains office space, a conference room, storage space, and vehicle bays. The BCMCP also utilizes a flat-roofed concrete structure, called the lower garage, that serves as a vehicle workshop, and maintenance and pesticide storage areas (Picture 2).

Bristol County Mosquito Control Program building, note northernmost garage door sealed for office space

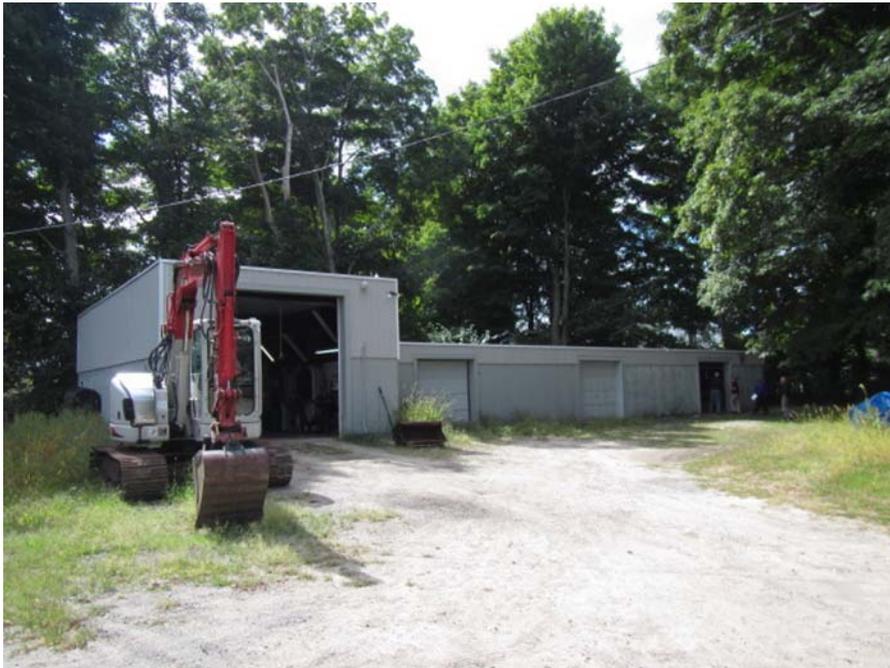
Picture 2

Lower garage containing the maintenance shop and pesticide storage area (end bay)

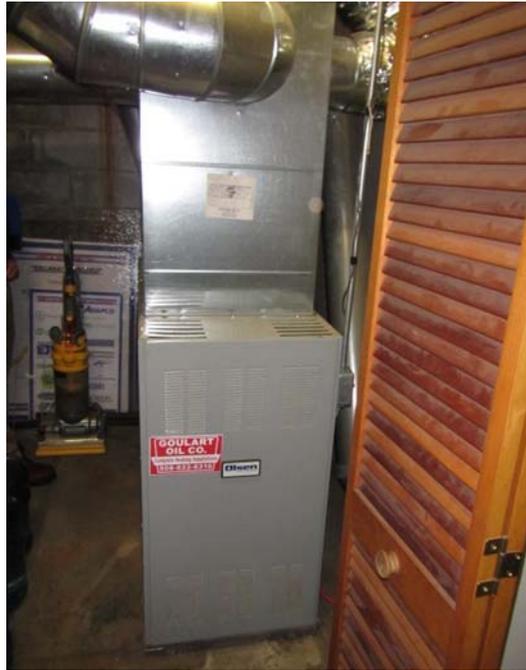
Picture 3

The mechanical ventilation system for office areas is provided by an air-handling unit (AHU) located in a mechanical room (Picture 3). Other AHUs are located in the vehicle bay of the main building and in the vehicle maintenance bay of the lower garage respectively. It is important to note that these existing mechanical ventilation systems do not introduce fresh/outside air into the building nor do they exhaust stale air from occupied spaces. These units only heat and *recirculate* air. Openable windows are the sole means of providing fresh air

to the building. However, since several of the windows have been rendered inoperable due to the installation of plexi-glass and/or window-mounted air conditioners, there is no direct means of providing fresh/outside air to these areas. In addition, there was reportedly no preventative maintenance (PM) program on existing ventilation equipment.

Air handling unit in mechanical room

1. Consult with an HVAC engineer to determine if existing AHUs can be retro-fitted to provide fresh/outside air.

5. Develop and implement a preventative maintenance plan for all HVAC equipment including regular filter changes. Consider upgrading filters to the recommended minimum 40% dust-spot efficiency (MERV 9) accounting for manufacturer limitations with pressure drop.

1. Consider installing a new HVAC system that incorporates both exhaust ventilation and fresh air intake to remove common indoor pollutants and alleviate health complaints. Consideration should be taken during design to account for the location of local exhaust vents for point source pollutants such as copy areas and restrooms.

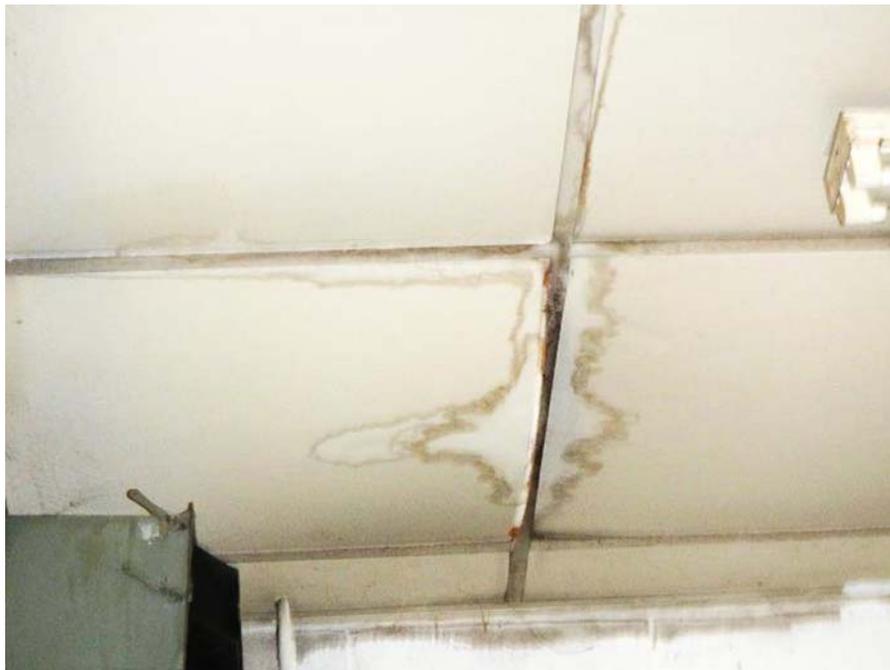
Picture 4

Water-damaged gypsum wallboard ceilings were observed in storage/vehicle bays; some areas had visible mold growth (Table 1; Pictures 4 and 5). Water-damaged ceiling tiles were also observed in a few areas (Table 1; Picture 6). Water-damaged building materials indicate leaks from either the roof or plumbing system and can provide a source for mold growth. Water-damaged ceiling tiles should be replaced after a water leak is discovered and repaired.

Water-damaged/mold-colonized gypsum wallboard ceiling in storage/vehicle bay

6. Ensure building/plumbing leaks are repaired and replace any remaining water-damaged ceiling tiles and other building materials. Disinfect areas of water leaks with an appropriate antimicrobial, as needed.

7. Remove/replace water-damaged/mold-colonized gypsum wallboard in accordance with isolation and ventilation procedures included in “Mold Remediation in Schools and Commercial Buildings” published by the US Environmental Protection Agency (US EPA, 2001) for more information on mold. This document can be downloaded from the US EPA website at: http://www.epa.gov/mold/mold_remediation.html.

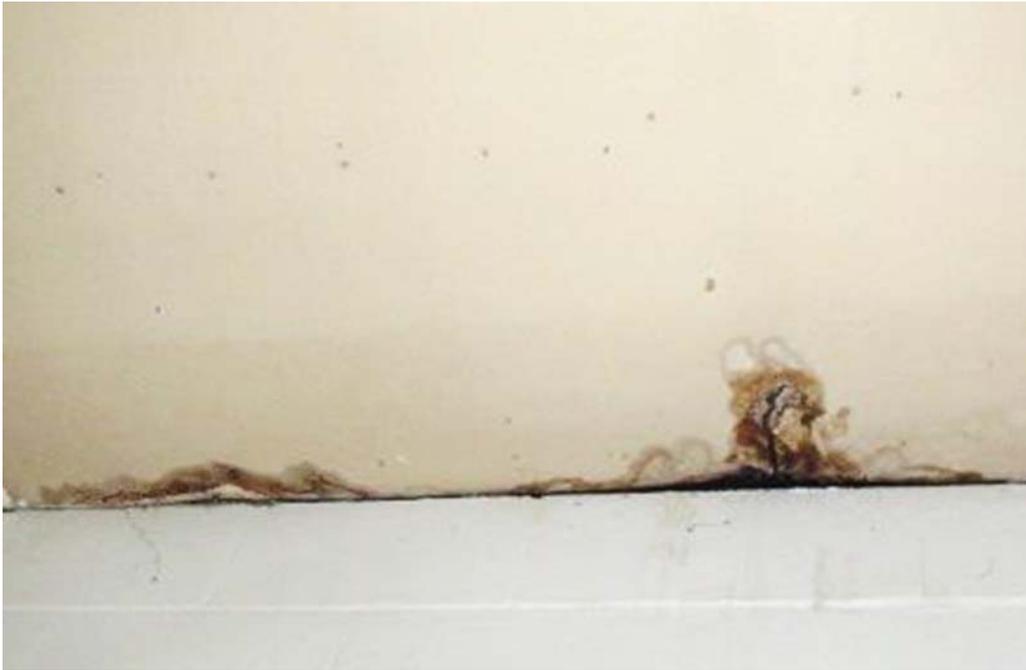
Picture 5

Water-damaged/mold-colonized gypsum wallboard ceiling in storage/vehicle bay

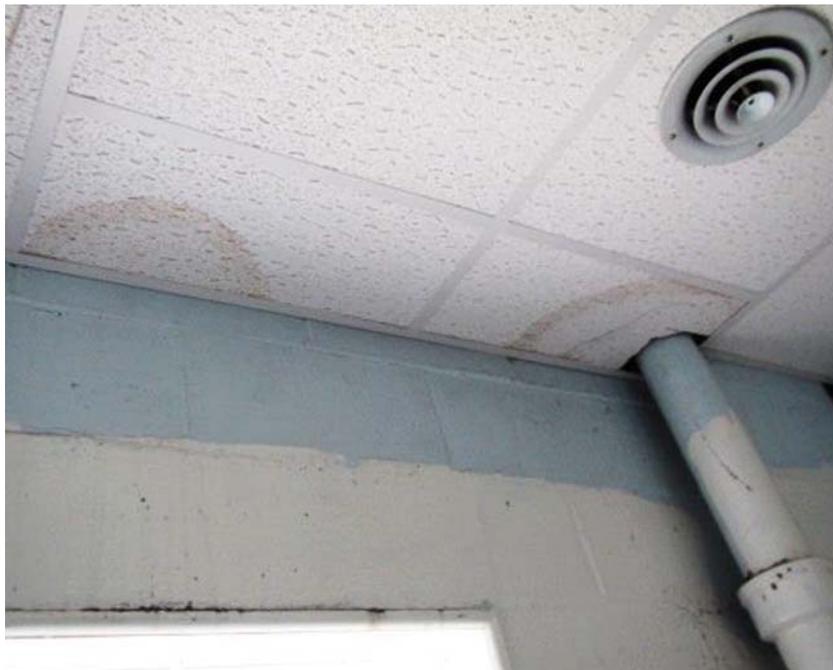
Picture 6

Water-damaged ceiling tiles

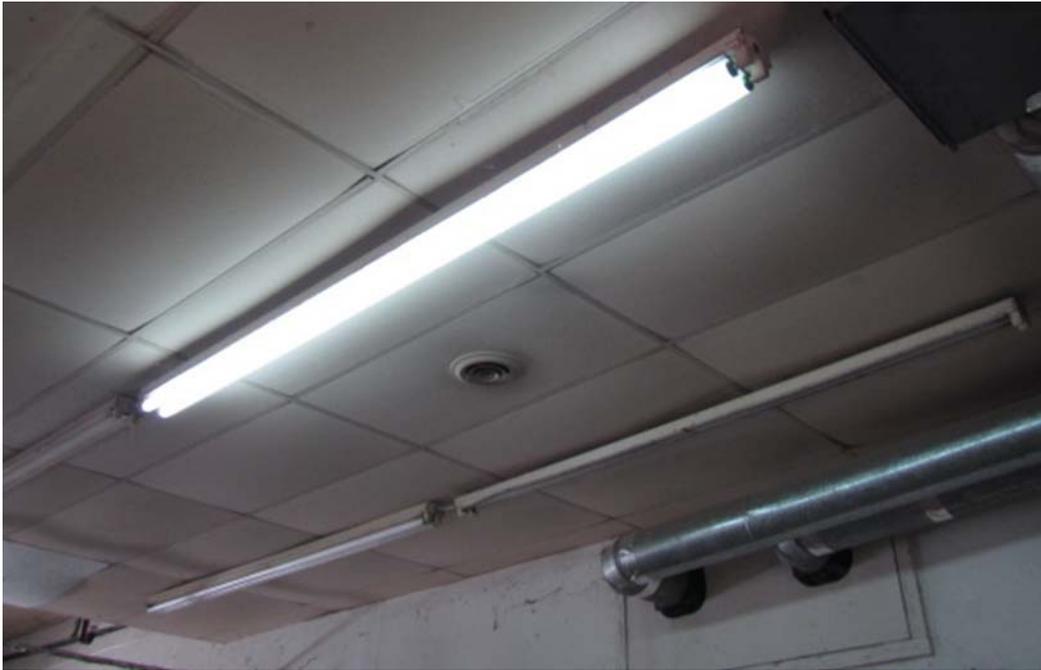
Picture 7

Missing light covers were noted in a number of areas (Picture 7) and florescent bulbs were improperly stored (e.g. leaning against the wall/unsecured) in the mechanical room (Picture 8) and vehicle bay (Picture 9). Fixtures should be equipped with access covers installed with

Missing light covers

12. Replace covers for fluorescent light fixtures. Store florescent light bulbs properly in a secure manner in order to prevent accidental breakage.
13. Install make-up air vent for pesticide storage room. In the interim, ensure that bay door is open to provide sufficient make-up air.

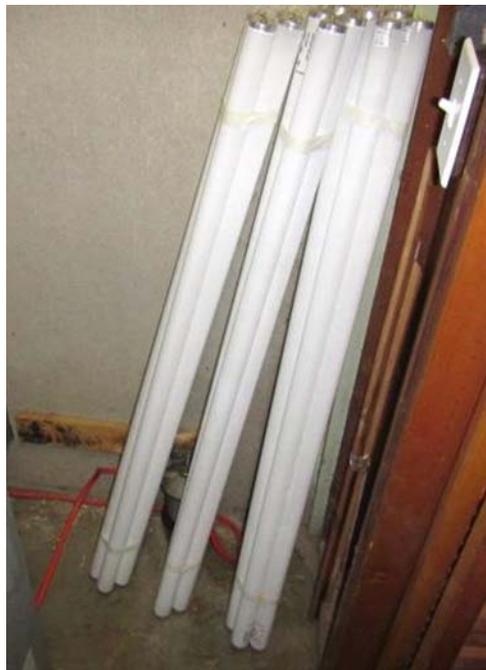
Picture 8

bulbs fully secured in their sockets. Blubs should also be stored properly to prevent breakage of glass, which can cause injuries and may result in the release of mercury and/or other hazardous compounds.

Florescent bulbs in mechanical room

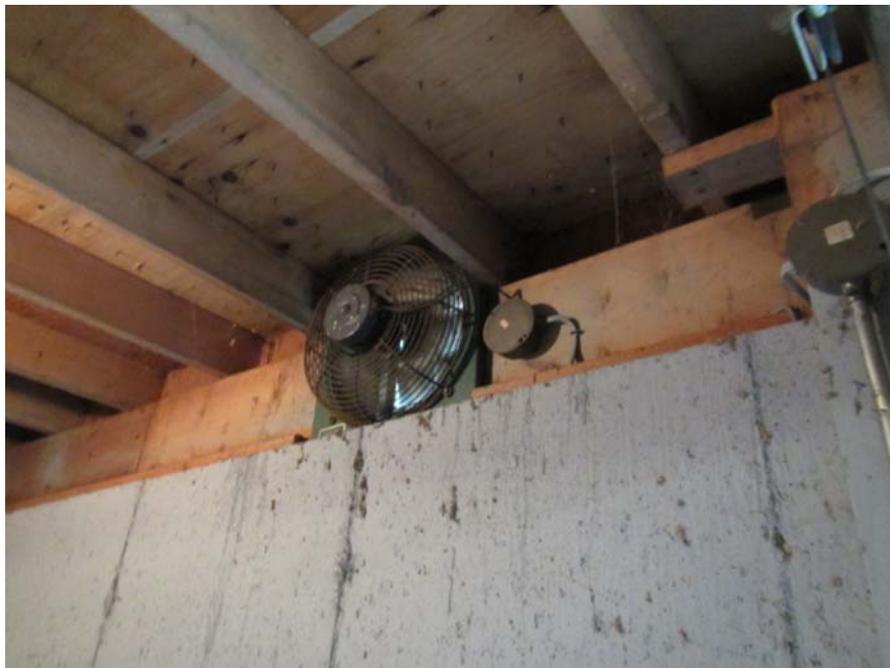
Picture 10

Finally, the pesticide storeroom is equipped with a local exhaust fan (Picture 10). However, no make-up air vent exists to draw in outside air. Therefore, it is important to keep the bay door open at all times unless/until a make-up air vent is installed.

Local exhaust fan in pesticide storage room
