INDOOR AIR QUALITY ASSESSMENT

**Earl D. Taft Elementary School
16 Granite Street
Uxbridge, Massachusetts**

Prepared by:
Massachusetts Department of Public Health
Bureau of Environmental Health
Indoor Air Quality Program
January 2014

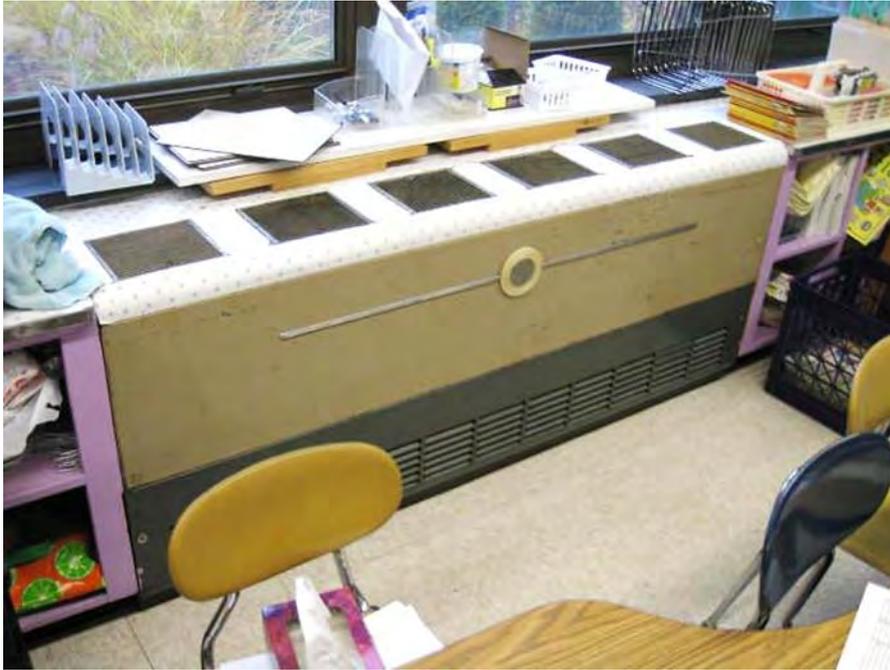
Picture 1

Note that the univents are original equipment, over 60 years old in the original wing (Picture 1), over 24 years old for the 1989 wing. Function of equipment of this age is difficult to maintain, since compatible replacement parts are often unavailable. According to the American Society of Heating, Refrigeration and Air-Conditioning Engineers (ASHRAE), the service life¹

for a unit heater, hot water or steam is 20 years, assuming routine maintenance of the equipment (ASHRAE, 1991). Despite attempts to maintain the univents, the operational lifespan of the equipment has been exceeded. Maintaining the balance of fresh air to exhaust air will become more difficult as the equipment ages and as replacement parts become increasingly difficult to obtain.

Classroom univent 1950s vintage

2. While carbon dioxide levels measured during this assessment suggested adequate provision of fresh air supply, maintaining the balance of fresh air to exhaust air will become more difficult as the equipment ages (i.e., classroom univents, exhaust vents and AHUs in common areas) and as replacement parts become increasingly difficult to obtain. Based on the age, physical deterioration and availability of parts, the BEH recommends that an HVAC engineering firm evaluate options to determine feasibility of repairing/replacing the equipment.

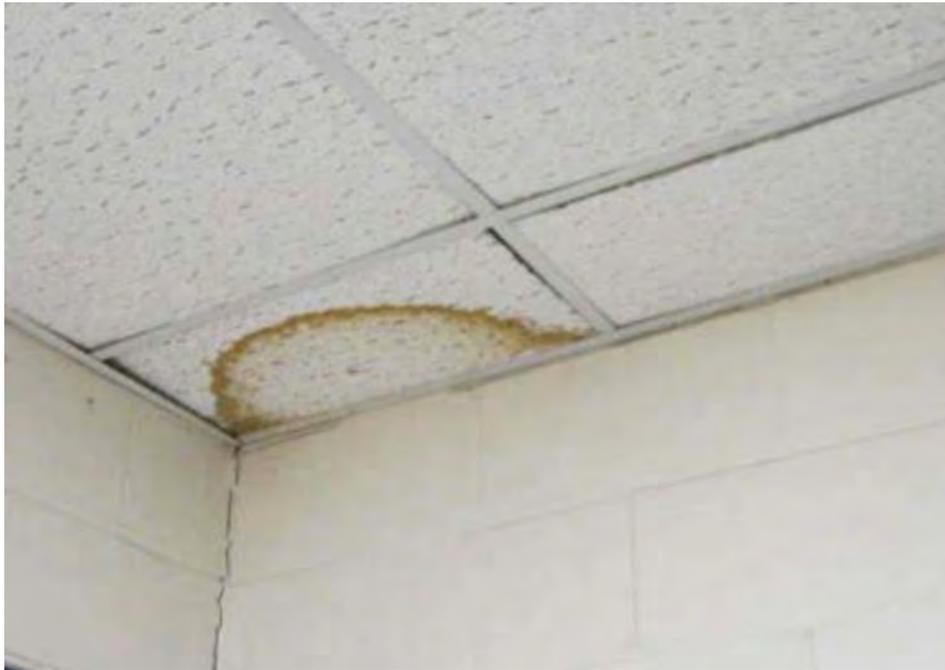
Picture 2

Water-damaged ceiling tiles were observed in several areas (Table 1; Picture 2); these can indicate active/historic leaks from either the roof/building envelope or plumbing system. A tile in the corner of room 265 appeared to have possible mold growth (Picture 3). Water-damaged ceiling tiles can provide a source of mold and should be replaced after a water leak is discovered and repaired.

Water-damaged ceiling tile

11. Ensure roof/plumbing leaks are repaired and replace any remaining water-damaged ceiling tiles (e.g., room 265). Examine the area above these tiles for mold growth. Disinfect areas of water leaks with an appropriate antimicrobial, as needed.

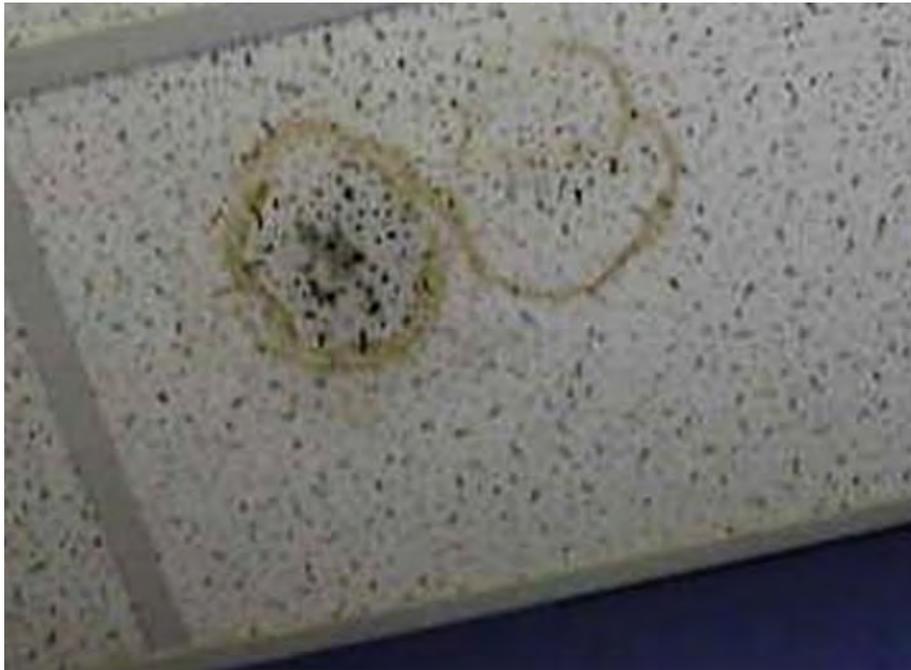
Picture 3

Water-damaged ceiling tile with possible mold in room 265

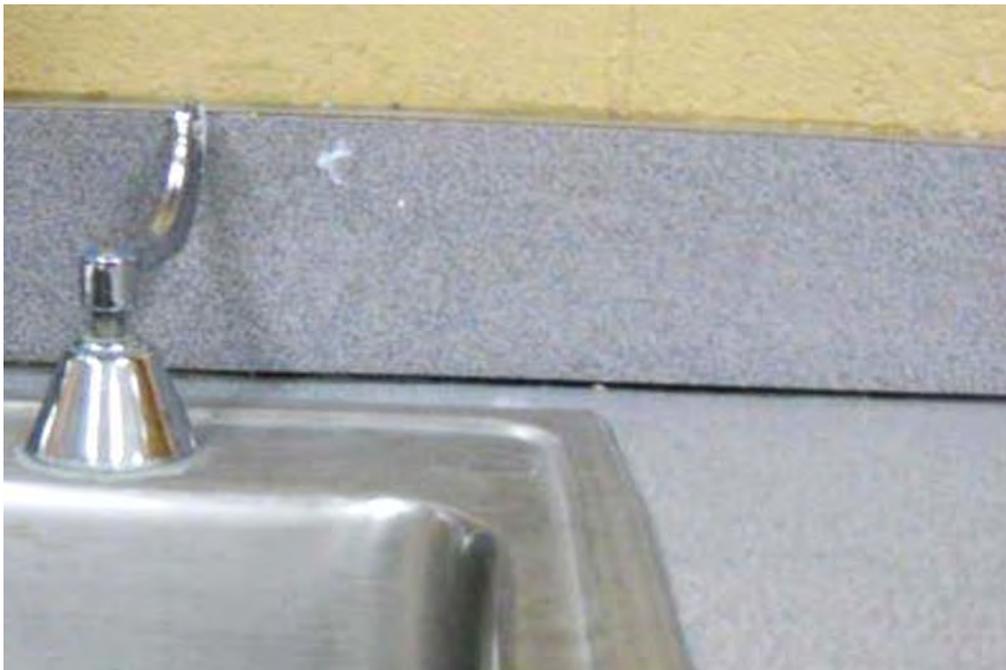
Picture 4

Open seams between the sink countertop and backsplash were observed in several rooms (Table 1; Picture 4). If seams are not watertight, water can penetrate the seam, causing water damage. Water penetration and chronic exposure of porous and wood-based materials can cause these materials to swell, show signs of water damage and lead to potential mold growth. Sink caulking in room 265 appeared to be visibly mold-colonized (Picture 5).

Space between sink backsplash and countertop in classroom

14. Consider replacing older model refrigerator in Teacher's Lunchroom with a modern, energy-efficient model.
15. Seal breaches, seams, and spaces between sink countertops and backsplashes to prevent water damage. Remove/replace moldy caulking in room 265. Consider eventual replacement with a one-piece molded countertop.

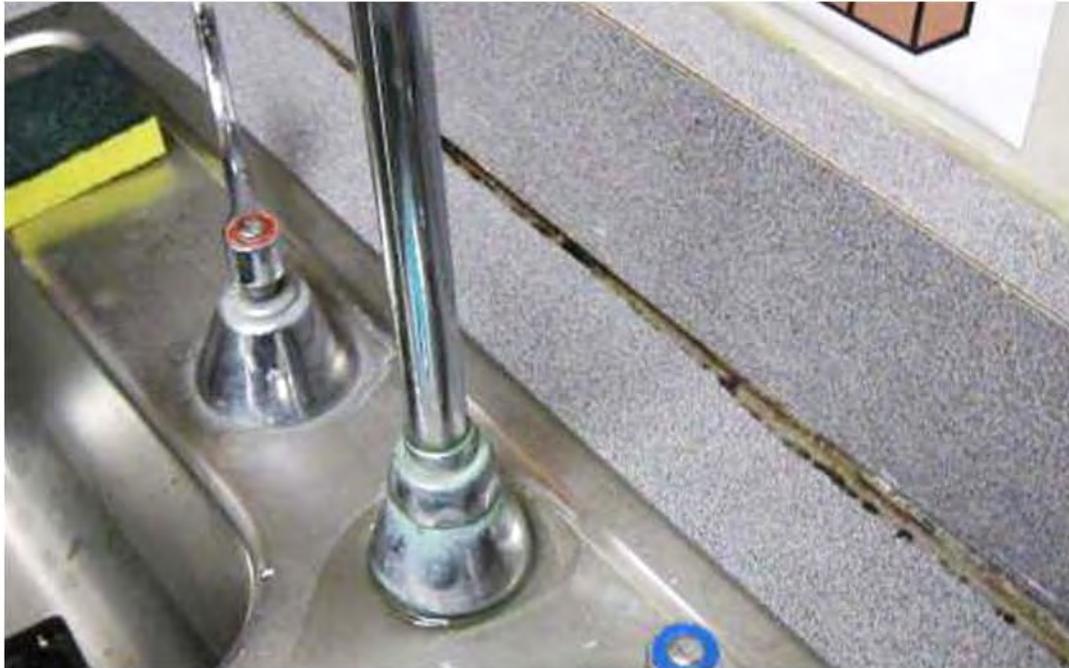
Picture 5

Visible mold on sink caulking in classroom 265

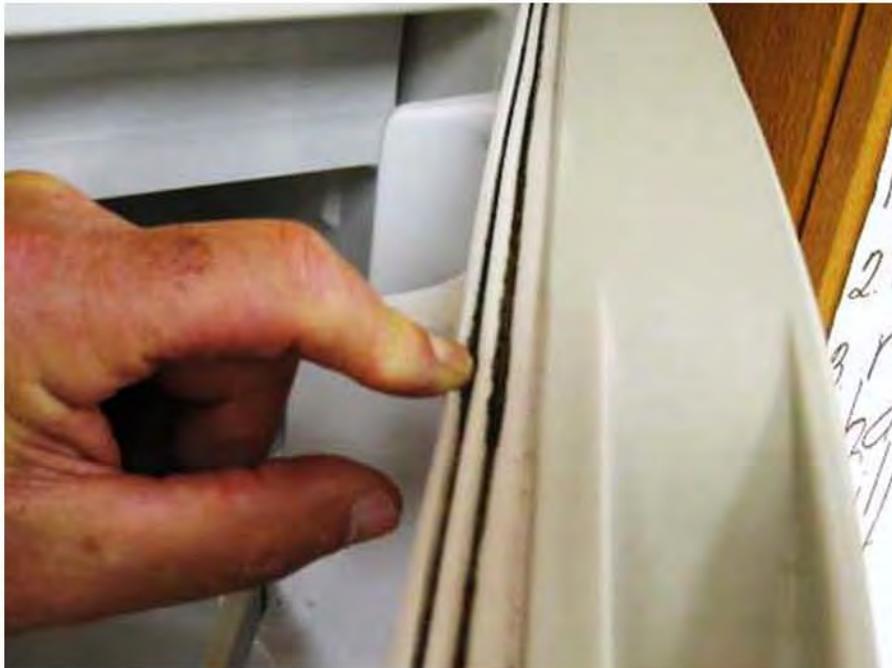
Picture 6

Visible mold growth was observed in the refrigerator in the teacher's lunchroom as well as several refrigerators located in classrooms. Upon opening refrigerators used by staff for food storage, BEH/IAQ staff found both refrigerator and freezer door gaskets to be colonized with mold (Table 1; Pictures 6 through 8). Some of the refrigerators had noticeable odors and/or had spillage of unknown origin. In addition, the drip pan beneath the refrigerator in the teacher's lunchroom had a large amount of mold/debris (Picture 9); it appeared not to have been cleaned for some time.

Visible mold (dark staining) in gasket of portable refrigerator in classroom

13. Clean and disinfect interior of refrigerators and freezers with mild detergent or antimicrobial agent. Consider replacing mold-contaminated gaskets. Clean spilled food promptly, and clean out the refrigerator of expired items on a regular schedule.

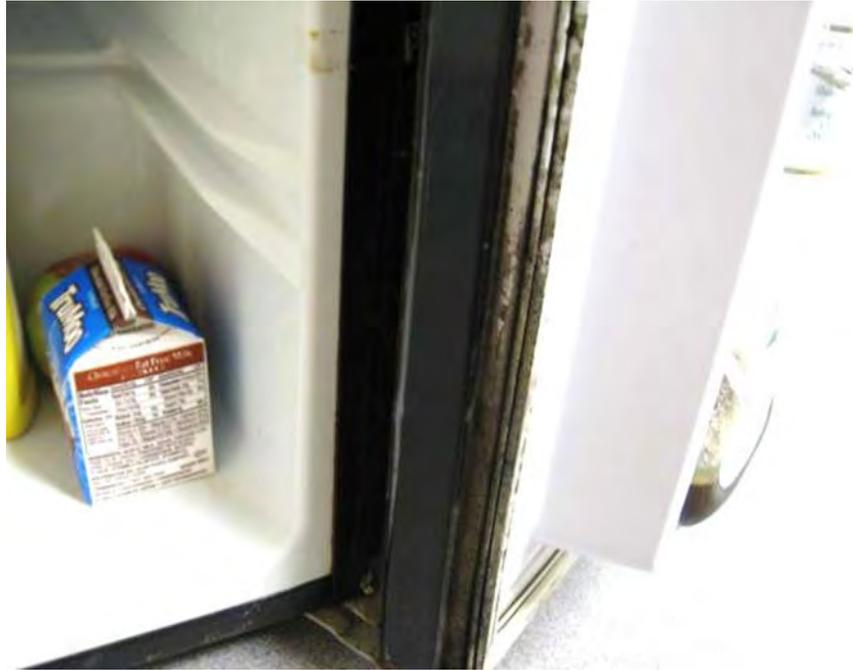
Picture 7

Mold growth (dark staining) on gasket of portable refrigerator in classroom

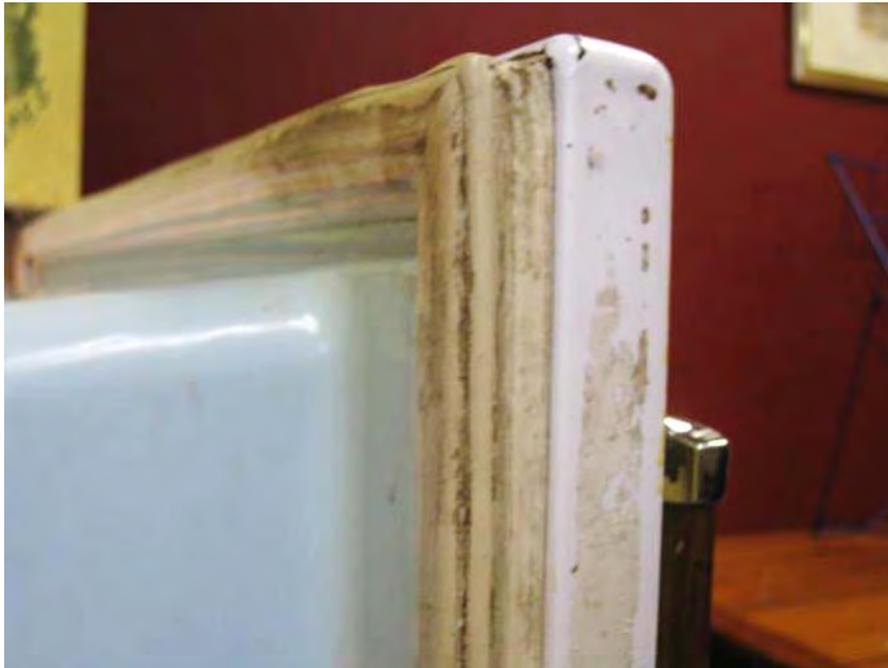
Picture 8

Visible mold (dark staining) on gasket of refrigerator in teachers' lunchroom

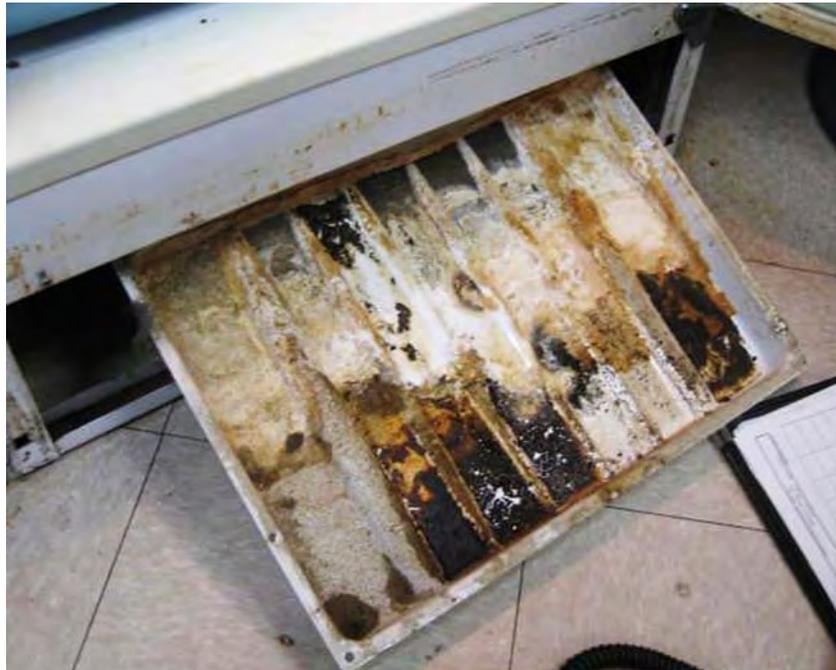
Picture 9

Visible mold/debris (dark staining) in drip pan of refrigerator in teachers' lunchroom

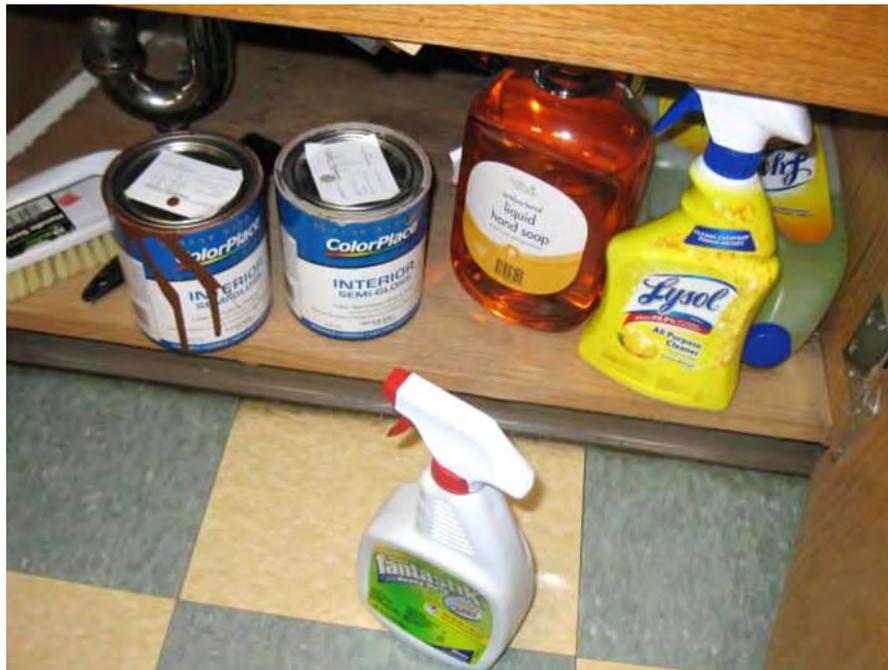
Picture 10

Cleaning, sanitizing and paint products were observed on/under sinks in some rooms (Table 1; Pictures 10 and 11). These products contain chemicals that can be irritating to the eyes, nose and throat of sensitive individuals. Cleaning products should be properly labeled and stored in an area inaccessible to children. In addition, a Material Safety Data Sheets (MSDS) should be available at a central location for each product in the event of an emergency. Consideration should be given to providing teaching staff with school issued cleaning products and supplies to prevent any potential for adverse chemical interactions between residues left from cleaners used by the facilities staff and those left by cleaners brought in by others. In one case, metal spray containers were rusted/corroded (Picture 12), which can lead to an unwanted release of product. At the time of the assessment, Mr. Legendre removed these containers from the classroom.

Spray cleaners and paints under sink in classroom

16. Refrain from storing porous materials (e.g., paper, cardboard) under sinks.

22. Refrain from using air fresheners and deodorizers to prevent exposure to VOCs.
23. Store cleaning products properly and out of reach of students. Ensure spray bottles are properly labeled. All cleaning products used at the facility should be approved by the school department with MSDS' available at a central location.

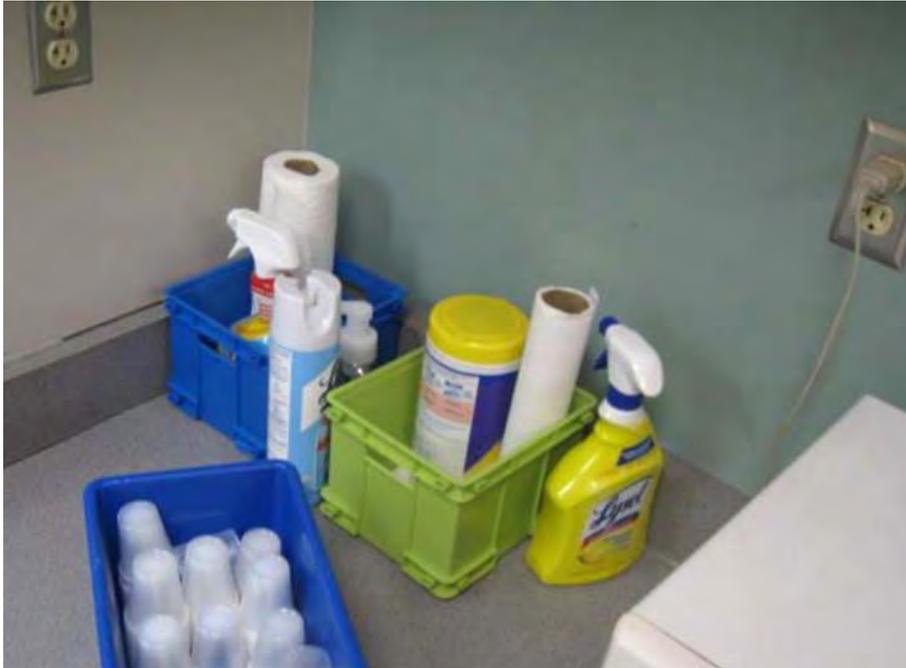
Picture 11

Spray cleaners on countertop in classroom

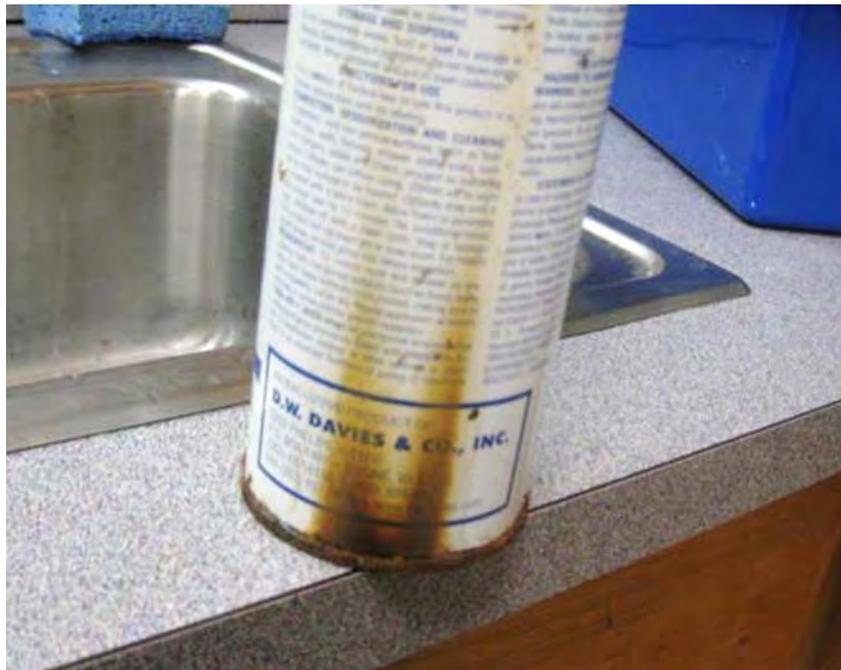
Picture 12

Severely rusted/corroded (dark staining) metal spray container

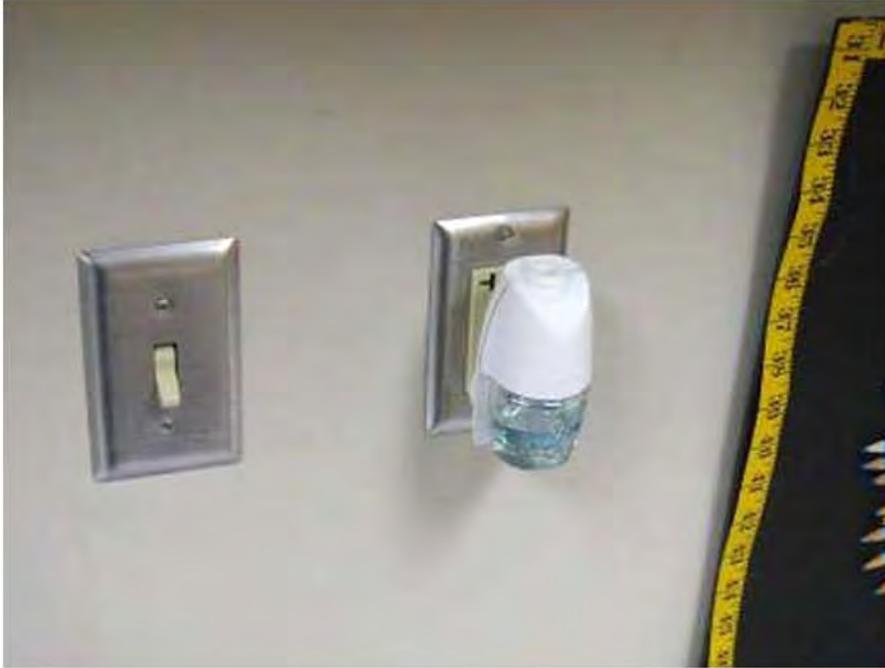
Picture 13

Plug-in air deodorizers (Picture 13), air fresheners and scented oils were found in several areas (Table 1). Air deodorizers contain chemicals that can be irritating to the eyes, nose and throat of sensitive individuals. Many air deodorizers contain 1,4-dichlorobenzene, a VOC which may cause reductions in lung function (NIH, 2006). Further, air deodorizers do not remove materials causing odors, but rather, mask odors which may be present in the area.

Plug-in air freshener in classroom

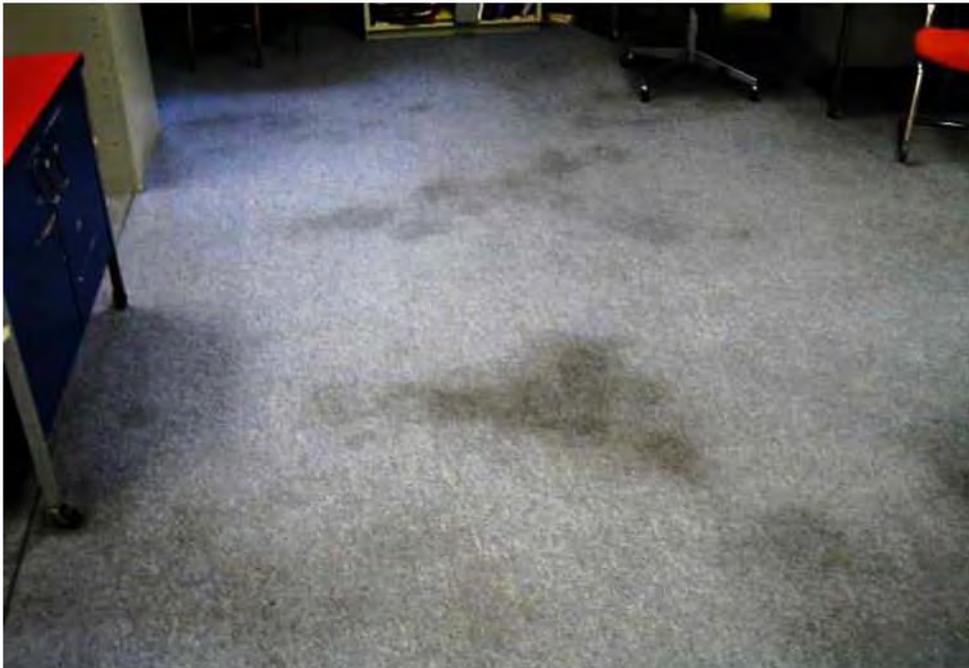
Picture 14

Many classrooms carpets were found soiled and deteriorated, in some cases loose/wrinkled, which could be a tripping hazard (Pictures 14 and 15). The Institute of Inspection, Cleaning and Restoration Certification (IICRC), recommends that carpeting be cleaned annually (or semi-annually in soiled high traffic areas) (IICRC, 2005). Since the average service time of carpeting in a school environment is approximately eleven years (Bishop, 2002), consideration should be given to planning for the replacement of carpeting with new flooring.

Stained/soiled carpeting

24. Seal the space in the corner of music room 229 between where the two walls meet to mitigate drafts/odor complaints from wall cavity.
25. Continue to clean carpeting annually or semi-annually in soiled high traffic areas as per the recommendations of the Institute of Inspection, Cleaning and Restoration Certification (IICRC). Copies of the IICRC fact sheet can be downloaded at: http://www.cleancareseminars.com/carpet_cleaning_faq4.htm (IICRC, 2005)

26. Consider a long-term plan to replace old/soiled/damaged carpeting in the building as funds become available. Consider replacing carpeting with a non-porous surface such as vinyl tile.

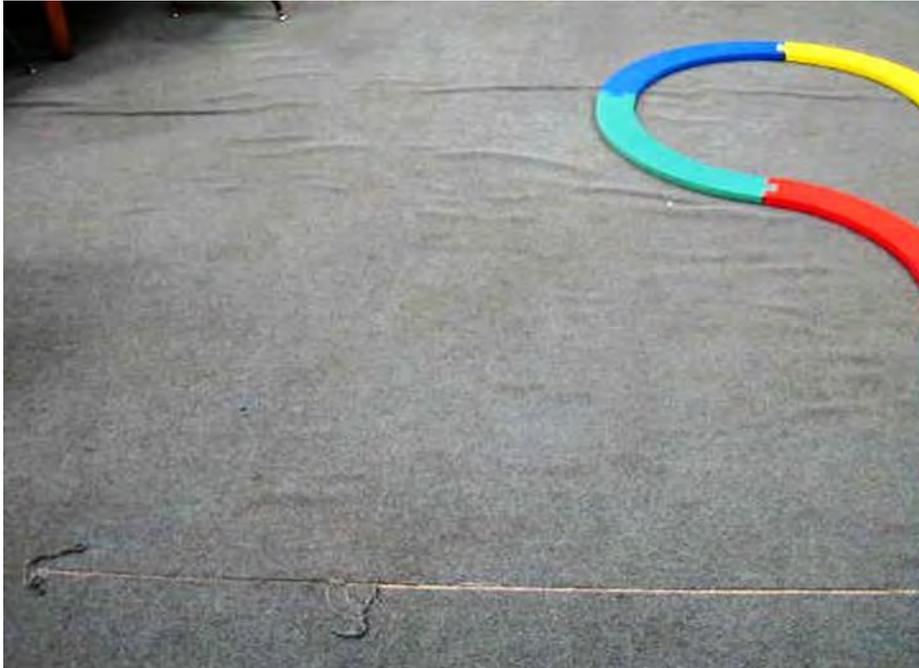
Picture 15

Wrinkled/damaged carpeting

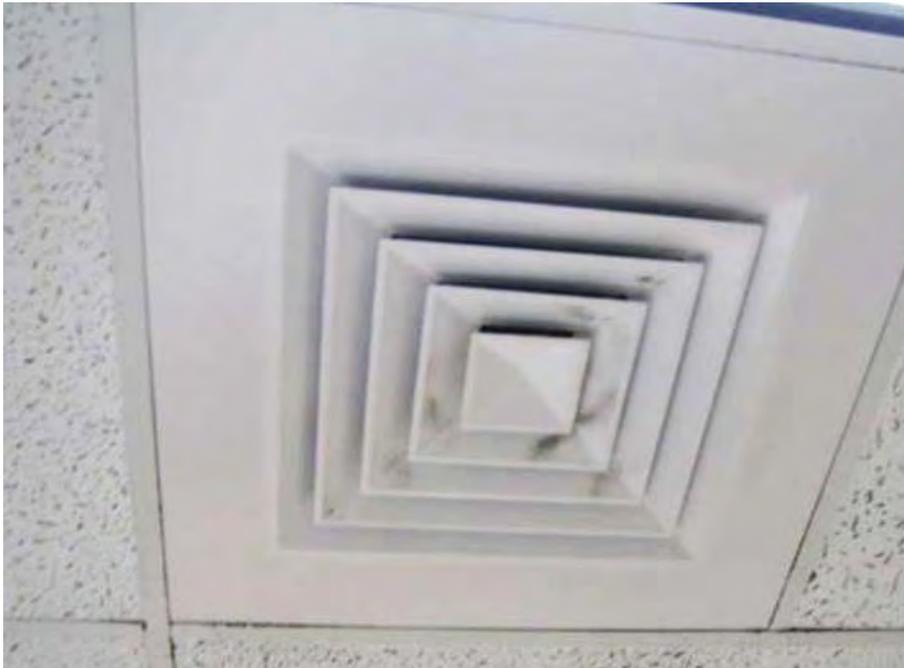
A number of air diffusers, exhaust/return vents and personal fans were found to have accumulated dust/debris (Table 1; Picture 16 and 17). If exhaust vents are not functioning, backdrafting can occur, which can re-aerosolize accumulated dust particles. Re-activated supply, exhaust/return vents and fans can also aerosolize dust accumulated on vents/fan blades.

Dust/debris on supply louvers

27. Clean personal fans, air diffusers and return vents periodically of accumulated dust.
28. Clean upholstered furniture, cloth curtains, stuffed animals, pillows and curtains on a regular schedule. If not possible/practical, consider removing from classrooms.
29. Consider adopting the US EPA (2000) document, “Tools for Schools”, as an instrument for maintaining a good indoor air quality environment in the building. This document is available at: <http://www.epa.gov/iaq/schools/index.html>.
30. Refer to resource manual and other related indoor air quality documents located on the MDPH’s website for further building-wide evaluations and advice on maintaining public buildings. These documents are available at: <http://mass.gov/dph/iaq>.

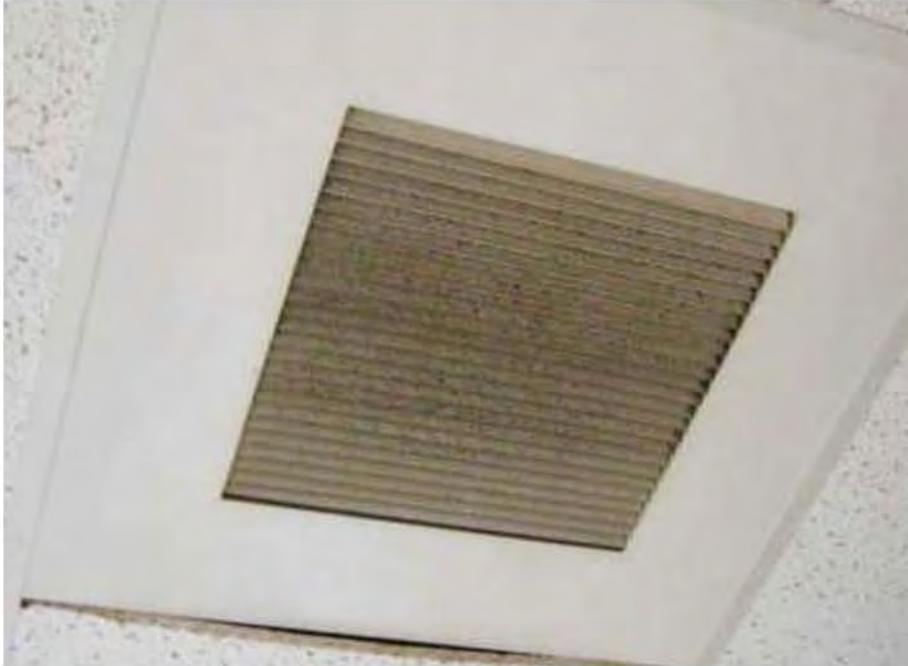
Picture 17

Dust/debris accumulation on exhaust vent

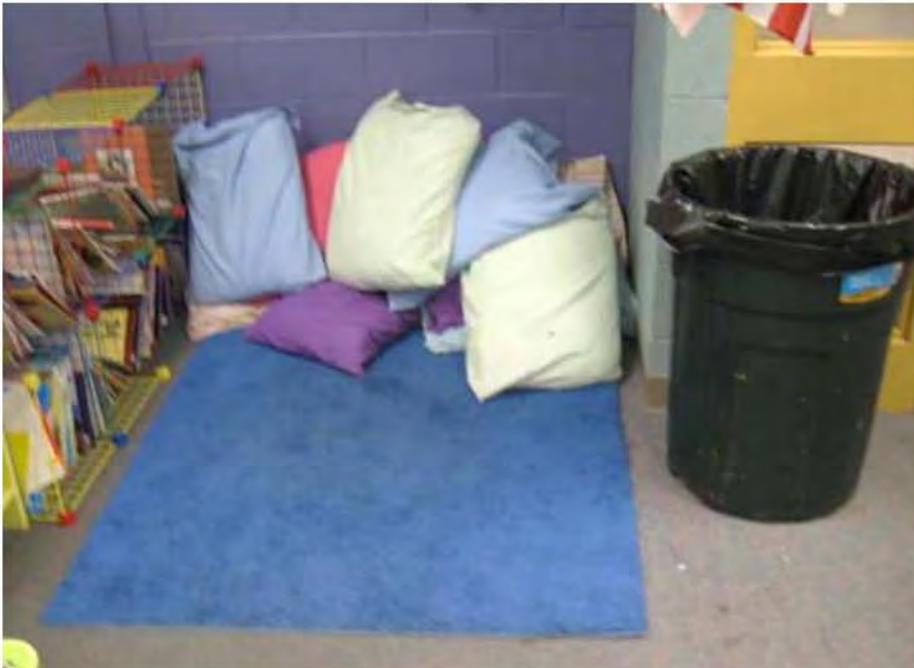
Picture 18

Upholstered furniture, pillows/cushions and large stuffed animals were seen in several classrooms (Picture 18). Upholstered furniture, pillows and cushions are covered with fabric that comes in contact with human skin. This type of contact can leave oils, perspiration, hair and skin cells. Dust mites feed upon human skin cells and excrete waste products that contain allergens. In addition, if relative humidity levels increase above 60 percent, dust mites tend to proliferate (US EPA, 1992). In order to remove dust mites and other pollutants, frequent vacuuming of upholstered furniture is recommended (Berry, M.A., 1994). It is also recommended that upholstered furniture (if present in schools), be professionally cleaned on an annual basis. If outdoor conditions or indoor activities (e.g., renovations) create an excessively dusty environment, cleaning frequency should be increased (every six months) (IICRC, 2000).

Pillows on floor of classroom

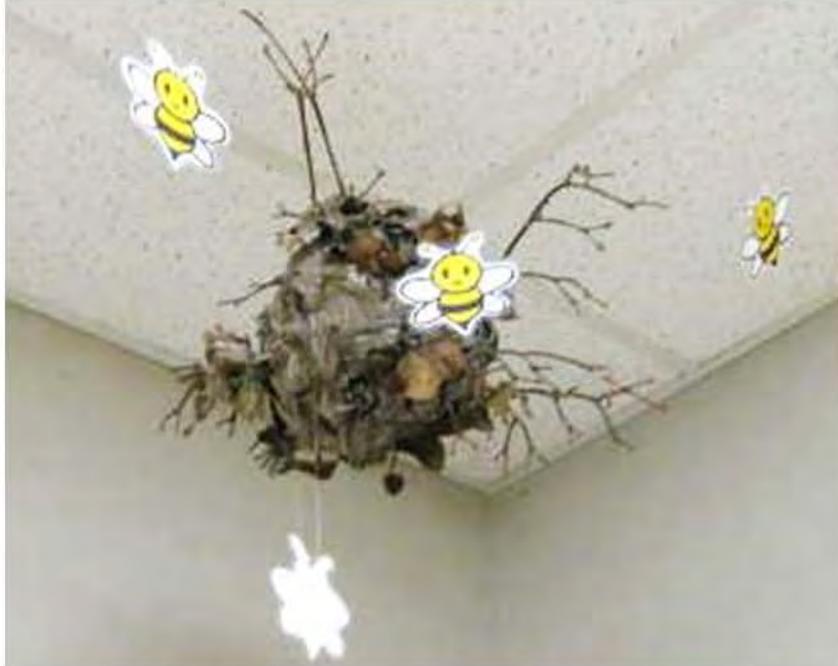
Picture 19

An inactive insect nest and other items were noted suspended from the ceiling system in classroom 248 (Picture 19). Nests can contain bacteria and may be a source of allergenic material. Nests should be placed in resealable bags to prevent aerosolization of allergenic material. In a number of other classrooms, items were seen hanging from the suspended ceiling tile system (Table 1; Picture 20). Items should not be suspended from ceiling tile systems; movement of ceiling tiles may aerosolize dust above ceiling tiles. Moreover, the accumulated weight of items may damage the ceiling tile frames.

Wasp's nest hanging from classroom ceiling

18. Clean and maintain aquariums and terrariums to prevent bacterial/microbial growth and associated odors.
19. Store nests in resealable bags, away from ventilation sources.

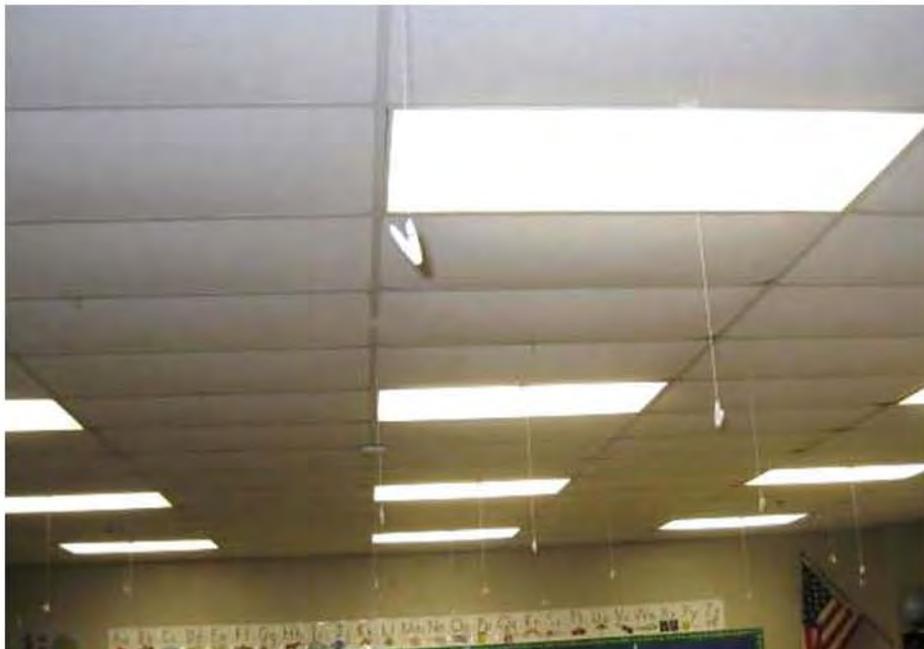
Picture 20

Multiple clips/strings hanging from suspended ceiling tile system

20. Refrain from hanging objects from ceiling tile systems.
21. Relocate or consider reducing the amount of materials stored in classrooms to allow for more thorough cleaning of classrooms. Clean items regularly with a wet cloth or sponge to prevent excessive dust build-up.
