INDOOR AIR QUALITY ASSESSMENT

**Spring Street Elementary School
2 Spring Street
West Bridgewater, MA**

Prepared by:
Massachusetts Department of Public Health
Bureau of Environmental Health
Indoor Air Quality Program
July 2014

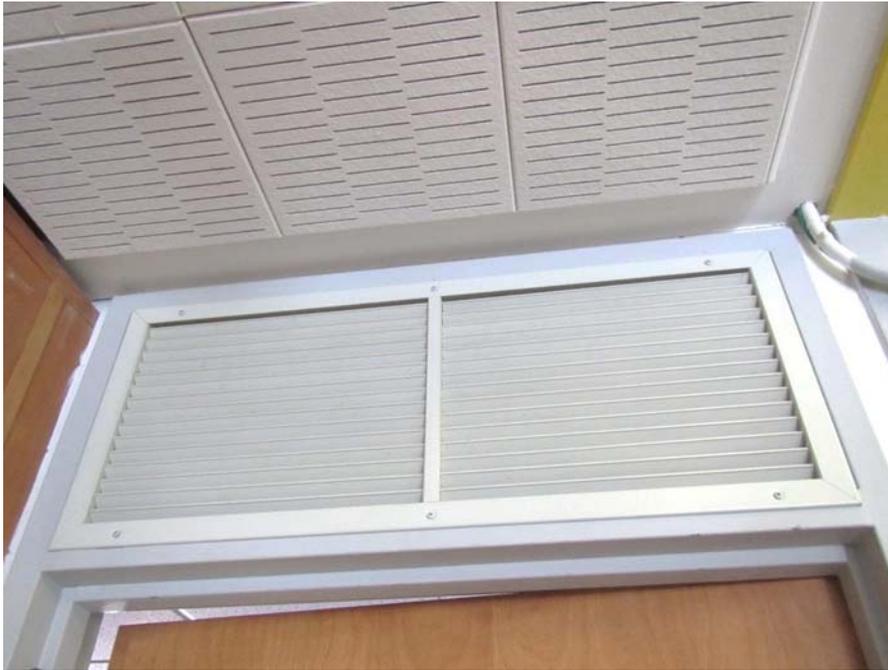
Picture 1

It can be seen from Table 1 that carbon dioxide levels were above 800 parts per million (ppm) in 4 of 8 areas at the time of assessment, indicating less than optimal air exchange in half of the areas surveyed. Most classrooms do not have any mechanical ventilation to provide fresh air, instead rely on openable windows and passive vents located above the door (Picture 1). Cross ventilation can be created when windows on opposing sides of the building are open, allowing movement of air through the passive vents.

Passive vent above door

3. Consider operating window-mounted air-conditioning units as a means for providing fresh filtered air.
4. Use openable windows to supplement fresh air in classrooms as necessary. Opening windows on opposite sides of the building can create cross-ventilation to improve airflow within the school. Ensure that all windows opened are equipped with intact screens to prevent insect entry and that all windows are closed at the end of each day to prevent security issues and freezing of pipes in colder weather.

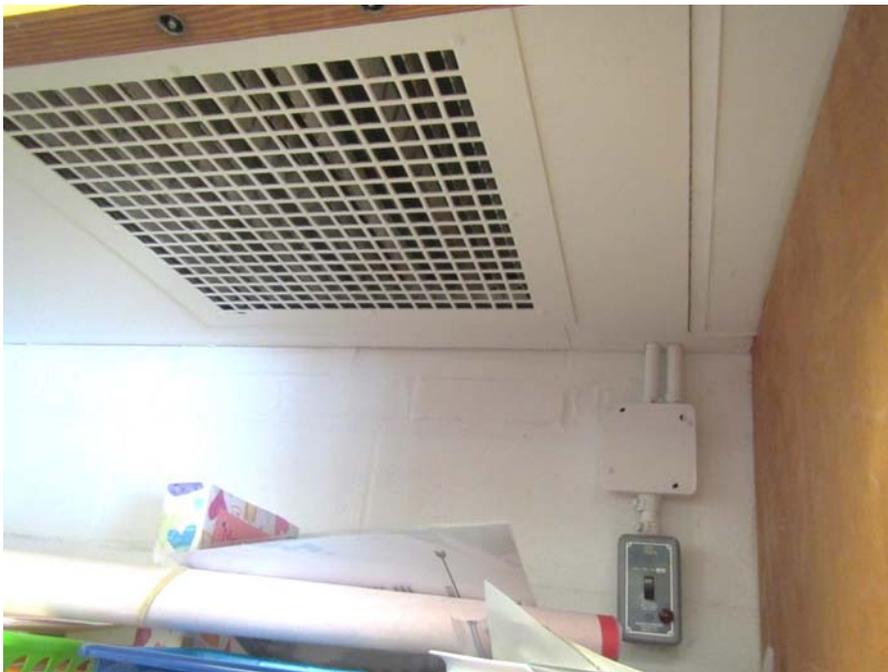
Picture 2

In many classrooms, exhaust ventilation is provided by exhaust openings located in closets. Some of these units are switch-activated (Picture 2); however, they were not operating at the time of assessment. Exhaust ventilation is necessary for reducing the accumulation of normally-occurring indoor pollutants, including water vapor from occupants/respiration. Operating the exhaust system can also increase the draw of fresh air in through open windows or passive vents. Blockages to ventilation should be removed to allow for adequate airflow.

Switch-activated exhaust fan

5. Operate all exhaust vents to ensure removal of air and typical indoor air pollutants from classrooms. Ensure switch-activated exhaust fans are turned on during the school day. Ensure airflow is not obstructed by stored items.

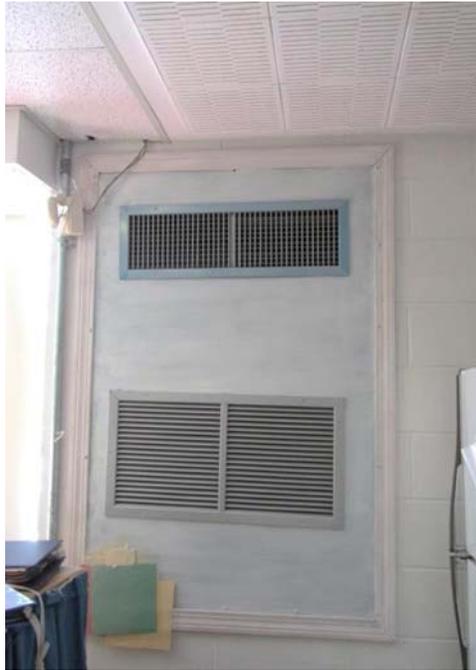
Picture 3

One classroom was retrofitted with an air-handling unit (AHU; Pictures 3 and 4). Air is provided by a supply vent and returned to the AHU via a return vent. At the time of assessment, the return vent appeared to be backdrafting, indicating that air from the outside is penetrating into the building. This system should be operated continuously during school hours to ensure the provision of fresh air and prevent backdrafting.

AHU supply (top) and return (bottom) vents

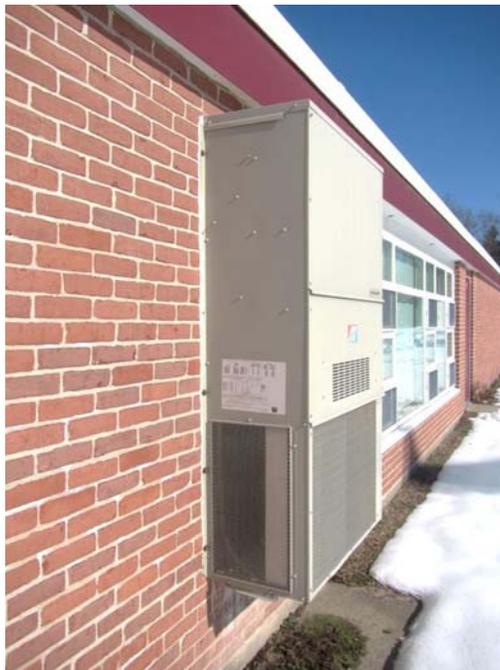
Picture 4

AHU

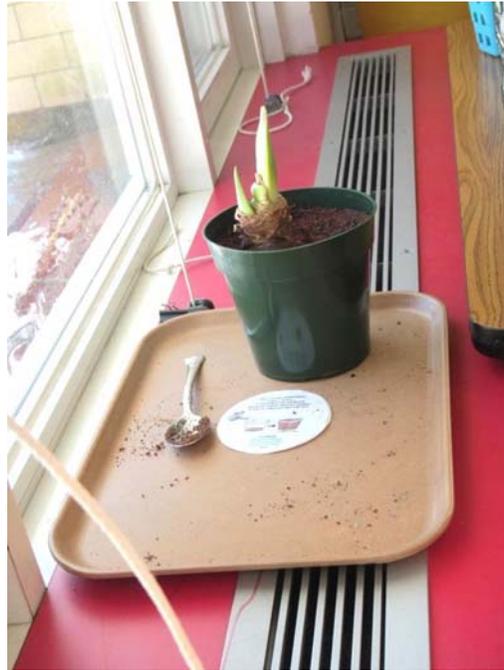
Picture 7

Plants were observed on heating unit diffusers (Picture 8). Plants can be a source of pollen and mold which can be respiratory irritants to some individuals. Plants should be properly maintained and equipped with drip pans. They should also be located *away* from diffusers to prevent the aerosolization and distribution of dirt, pollen, and mold.

Plants on air diffuser

10. Relocate plants away from the air diffusers to prevent aerosolization of mold and debris.
11. Store cleaning products properly and out of reach of students. Ensure spray bottles are properly labeled. All cleaning products used at the facility should be approved by the school department with MSDS available at a central location. Consider providing teaching staff with approved cleaning products.

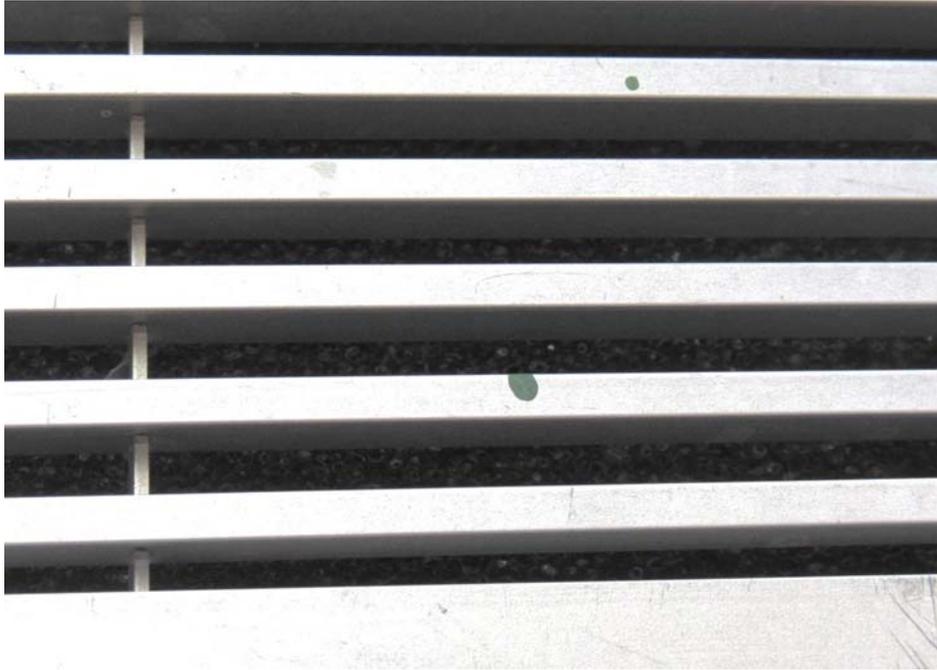
Picture 1

As mentioned, BEH/IAQ staff previously visited the building to assess conditions related to water intrusion through heating ductwork in some areas of the building. At the time of the previous assessment, BEH/IAQ staff recommended that filter medium be installed to prevent the distribution of materials from the heating ductwork (MDPH, 2013). The filters were in place at the time of the current assessment (Picture 5).

Action: BEH/IAQ staff observed filter medium in place at the time of assessment (Picture 1).

Filter media installed below air diffuser

1. Remove all blockages/items from the surface of heat diffusers to ensure adequate airflow.
2. Continue maintaining filtration material installed directly below the air diffuser.
