INDOOR AIR QUALITY ASSESSMENT

**Bedford Town Hall
10 Mudge Way
Bedford, Massachusetts**

Prepared by:
Massachusetts Department of Public Health
Bureau of Environmental Health
Indoor Air Quality Program
May 2015

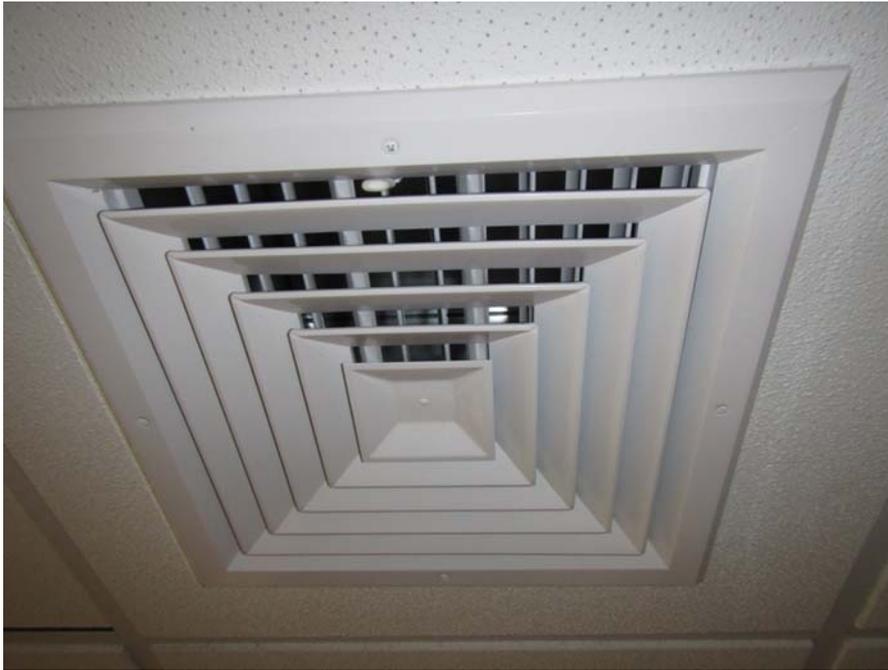
Picture 1

Fresh air provided by the AHU is ducted to ceiling-mounted supply diffusers (Picture 1). Return air is drawn back into vents (Picture 2) and returned to the AHU. Note that in a few areas, supply vents were diverted or blocked off, which reduces the ability of the system to supply fresh air to that space. Without continuous operation of supply/exhaust ventilation, indoor air pollutants can build up and lead to IAQ/comfort complaints.

Ceiling-mounted supply diffuser

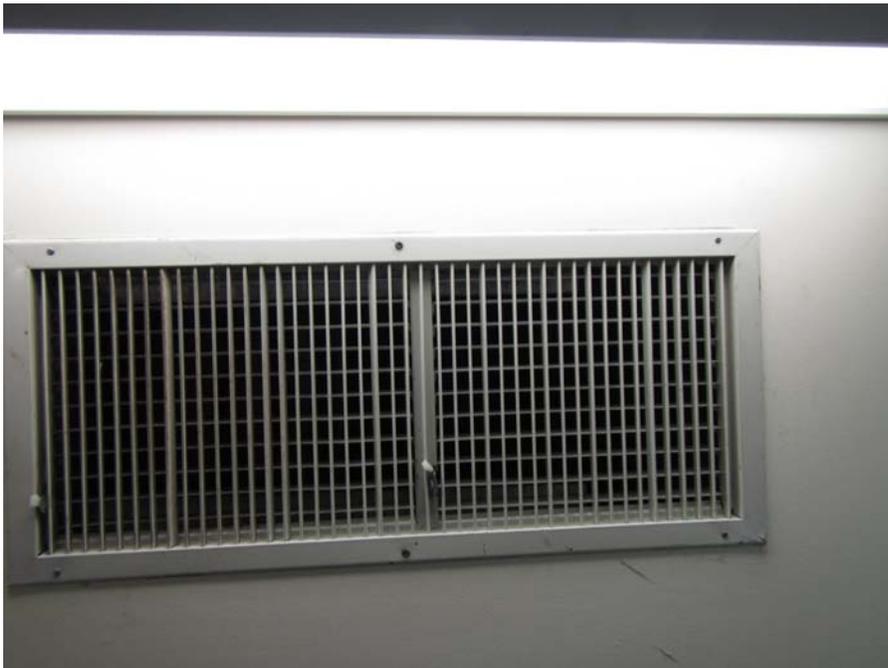
Picture 2

Wall-mounted return vent

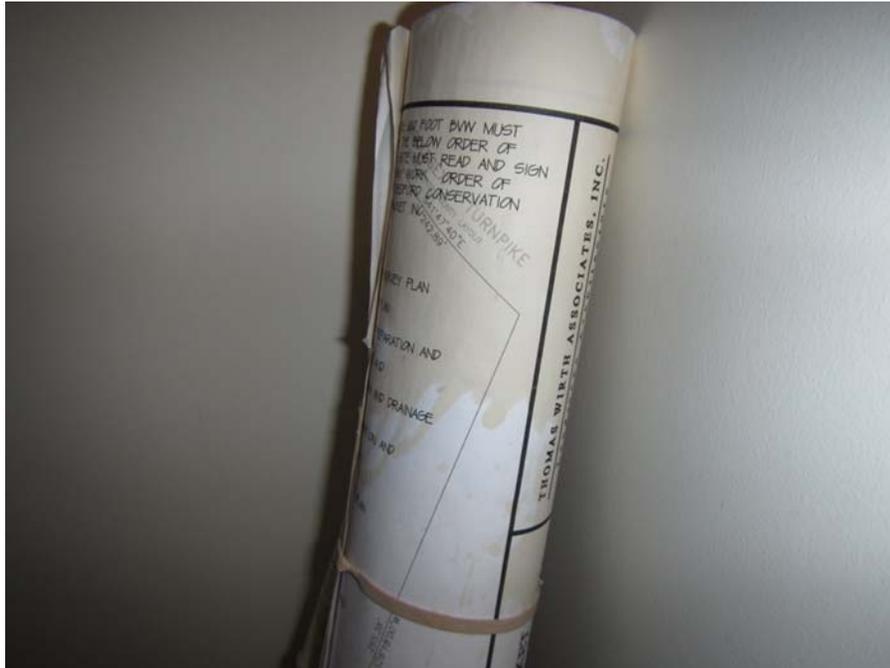
Picture 3

At the time of the assessment, BEH/IAQ staff detected a musty odor in the Planning Director's office, as well as a slight musty odor in the copy area of the Planning Department. Both of these rooms are located on the first floor (main level) and have stored plans/records that have historic water damage (Picture 3) which is the likely source of musty odors.

BEH/IAQ staff did not find any active leaks or water-damaged building materials in either of these locations. It is likely that odor complaints are due to excess humidity moistening porous items stored (papers, plans, clothing, etc.) or odors from items that were water-damaged prior to being brought into the space. All items in this space should be examined to find any water-damaged, mold-colonized or odorous materials. Any porous materials found to be mold-colonized should be discarded. Necessary documents could be scanned prior to discarding. Items of historical significance could be professionally restored if original copies are required.

Water-damaged plans in Planning Department Copy Area

9. Perform a thorough search for any water-damaged or mold-colonized porous items in the Planning Department Copy Area and the Planning Director's office. This would include items brought into the space (clothing, drapes, papers, boxes, food, etc.).

10. Remove and discard any porous items found to have visible mold colonization or odors. Items of importance such as plans or important legal documents could be scanned or copied prior to discarding.

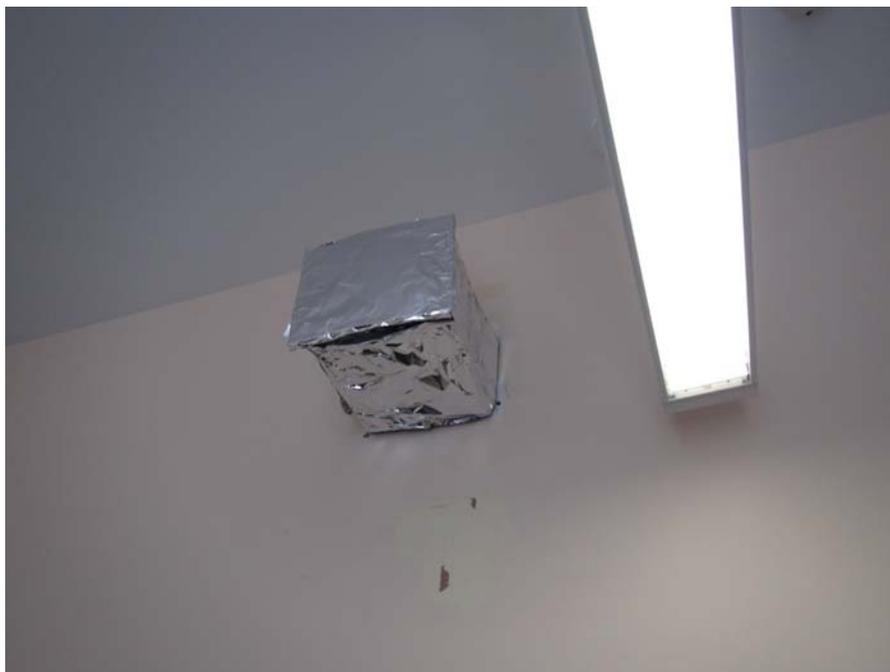
Picture 4

Some occupants in these two areas have blocked ventilation ducts/vents (Pictures 4 and 5) and opened windows to alleviate musty odors. It should be noted that blocking exhaust vents would prevent the ventilation system from removing moisture and odors from the rooms, thereby enhancing odors. Also, blocking supply vents would prevent adequate fresh air supply from entering the space to dilute any common indoor pollutants. Further, when windows are left open

Blocked supply vent

2. Continue with plans to upgrade heating system and ventilation controls.
3. Remove any obstructions or materials blocking supply and/or exhaust vents.

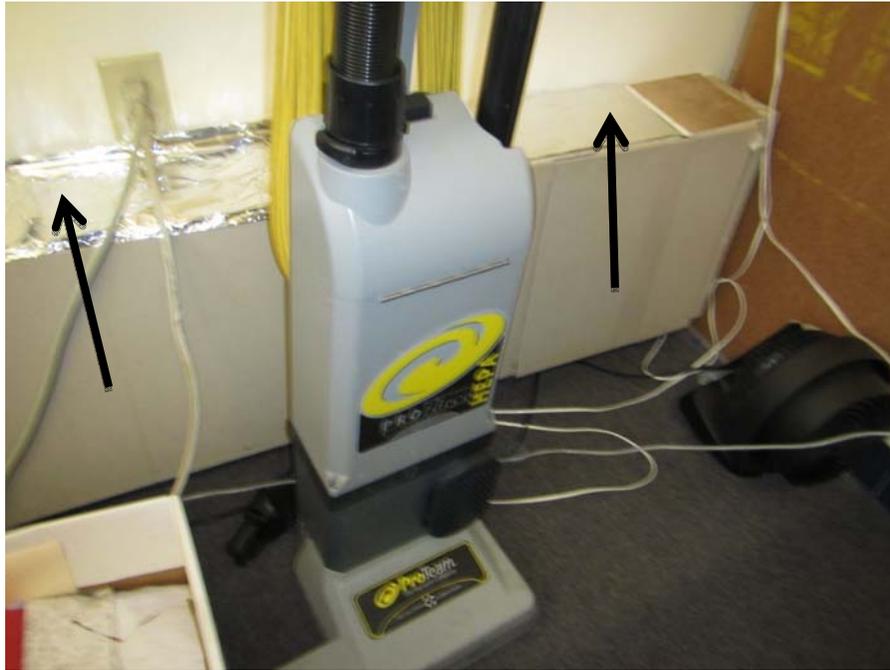
Picture 5

Blocked heating unit (arrows)

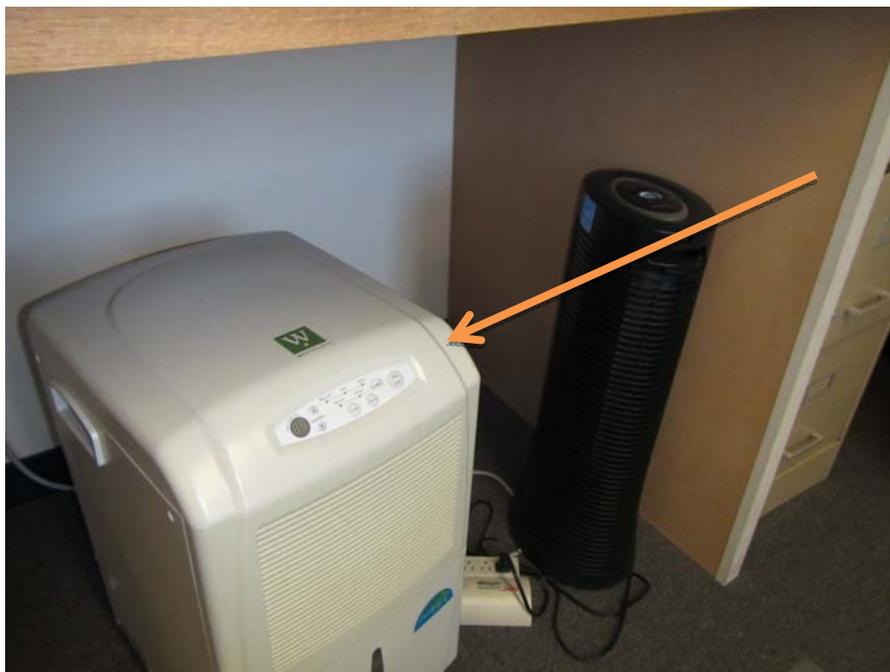
Picture 6

BTH staff reported that due to excess humidity in some lower level locations, portable dehumidifiers (Picture 6) are utilized. Improperly maintained dehumidifiers can also be a source for water damage and microbial growth. The manufacturer's recommendations should be followed regarding cleaning and proper maintenance procedures to avoid spills, stagnant water and associated odors.

Dehumidifier in lower level (arrow)

13. Continue to use dehumidifiers in lower level to reduce humidity. Manufacturer's recommendations concerning cleaning and regular maintenance should be followed to avoid water damage and microbial growth.

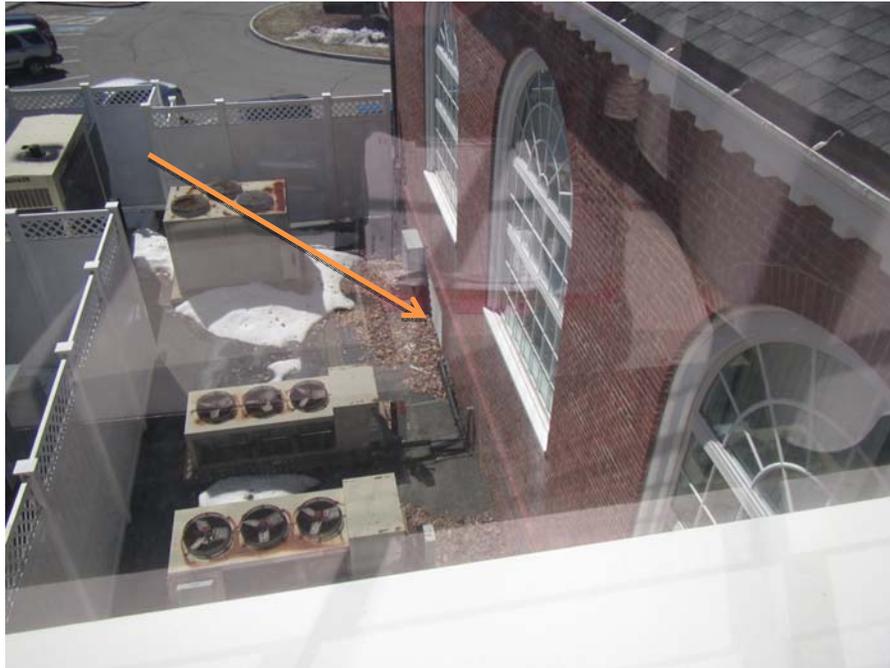
Picture 7

The fresh air intake vent for the AHU appeared to have a subterranean pit directly beneath it. Also noted were piles of accumulated leaves/debris in the immediate vicinity of the vent (Pictures 7 and 8). These conditions have the potential of drawing odors/mold from standing water or decomposing leaves into occupied areas. This area should be regularly maintained to remove any standing water and accumulated debris from beneath the fresh air intake.

Location of fresh air intake showing leaves/debris (arrow)

14. The area near the fresh air intake vent shown in Pictures 7 and 8 should be maintained to remove any standing water and accumulated debris.
15. Avoid storing porous items in areas subject to chronic moisture. In particular, do not store cardboard/paper items in direct contact with floors or walls where condensation may occur during humid conditions.

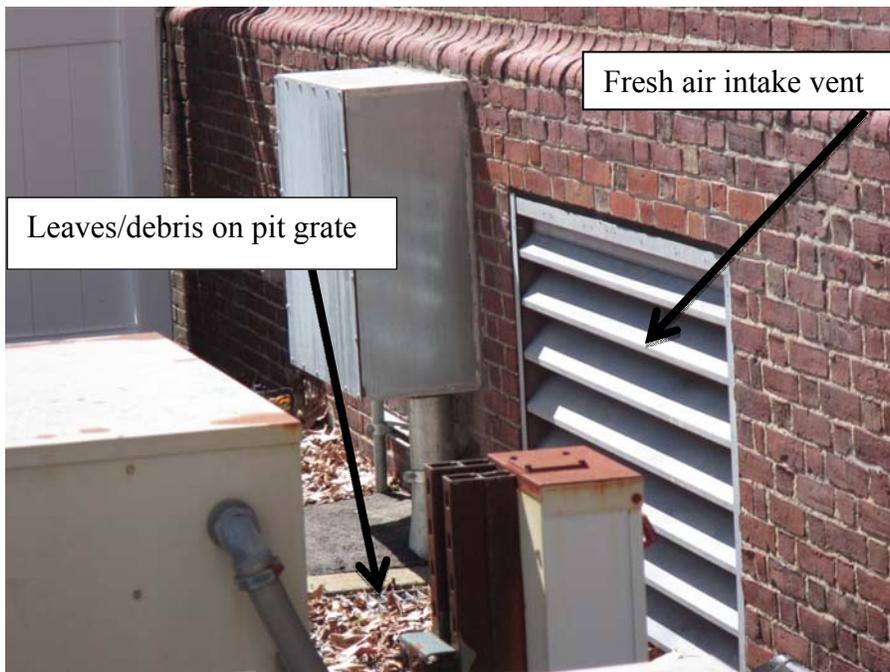
Picture 8

Fresh air intake vent with leaves on grate of pit

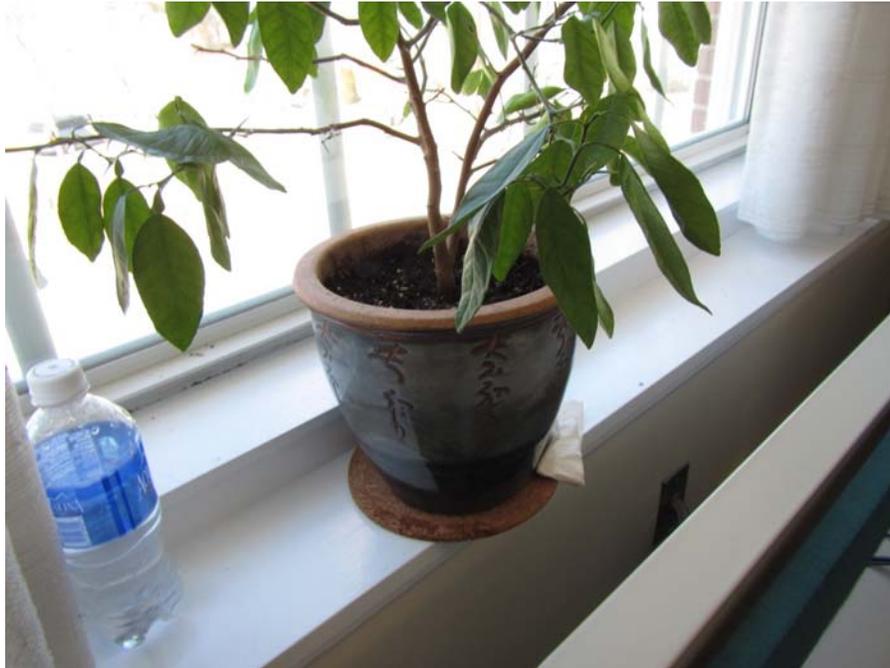
Picture 9

Plants were observed in some areas (Picture 9). Plants can be a source of pollen and mold, which can serve as respiratory irritants for some sensitive individuals. Plants should be properly maintained and equipped with drip pans to prevent water damage to porous building materials and be located away from ventilation sources to prevent the aerosolization of dirt, pollen or mold.

Plant on top of porous materials

17. Consider placing rubber or plastic trays beneath refrigerators to protect the carpet from water damage and microbial growth.
18. Plants should be properly maintained and equipped with drip pans to prevent water damage to porous building materials and be located away from ventilation sources to prevent the aerosolization of dirt, pollen or mold.

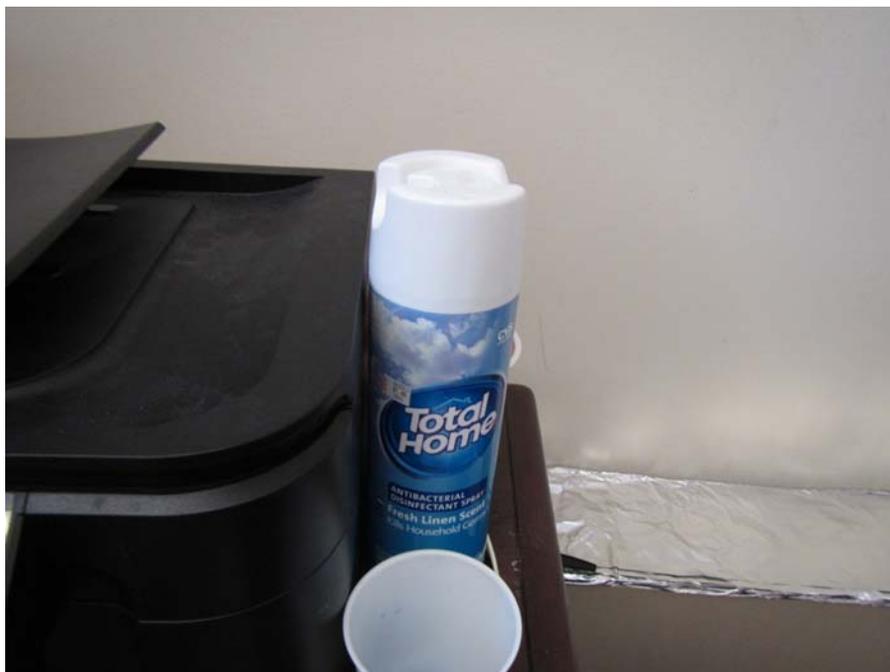
Picture 10

Air fresheners and cleaners with deodorizing materials were observed in some areas (Picture 10). Air deodorizers contain chemicals that can be irritating to the eyes, nose and throat of sensitive individuals. Many air fresheners contain 1,4-dichlorobenzene, a VOC which may cause reductions in lung function (NIH, 2006). Furthermore, deodorizing agents do not remove materials causing odors, but rather mask odors that may be present in the area. Cleaning products contain chemicals that can be irritating to the eyes, nose and throat of sensitive individuals. These products should be properly labeled. Consideration should be given to

Disinfectant/deodorizing spray

20. Avoid the use of air deodorizers and other scented products in the office to reduce exposure to VOCs.
21. Consider supplying staff with compatible cleaning products.

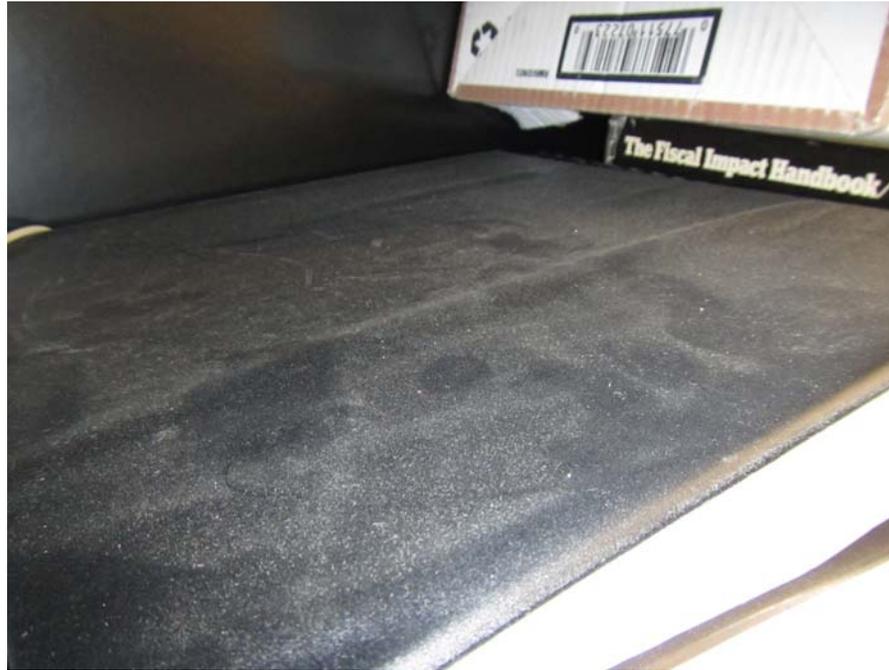
Picture 11

There were a number of items that had gathered a considerable amount of dust and debris in the Planning Director's office and Planning area (Picture 11). This dust/debris can cause irritation when aerosolized due to air movement or movement of items. The dust/debris can also serve as a substrate for mold colonization if sufficient moistening occurs.

Items with dust/debris accumulation (Planning Director Office)

6. Consider using adjustable blinds and shades and/or the application of additional window tinting film to prevent heat complaints due to solar gain.
7. It is recommended that the Planning/Planning Director offices be thoroughly cleaned. Use of a High Efficiency Particulate Arrestance (HEPA) vacuum cleaner and/or damp cloths will help remove dust/debris rather than aerosolizing it.

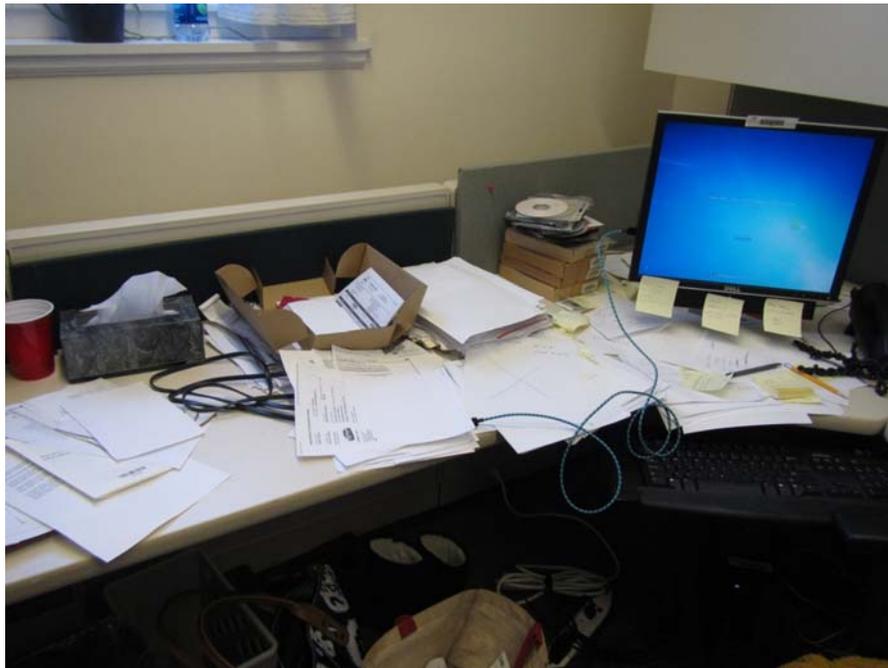
Picture 12

In some areas, accumulation of items, including papers, boxes and personal items were found stored on desks, tables and counters (Picture 12). Large numbers of items provide a source for dusts to accumulate. These items make it difficult for custodial staff to clean. Items should be relocated and/or cleaned periodically to avoid excessive dust build up.

Accumulated items on surfaces

22. Large amounts of accumulated items on flat surfaces should be relocated and/or cleaned periodically to avoid excessive dust build up.
23. Clean carpeting annually (or semi-annually in soiled high traffic areas) as per the recommendations of the Institute of Inspection, Cleaning and Restoration Certification (IICRC, 2012). Copies of the IICRC fact sheet are available at:
<http://www.iicrc.org/consumers/care/carpet-cleaning/#faq>.
