INDOOR AIR QUALITY ASSESSMENT

**Massachusetts Executive Office of Health and Human Services
600 Washington Street, 7th floor
Boston, Massachusetts**

Prepared by:
Massachusetts Department of Public Health
Bureau of Environmental Health
Indoor Air Quality Program
November 2015

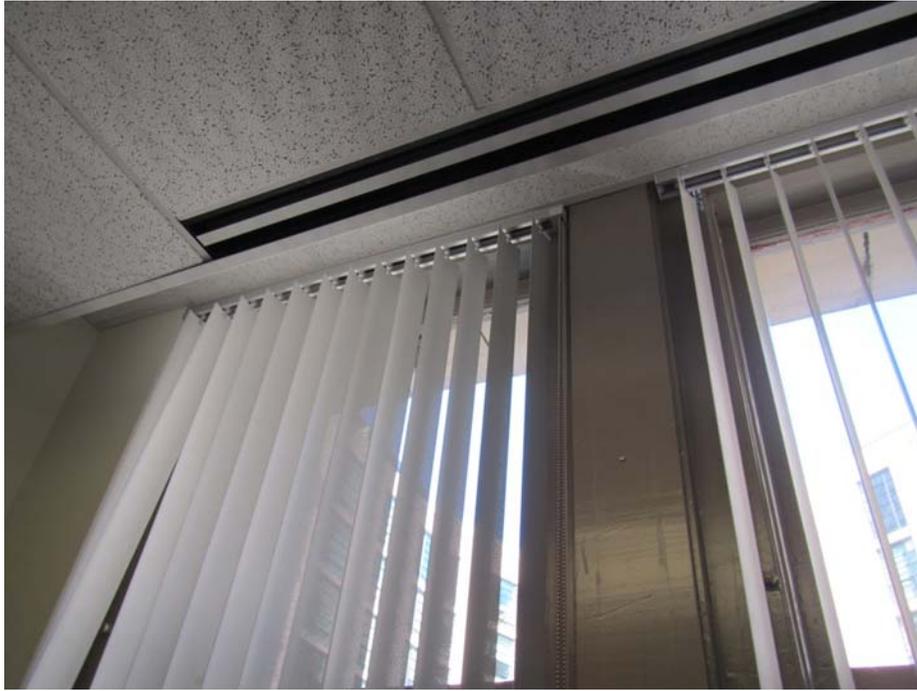
Picture 1

Supply diffuser

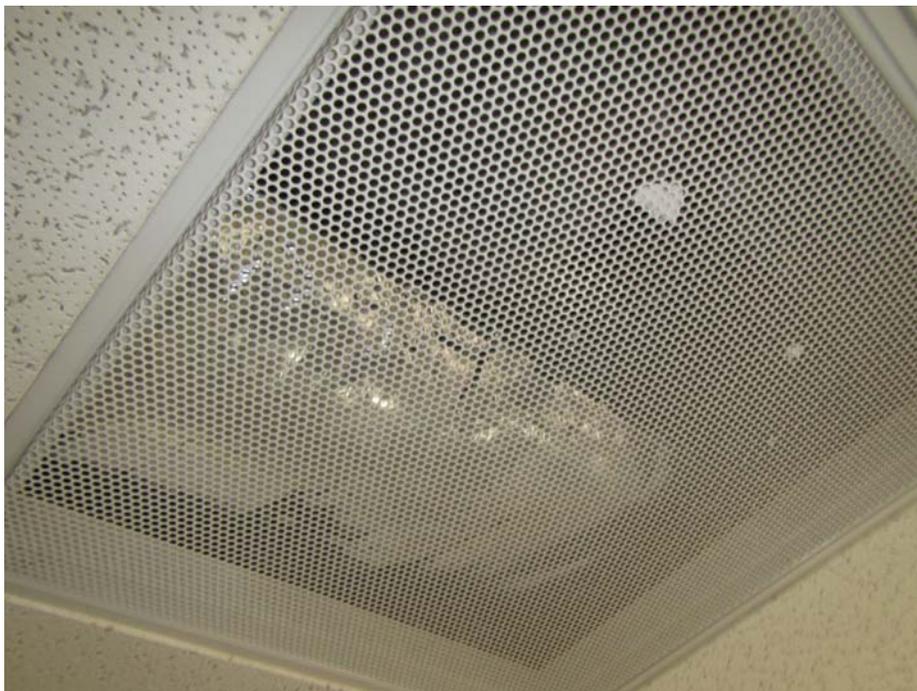
Picture 2

Other conditions that can affect IAQ were observed during the assessment. Some personal fans and supply vents were observed to be dusty (Picture 8). Also, one return vent was noted to have debris behind the vent (Picture 2). Dust on these items can be reaerosolized and cause irritation or odors.

Ceiling-mounted return air grate (note debris in vent)

7. Reduce the use of items containing VOCs including scented cleaners, air fresheners, dry erase materials and hand sanitizer.
8. Clean surfaces, carpets and vents on a preventative maintenance schedule.

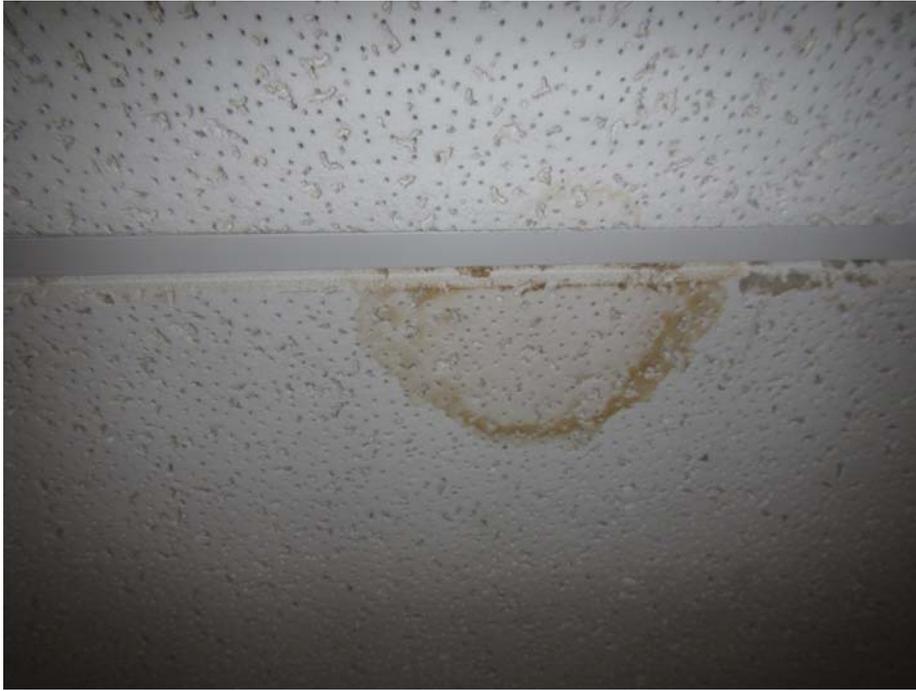
Picture 3

Water-damaged ceiling tiles were observed in some areas (Pictures 3 and 4; Table 1). The US Environmental Protection Agency (US EPA) and the American Conference of Governmental Industrial Hygienists (ACGIH) recommend that porous materials (e.g., carpeting, gypsum wallboard) be dried with fans and heating within 24 to 48 hours of becoming wet (US EPA, 2001; ACGIH, 1989). If not dried within this time frame, mold growth may occur. Once mold has colonized porous materials, they are difficult to clean and should be removed. The source of the leak above the ceiling tiles should be repaired and the water-damaged ceiling tiles should be removed and replaced.

Water-damaged ceiling tile

1. Continue to operate all thermostats in the fan “on” setting to provide continuous airflow/filtration during occupied hours.
2. Replace water-damaged ceiling tiles once the source of the leak is discovered and repaired.

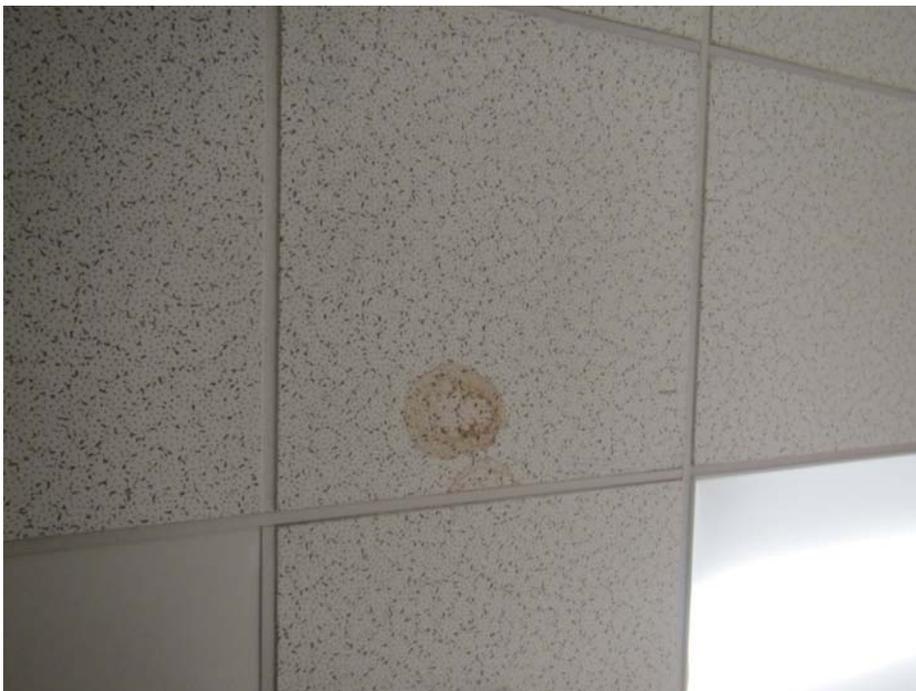
Picture 4

Water-damaged ceiling tile

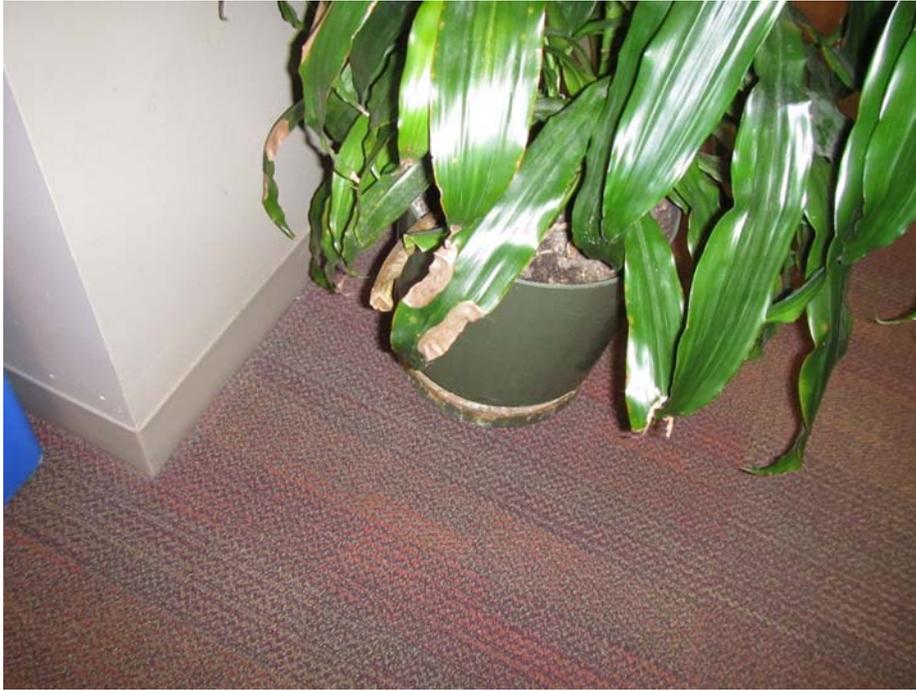
Picture 5

Plants were observed in some offices and open areas (Pictures 5 and 6; Table 1). Plants can be a source of pollen and mold, which can be respiratory irritants to some individuals. Plants should be properly maintained, over-watering of plants should be avoided and drip pans should be inspected periodically for mold growth and cleaned or replaced as necessary.

Plant on carpeting

3. Consider placing water dispensers/small refrigerators in non-carpeted areas or place a waterproof mat underneath them.
4. Maintain indoor plants, use non-porous drips pans, prevent overwatering and refrain from placing them near supply diffusers.

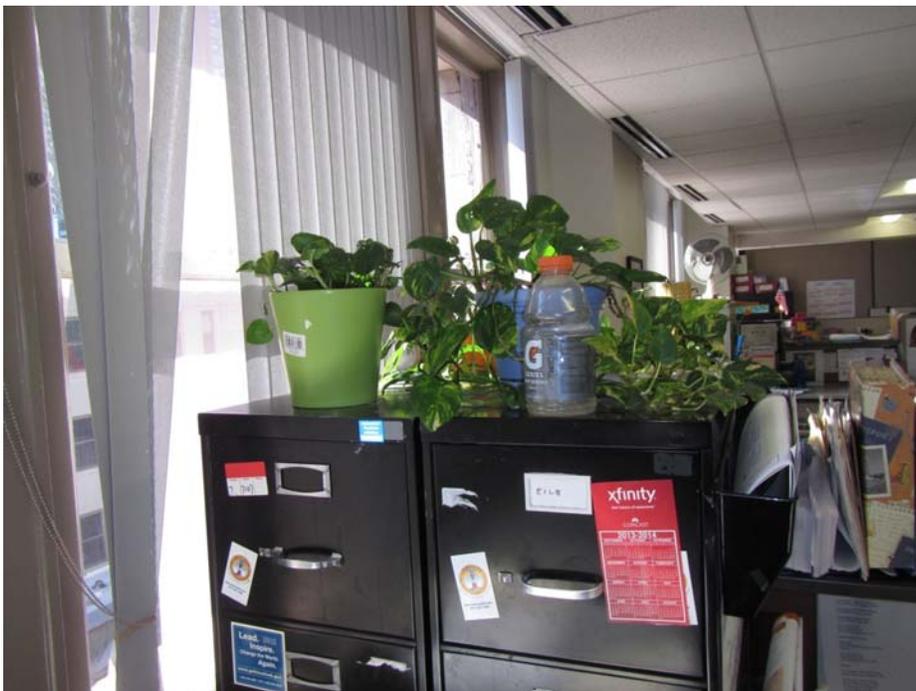
Picture 6

Plants located under supply air stream

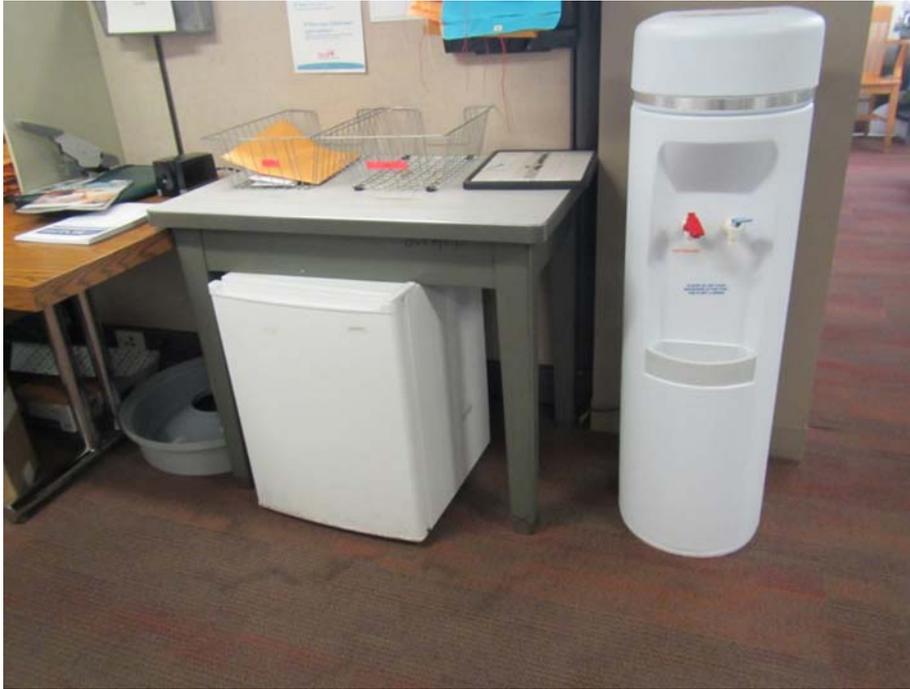
Picture 7

Water dispensing equipment and small refrigerators were observed in carpeted areas (Picture 7; Table 1). Spills or leaks from this equipment can moisten carpet and lead to microbial growth and carpet degradation.

Small refrigerator and water dispenser on carpet (note carpet staining)

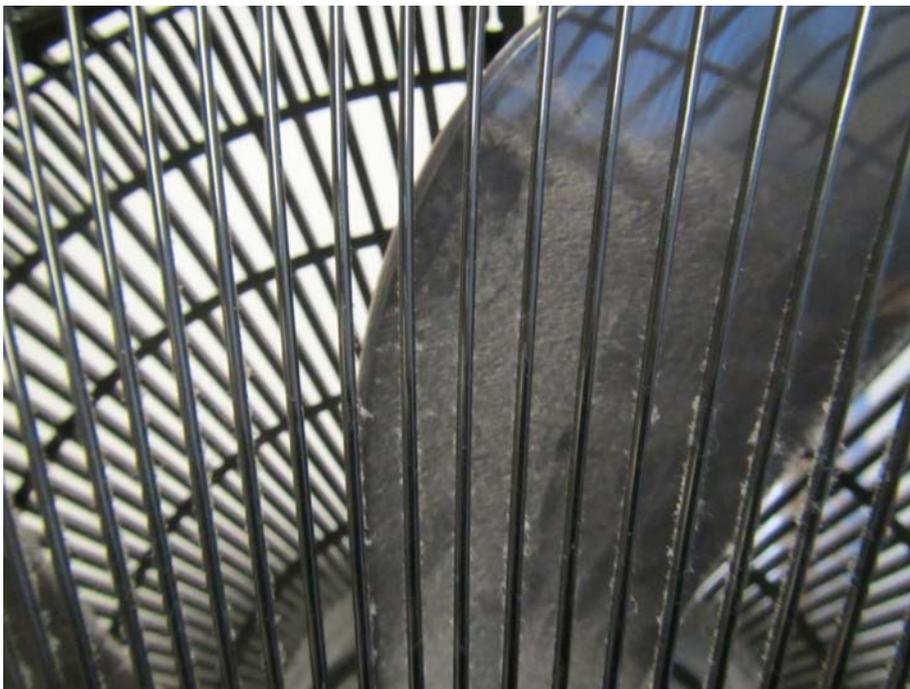
Picture 8

Personal fan showing dust accumulation

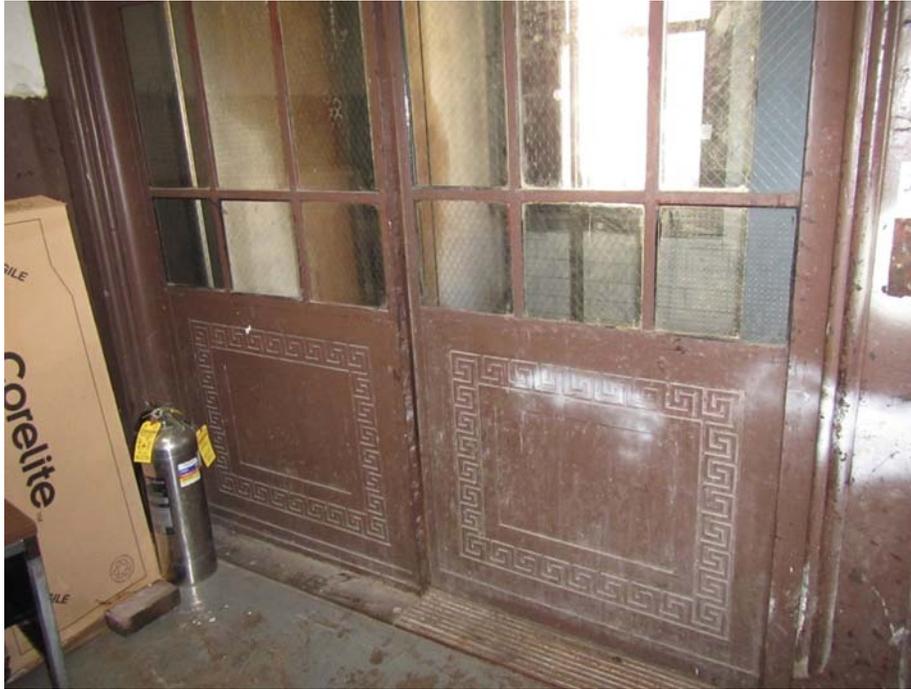
Picture 9

BEH/IAQ staff observed a door leading to an unoccupied space containing freight elevators (Picture 9). Large gaps were noted beneath the door into the hallway. If freight

elevators are used, the area can be pressurized and distribute odors and particulate matter to occupied areas. The installation of a tight-fitting door sweep and gaskets would help mitigate this concern. A stack of new AHU filters were found stored in this room (Picture 10). These filters should be stored in a sealed bag or container to prevent them from absorbing odors or dust prior to installation.

Unoccupied area with freight elevators

5. Consider installing a tight-fitting door sweep and gaskets for the door leading to the freight elevators.
6. Store new AHU filters in a sealed bag or container to prevent damage/contamination.

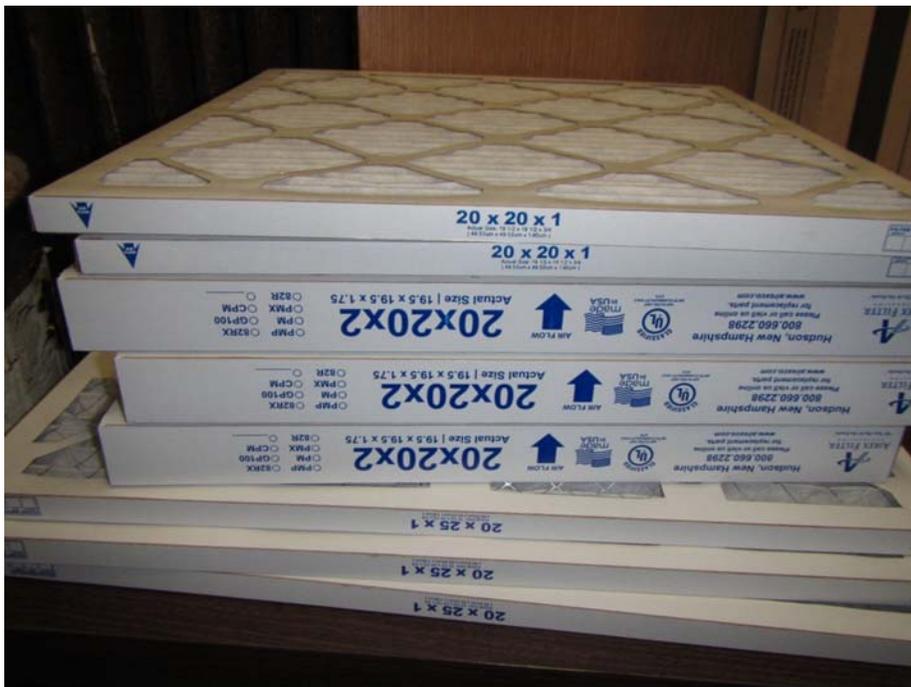
Picture 10

New AHU filters stored unprotected in freight elevator room

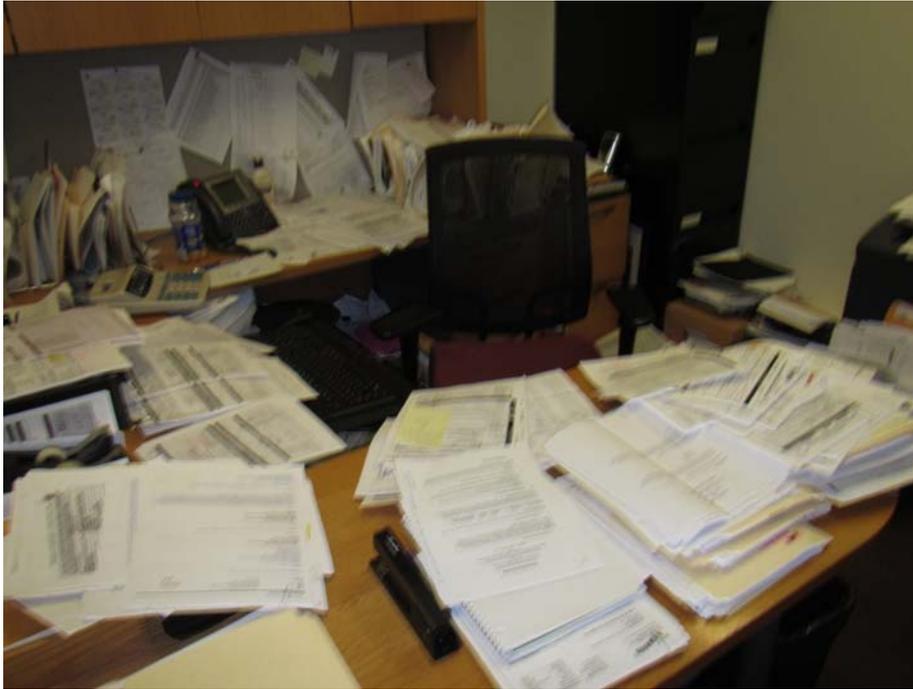
Picture 11

In some areas, accumulation of items, including papers, boxes, and personal items, were stored on floors desks, tables, and counters (Picture 11). Large numbers of items provide a source for dusts to accumulate. These items make it difficult for custodial staff to clean. Items should be relocated and/or cleaned periodically to avoid excessive dust build up.

Large accumulation of items on flat surfaces

9. Store items in an organized manner and move them to clean periodically to prevent a buildup of dust.

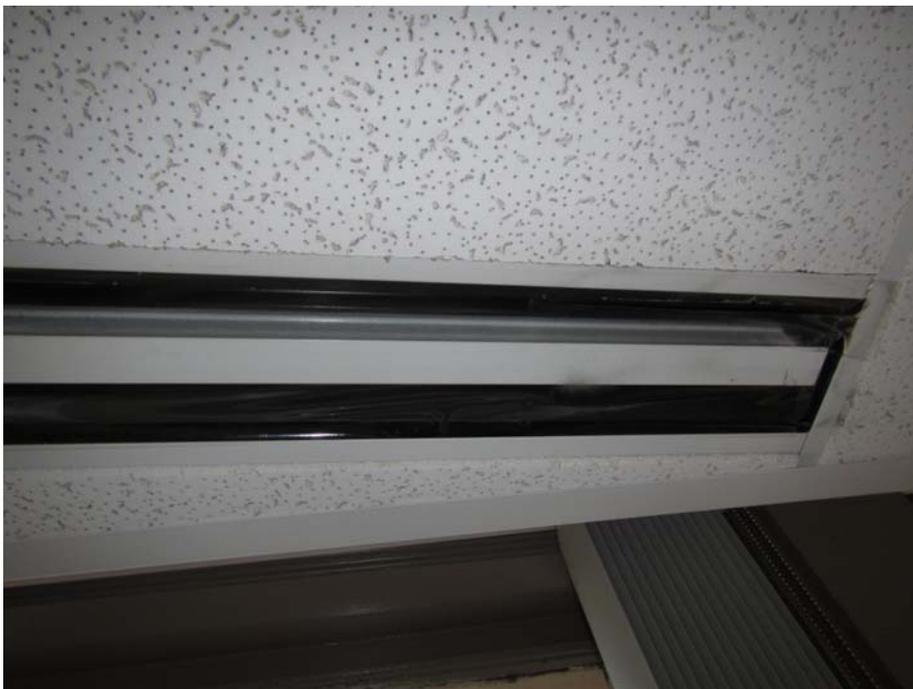
Picture 12

Some EOHHS staff members reported complaints regarding drafts due to the direction of airflow from supply diffusers. In some areas, staff have taped over supply diffusers (Picture 12).

Supply vent showing tape blocking vent openings

10. Consider redirecting supply diffusers in areas where staff have reported comfort complaints and remove blockages to airflow.
11. For buildings in New England, periods of low relative humidity during the winter are often unavoidable. Therefore, scrupulous cleaning practices should be adopted to minimize common indoor air contaminants whose irritant effects can be enhanced when the relative humidity is low. To control for dusts, a high efficiency particulate arrestance (HEPA) filter equipped vacuum cleaner in conjunction with wet wiping of all surfaces is recommended. Avoid the use of feather dusters. Drinking water during the day can help ease some symptoms associated with a dry environment (throat and sinus irritations).
