INDOOR AIR QUALITY ASSESSMENT

**Commonwealth of Massachusetts
Department of Children and Families
1561 North Main Street
Fall River, Massachusetts**

Prepared by:
Massachusetts Department of Public Health
Bureau of Environmental Health
Indoor Air Quality Program
May 2015

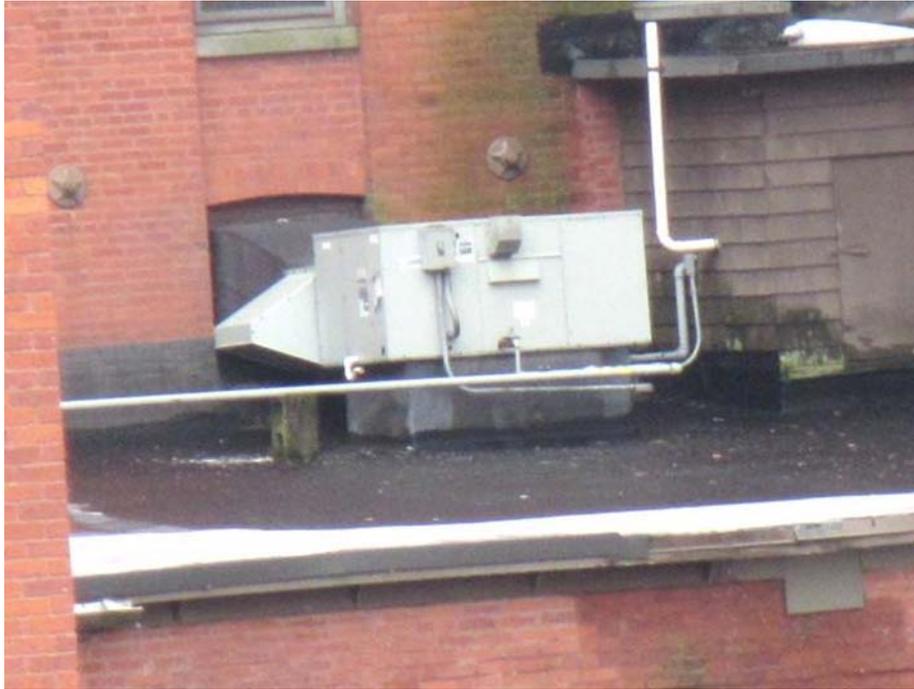
Picture 1

Fresh air is provided by air handling units (AHUs) located around the exterior of the building (Pictures 1 and 2). The AHUs draw in fresh air, heat/cool it and duct it to ceiling-mounted supply diffusers (Picture 3). Air is drawn back into ceiling vents (Picture 4) and returned to AHUs. Additional exhaust ventilation in restrooms is provided by exhaust vents ducted directly to fans on the roof. Office 'S' did not have a means of supply ventilation (nor a window or ceiling vent), however it did have a return vent, which would place the office under negative pressure conditions. In order to provide a source of make-up air, the door can be undercut or a passive vent/grill can be installed.

Air-handling unit

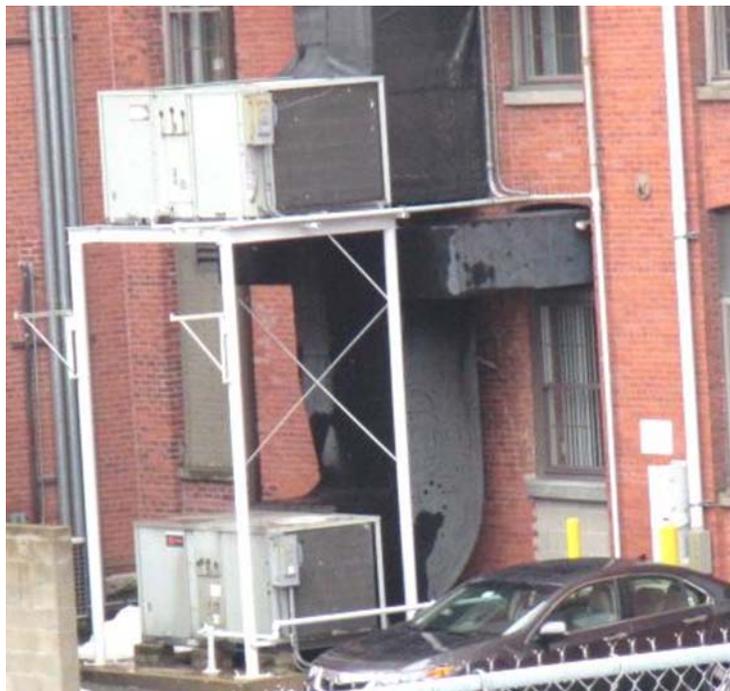
Picture 2

Air-handling units

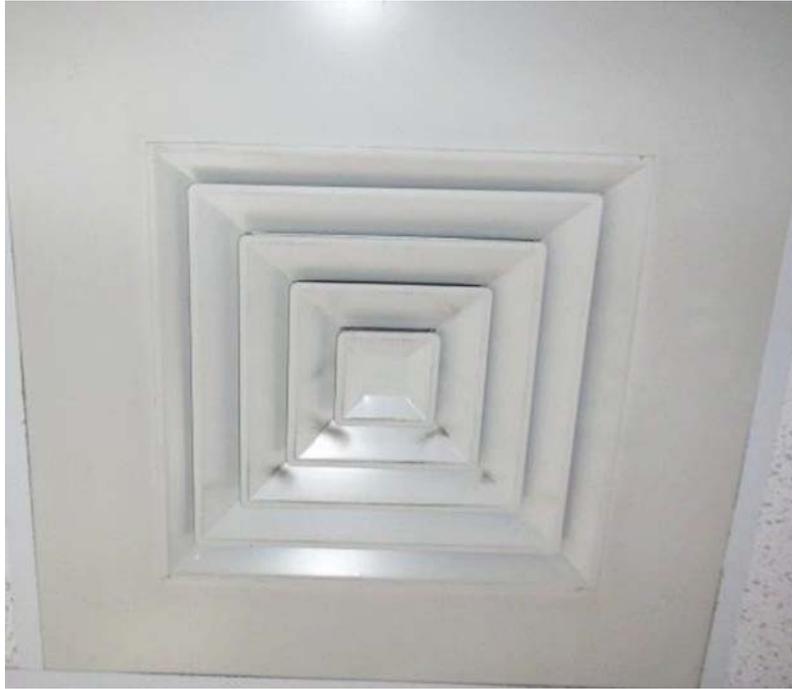
Picture 3

Personal fans, supply and exhaust vents were found to be dusty in some areas (Picture 3, Table 1). Regular cleaning of supply diffusers, exhaust vents and personal fans will reduce aerosolizing any accumulated particulate matter on these surfaces.

Ceiling-mounted supply diffuser, note dust/debris accumulation on vent

15. Regularly clean supply diffusers, exhaust vents and personal fans to avoid re-aerosolizing any accumulated debris.
16. Continue to clean carpeting annually or semi-annually in soiled high traffic areas as per the recommendations of the Institute of Inspection, Cleaning and Restoration Certification (IICRC, 2012). Consider a schedule for replacing any worn carpeting that is beyond its service life.

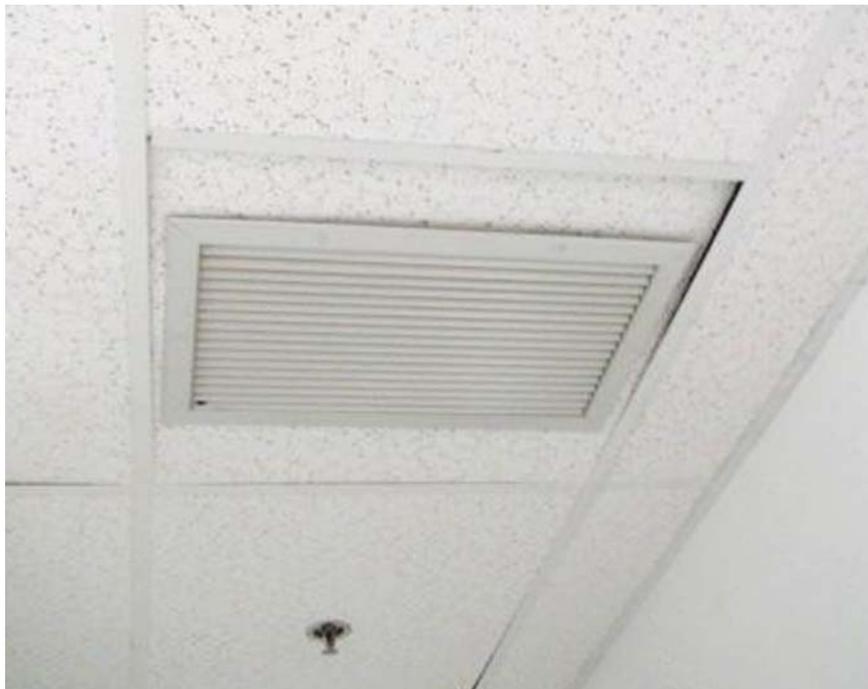
Picture 4

Ceiling-mounted return vent

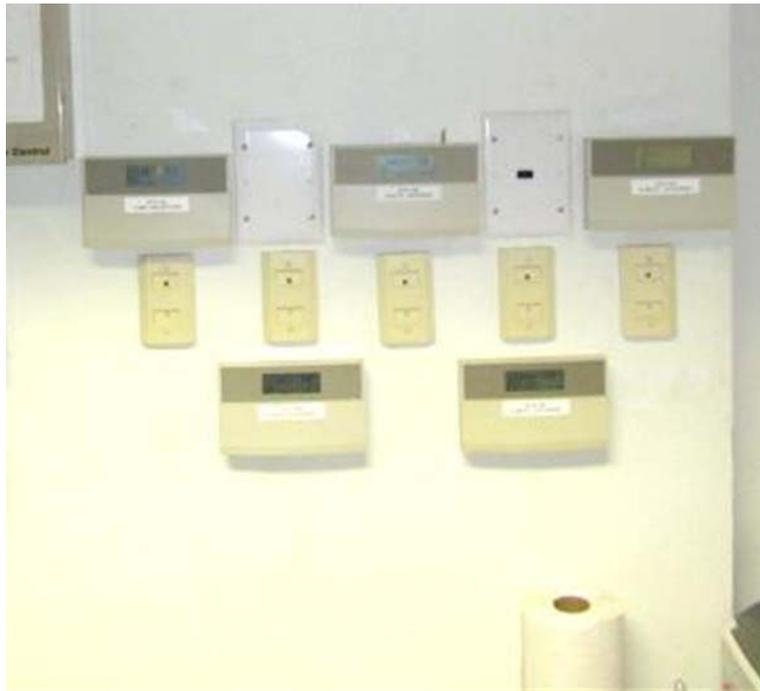
Picture 5

Digital thermostats for HVAC system in computer network room

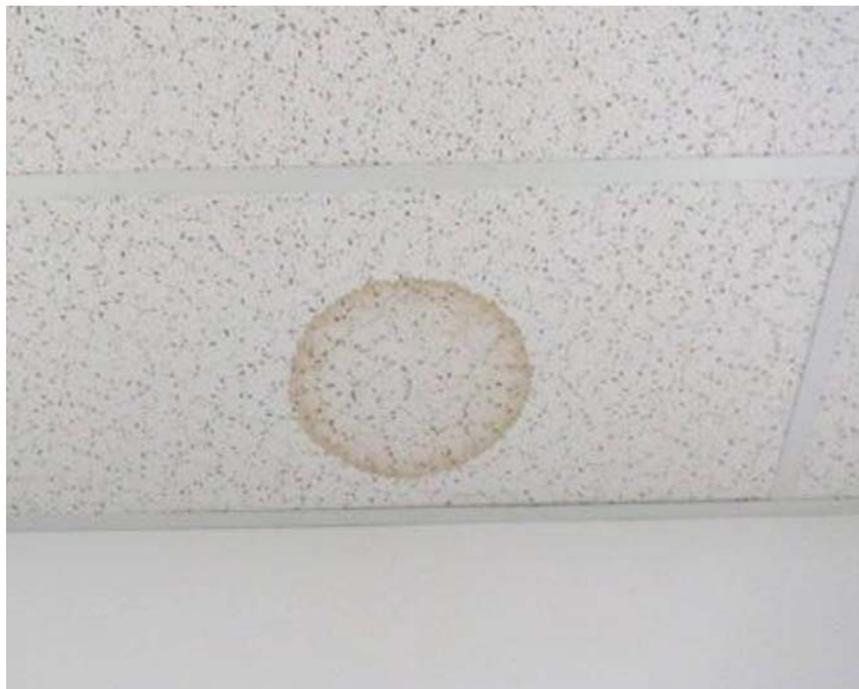
Picture 6

Water-damaged ceiling tiles were observed in a few areas (Picture 6, Table 1), indicating current/historic roof leaks, plumbing leaks or other water infiltration. Water-damaged ceiling tiles can provide a source of mold and should be replaced after a water leak is discovered and repaired.

Water-damaged ceiling tile

6. Ensure building/plumbing leaks are repaired and replace any remaining water-damaged ceiling tiles and other building materials. Disinfect areas of water leaks with an appropriate antimicrobial, as needed.

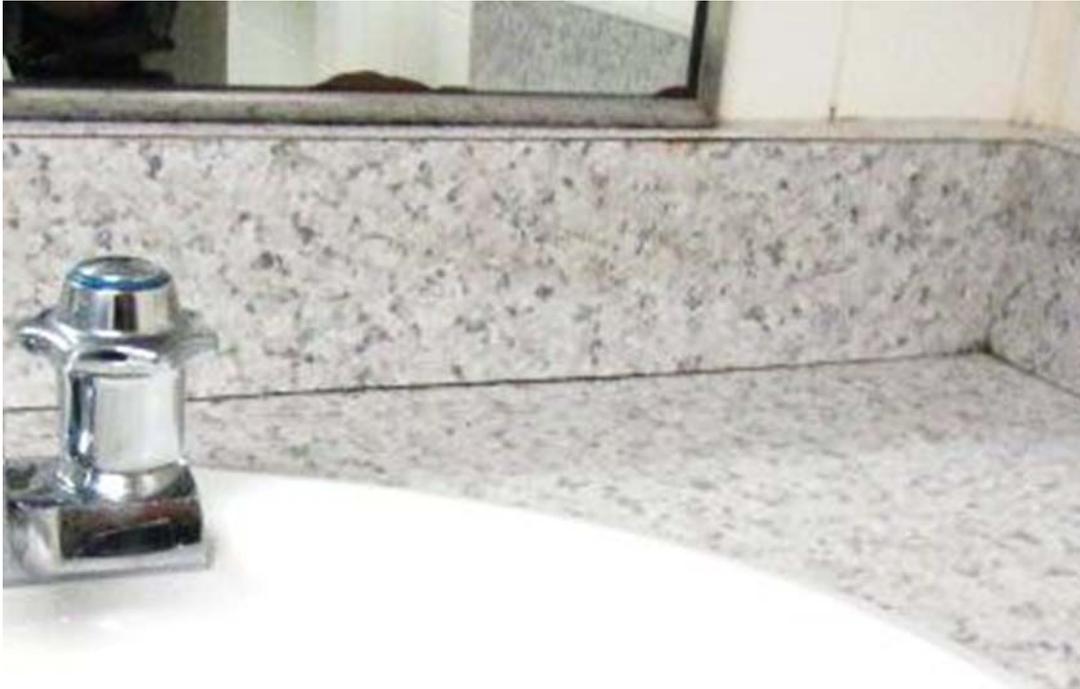
Picture 7

Gaps between the sink countertop and backsplash were noted in the ladies restroom and kitchen/break area (Picture 7, Table 1). Improper drainage or sink overflow can lead to water penetration of countertop wood, the cabinet interior and areas behind cabinets. Like other porous materials, if these materials become wet repeatedly they can provide a medium for mold growth.

Space between sink countertop and backsplash in ladies restroom

7. Seal areas around sinks (e.g., restrooms, kitchen/breakrooms) to prevent water damage to the interior of cabinets and adjacent wallboard.
8. Indoor plants should be properly maintained and equipped with drip pans to prevent water damage to porous building materials and be located away from ventilation sources to prevent the aerosolization of dirt, pollen or mold.

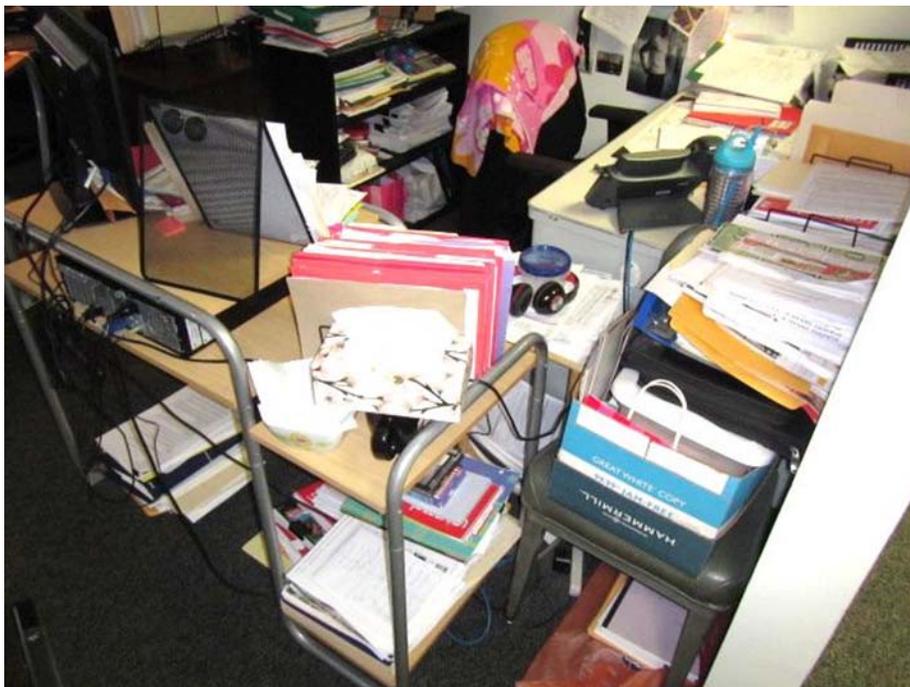
Picture 8

Other conditions that can affect IAQ were observed during the assessment. In some office areas, accumulations of items were seen on floors, windowsills, tabletops, counters, bookcases and desks, which provide a source for dusts to accumulate (Picture 8). These items (e.g., papers, folders, boxes) make it difficult for custodial staff to clean. Items should be relocated and/or be cleaned periodically to avoid excessive dust build up.

Accumulated items in work space

13. Avoid the use of air freshener sprays, solids and diffuser reeds to avoid exposure to VOCs and fragrance compounds.
14. Move items in offices periodically to allow for regular cleaning. Consider reducing the amount of items stored in offices.
