INDOOR AIR QUALITY ASSESSMENT

**Commonwealth of Massachusetts
Department of Children and Families
33 East Merrimack Street
Lowell, MA**

Prepared by:
Massachusetts Department of Public Health
Bureau of Environmental Health
Indoor Air Quality Program
April 2015

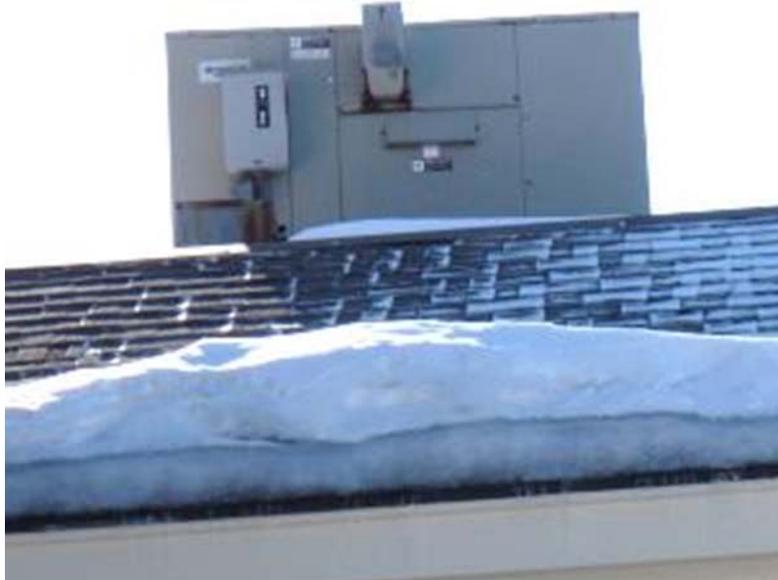
Picture 1

Fresh air is provided by rooftop air-handling units (AHUs; Picture 1). Fresh air is drawn into the AHUs, heated or cooled and delivered to occupied areas via ducted air diffusers (Picture 2). Return air is drawn into ceiling or wall-mounted vents and ducted back to rooftop AHUs (Pictures 3 and 4).

Rooftop air handling unit

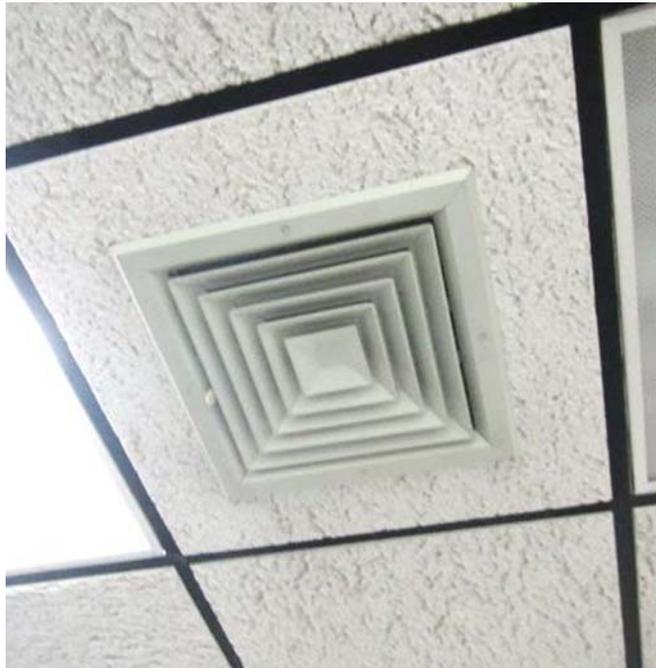
Picture 2

Ceiling-mounted supply diffuser

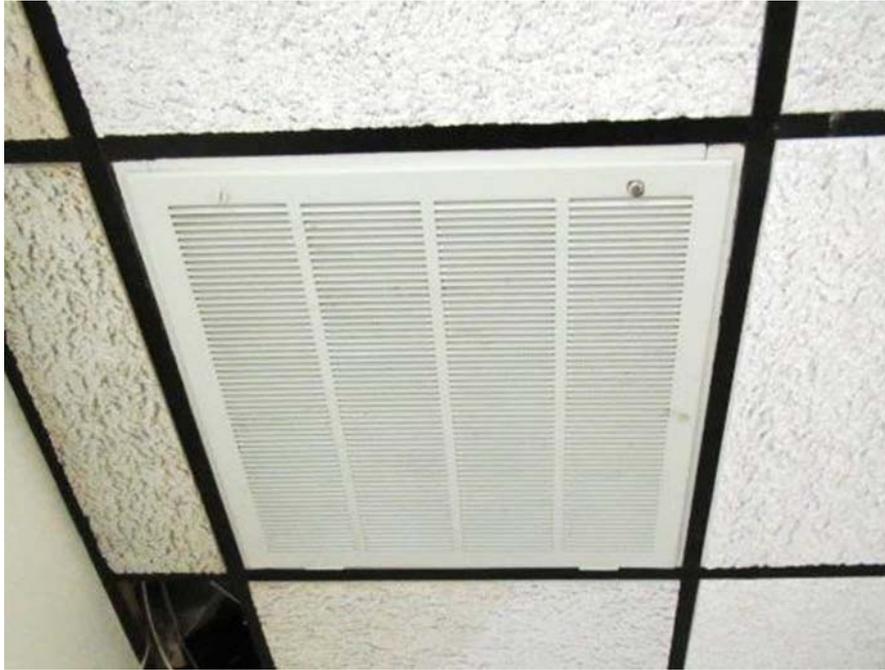
Picture 3

Ceiling-mounted return vent in annex

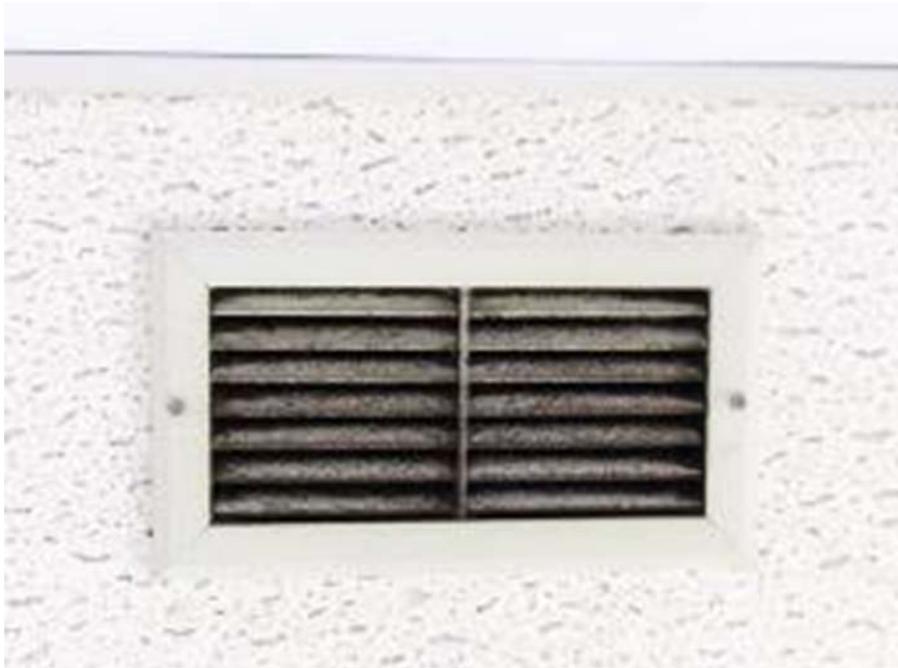
Picture 4

A number of supply diffusers, return grates and exhaust vents were observed to have accumulated dust/debris. If exhaust vents are not functioning, backdrafting can occur, which can re-aerosolize accumulated dust particles. Re-activated supply vents can also aerosolize dust accumulated on vents.

Ceiling-mounted exhaust/return vent in breakroom, note dust/debris accumulation

8. Clean air diffusers, exhaust and return vents periodically of accumulated dust/debris.
9. Relocate or consider reducing the amount of materials stored on flat surfaces to allow for more thorough cleaning. Clean items regularly with a wet cloth or sponge to prevent excessive dust build-up.

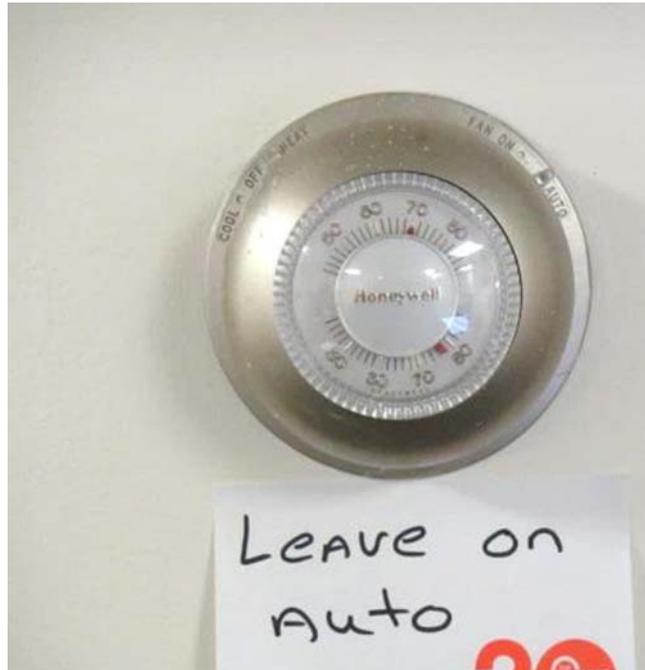
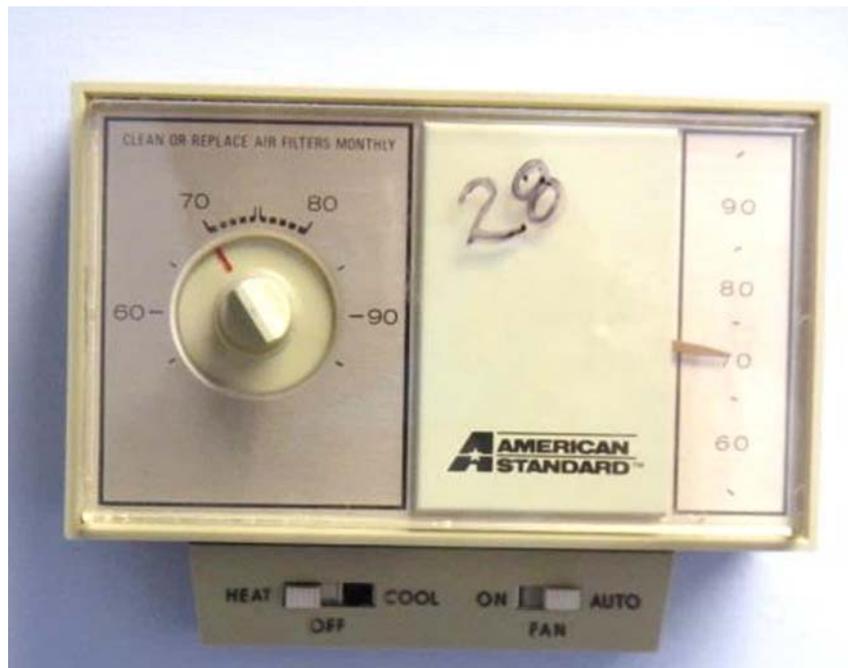
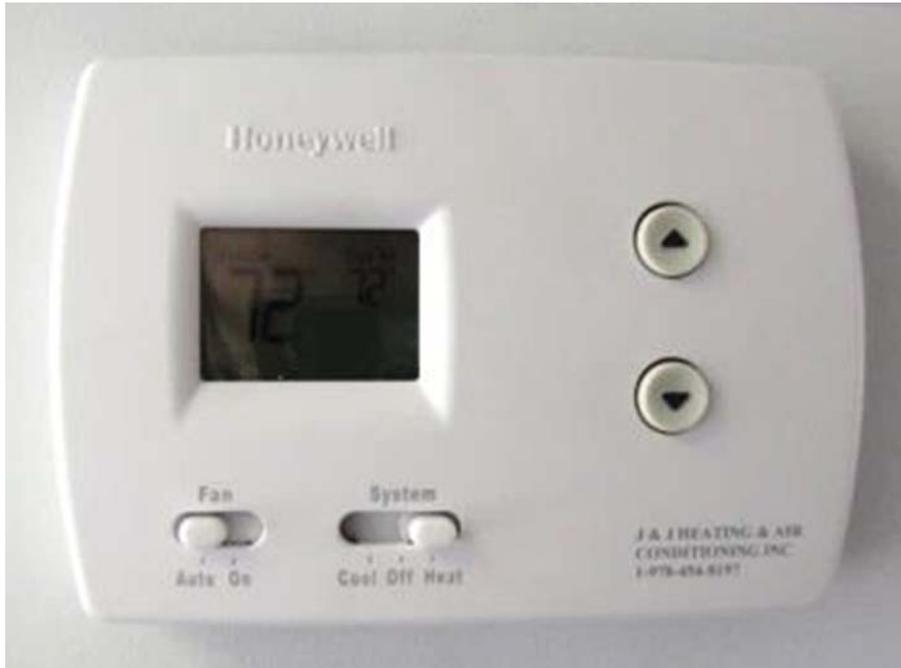
The HVAC system is controlled by digital thermostats (Pictures 5 through 7). Thermostats examined had a fan switch with two settings, *on* and *auto*. When the fan is set to *on*, the system provides a continuous source of air circulation and filtration. The *automatic* setting on the thermostat activates the HVAC system at a pre-set temperature. Once the pre-set

temperature is reached, the HVAC system is deactivated. Therefore, no mechanical ventilation is provided until the thermostat re-activates the system. At the time of the assessment, the thermostat fan settings were in the “auto” position (Pictures 5 through 7). As mentioned, this thermostat setting can limit airflow. The MDPH typically recommends that thermostats be set to the fan *on* setting during occupied hours to provide continuous air circulation.

HVAC thermostat in annex

HVAC thermostat in main DCF area

Digital HVAC thermostat in main DCF area

1. Consider setting thermostats to the fan “on” position to provide continuous air circulation/filtration during business hours.
2. Consider adopting a balancing schedule of every 5 years for all mechanical ventilation systems, as recommended by ventilation industrial standards (SMACNA, 1994).
3. For buildings in New England, periods of low relative humidity during the winter are often unavoidable. Therefore, scrupulous cleaning practices should be adopted to minimize common indoor air contaminants whose irritant effects can be enhanced when

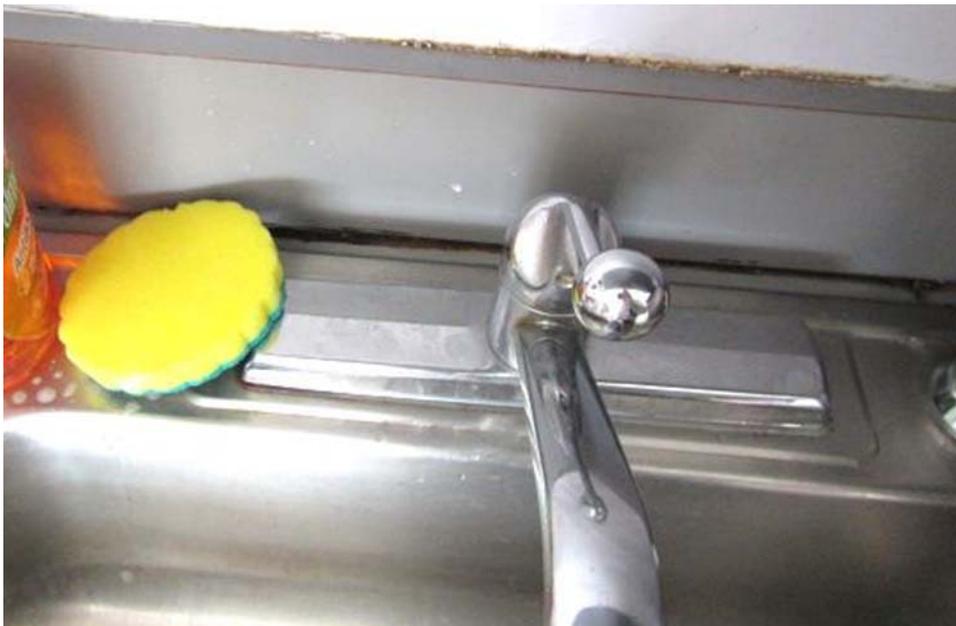
Picture 8

Gaps between the sink countertop and backsplash were noted in the kitchen/break area (Picture 8). Improper drainage or sink overflow can lead to water penetration of countertop

wood, the cabinet interior and areas behind cabinets. Like other porous materials, if these materials become wet repeatedly they can provide a medium for mold growth.

Space between sink countertop and backsplash, dark staining/debris may indicate mold growth

6. Seal areas around sinks (e.g., kitchen/breakroom) to prevent water damage to the interior of cabinets and adjacent wallboard.
7. Remove fiberglass insulation from supply vents in Ms. Miller's office. Consider installing a supply vent with adjustable louvers to control airflow in this area.

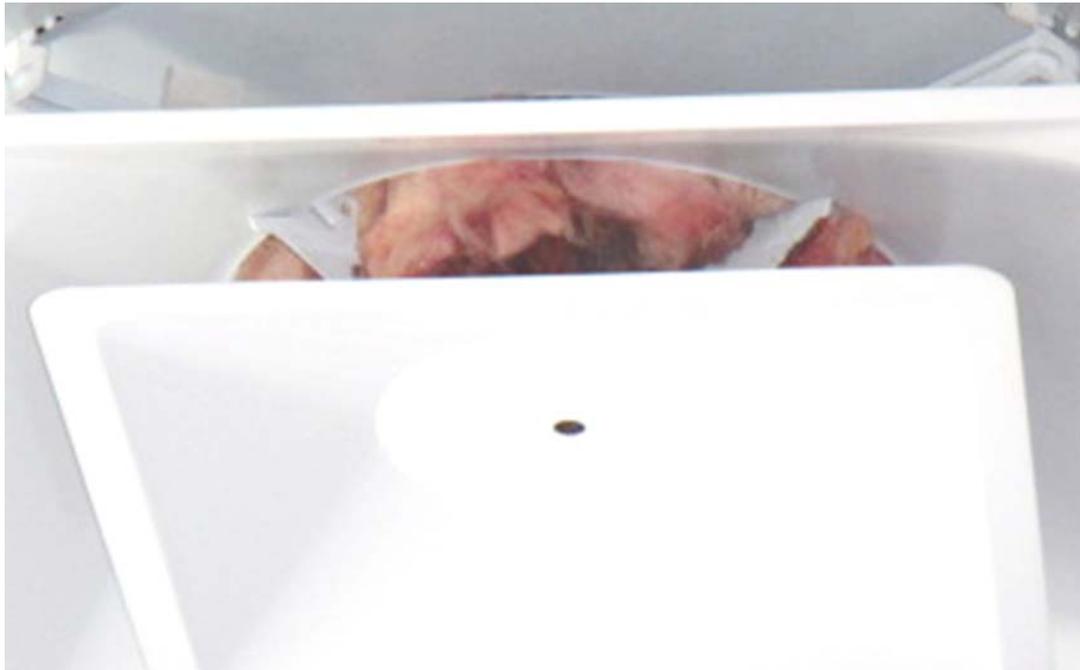
Picture 9

Other conditions that can affect indoor air quality were observed during the assessment. Fiberglass insulation was inserted into the supply vents of Ms. Miller's office (Picture 9), reportedly in an effort to to reduce drafts. Fiberglass insulation can be a source of skin, eye and respiratory irritation if damaged or disturbed. Use of this material to block fresh air grates is not recommended.

**Fiberglass insulation inserted into supply diffusers in Ms. Miller's office
(note hole in diffuser which suggests this vent should have had adjustable louvers installed
inside)**
