INDOOR AIR QUALITY ASSESSMENT

**North Reading Middle School
191 Park Street
North Reading, Massachusetts**

Prepared by:
Massachusetts Department of Public Health
Bureau of Environmental Health
Indoor Air Quality Program
January 2015

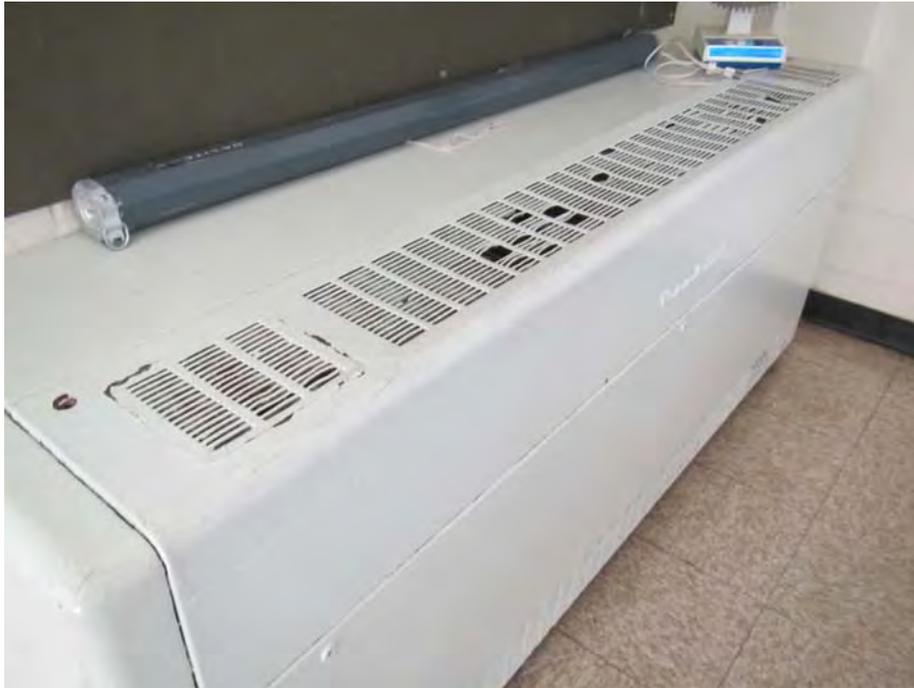
Picture 1

Univent cabinet

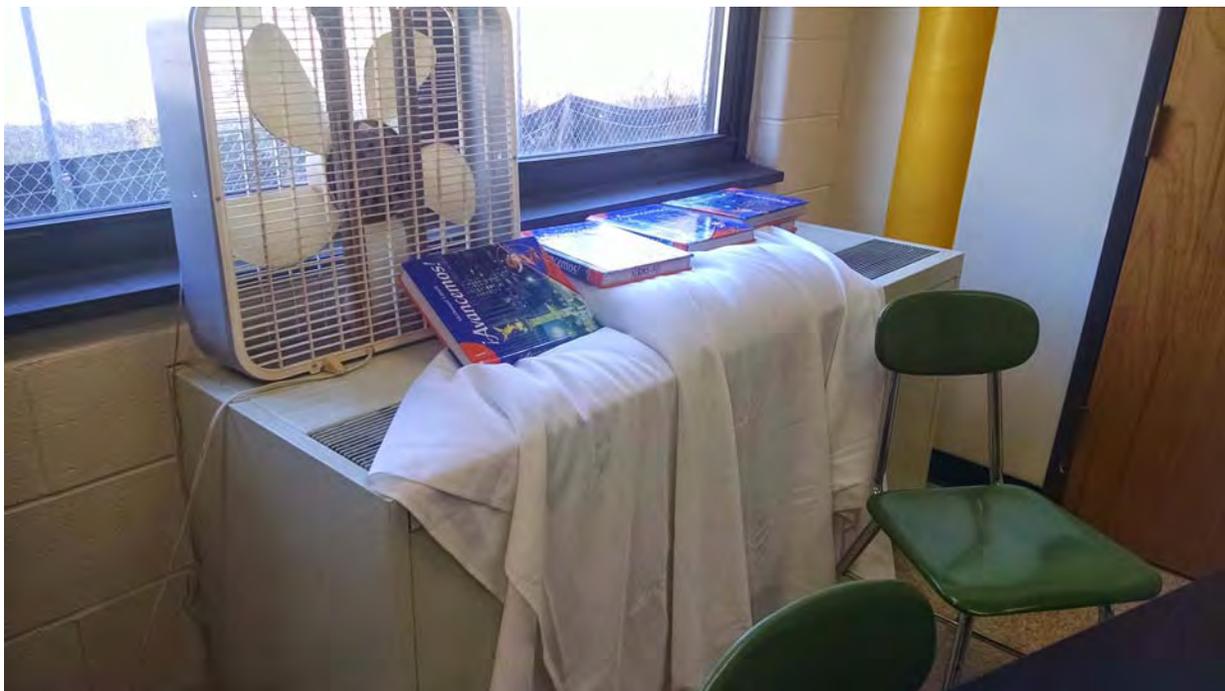
Picture 2

Univent with items on top blocking airflow

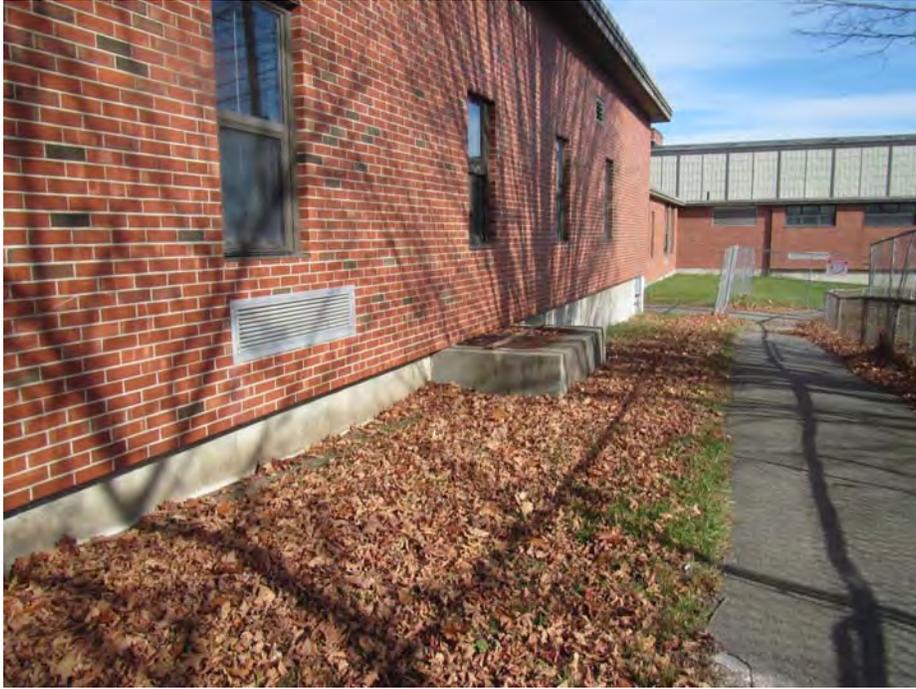
Picture 3

It can be seen from Table 1 that carbon dioxide levels were above 800 parts per million (ppm) in 60 out of 77 areas, indicating a lack of air exchange in most areas examined. Fresh air in A-, B- and C-wing classrooms is supplied by unit ventilators (univents) (Pictures 1 and 2). A univent is designed to draw air from outdoors through a fresh air intake located on the exterior

wall of the building (Picture 3). Return air is drawn through an air intake located at the base of each unit where fresh and return air are mixed, filtered, heated or cooled and provided to classrooms through an air diffuser located in the top of the unit (Figure 1). Univents were found deactivated or obstructed with classroom items/furniture on top/front of units in a number of areas (Picture 2 and Table 1). In order for univents to provide fresh air as designed, intakes/returns must remain free of obstructions. Importantly, these units must remain on and be allowed to operate while rooms are occupied.

Univent intake on exterior of building

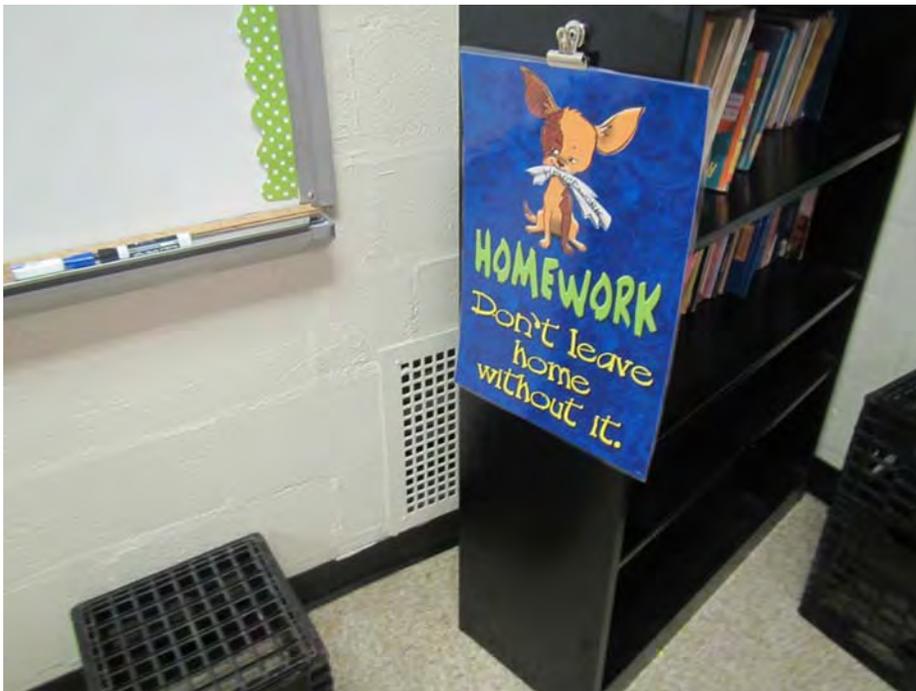
Picture 4

Exhaust ventilation in classrooms in the A-, B- and C-wings is provided by wall-mounted exhaust vents ducted to fans on the roof. These vents were observed to be off or drawing weakly in some areas. Some exhaust vents were also blocked by items or furniture (Picture 4).

Exhaust vent located behind bookcase (bookcase pulled away from wall during assessment)

2. Restore exhaust ventilation throughout the building. Inspect motors and belts for proper function, and perform repairs and adjustments as necessary.

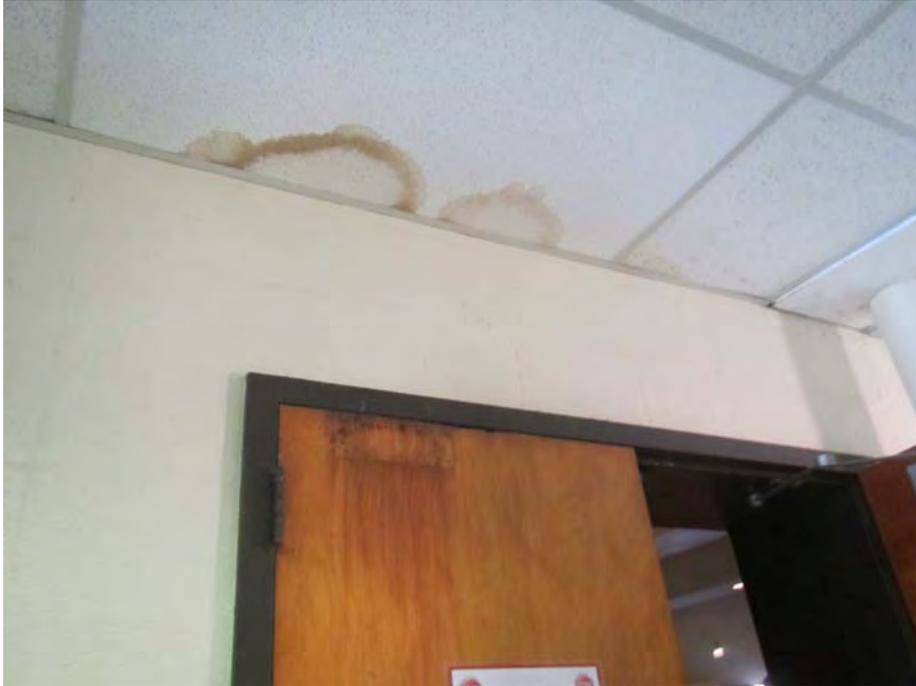
Picture 5

Water-damaged ceiling tiles were observed in a few of areas throughout the building (Picture 5; Table 1); these can indicate active/historic leaks from either the roof/building envelope or plumbing system. If repeatedly moistened, ceiling tiles serve as a mold growth medium. Water-damaged tiles should be replaced after a water leak is discovered and repaired.

Water-damaged ceiling tiles

11. Examine areas of leakage and ensure any water-damaged ceiling tiles and wall materials are repaired and/or replaced. Examine the area above ceiling tiles for mold growth. Disinfect areas of water leaks with an appropriate antimicrobial, as needed.

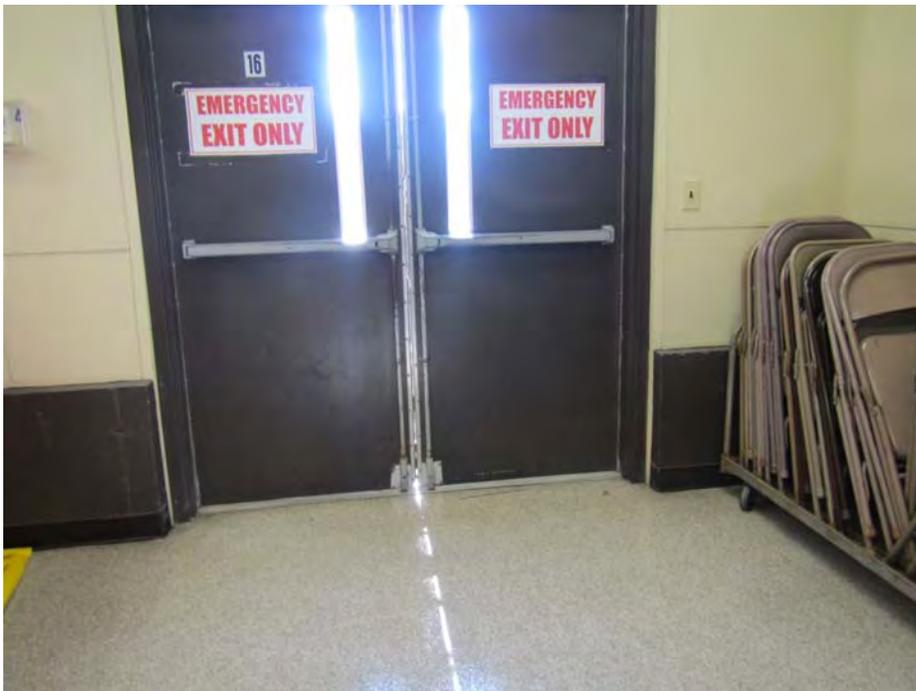
Picture 6

The exterior of the building was examined for conditions that might lead to indoor air quality concerns. Doors to the exterior were seen to be missing weather stripping (Picture 6), which can allow unconditioned air, moisture and pests into the building.

Light visible between doors showing lack of weather stripping

14. Maintain portable air conditioners in accordance with manufacturers' instructions, including emptying of any condensate receptacles.
 15. Ensure that doors to the outside close/fit tightly to prevent the ingress of unconditioned air, moisture and pests. Replace weather stripping and monitor for light and drafts.

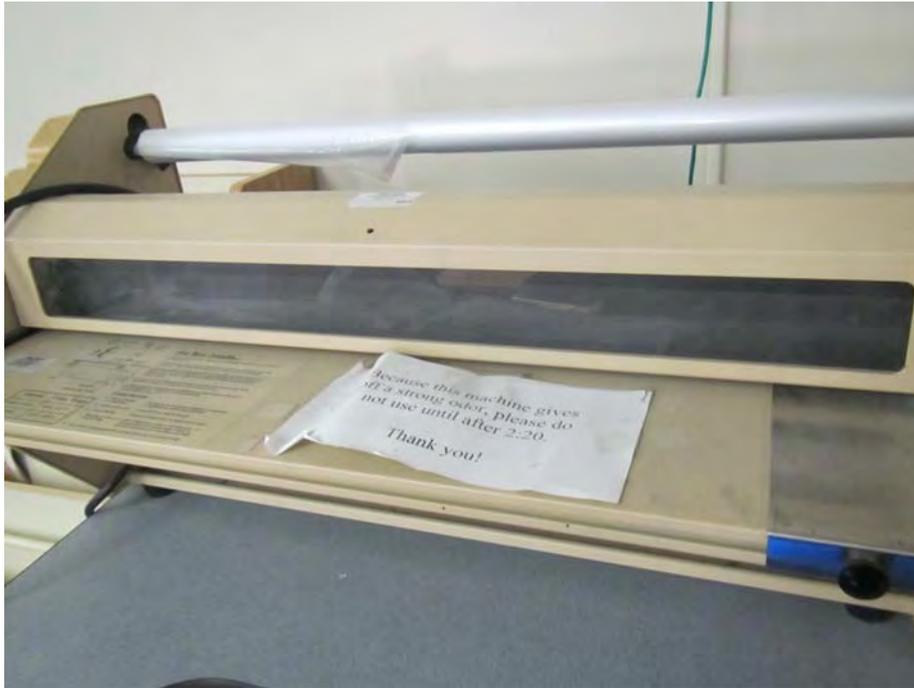
Picture 7

A laminator was observed in the library; a sign on the laminator indicates it should only be used after 2:30 pm, when the majority of occupants have left the building (Picture 7). Although this measure will serve to reduce exposure to pollutants and odors caused by the melting of plastic, laminators should also be located in areas with exhaust ventilation.

Laminator with sign

18. Remove the unused refrigerator from the storage room for room C111.
19. Consider moving laminators to areas with exhaust ventilation.
20. Avoid the use of air freshener/deodorizing materials.
21. Seal breaches in univent cabinets with an appropriate fire-rated sealant to prevent air from the crawlspace/basement area from being distributed to occupied areas and to exclude rodents.
22. It is highly recommended that the principles of integrated pest management (IPM) be used to rid the building of pests. A copy of the IPM recommendations can be obtained from the Massachusetts Department of Food and Agriculture (MDFA) website at the following website:

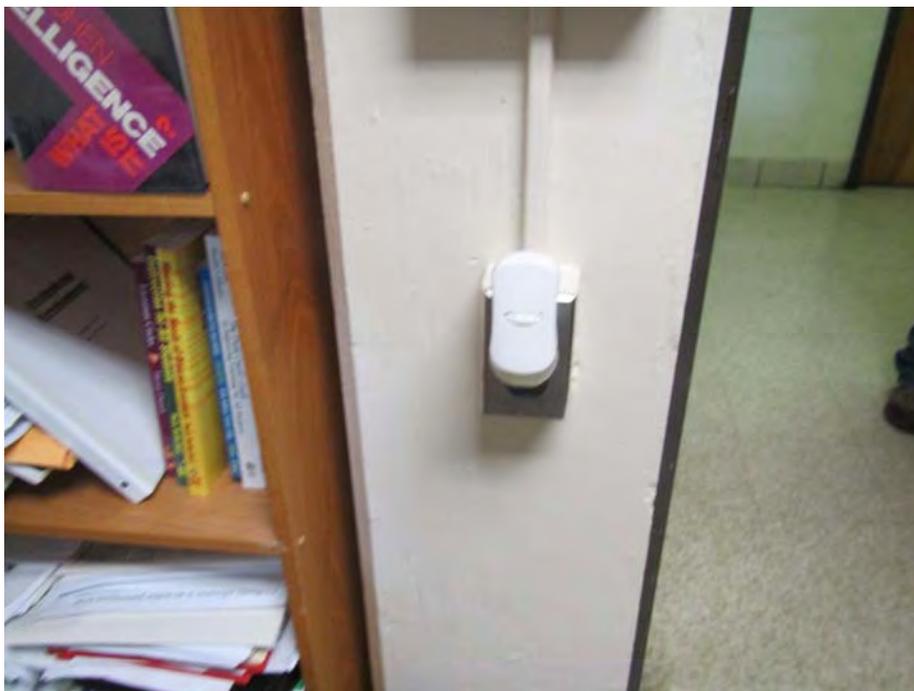
Picture 8

Plug-in air fresheners and other air deodorizers were also observed in the school (Picture 8; Table 1). Air deodorizers contain chemicals that can be irritating to the eyes, nose and throat of sensitive individuals. Many air fresheners contain 1,4-dichlorobenzene, a VOC which may cause reductions in lung function (NIH, 2006). Furthermore, deodorizing agents do not remove materials causing odors, but rather mask odors that may be present in the area.

Plug-in air freshener

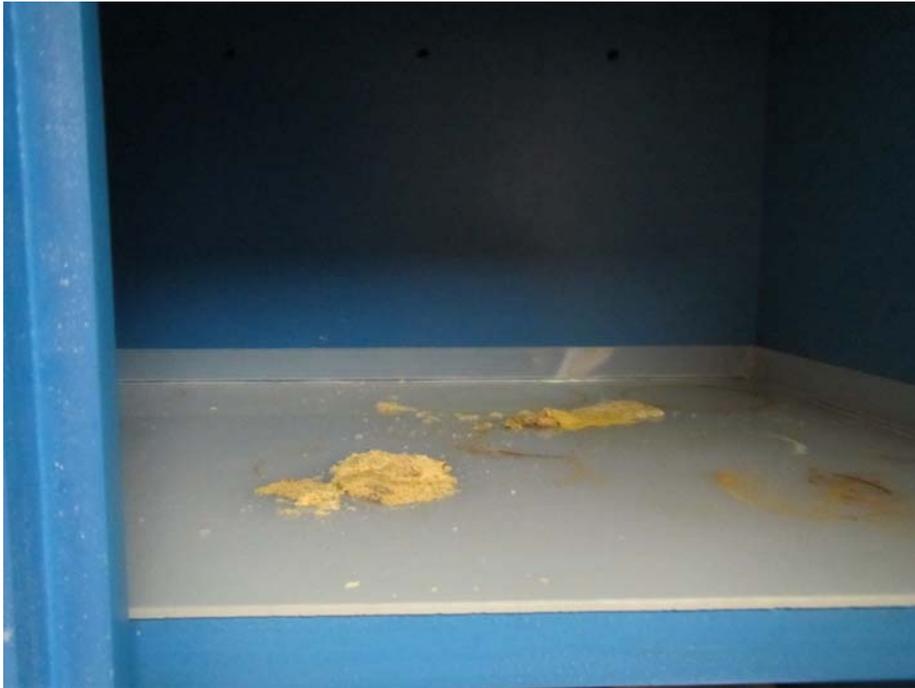
Picture 9

In addition to the copier odors referenced above, several other conditions were noted that are likely contributing to odors in the C-wing. A strong odor detected in the chemical storage area (next to room C111) was traced to a refrigerator that was empty and not in use/operation. This refrigerator should be removed as soon as possible. Some cabinets in this room are designed to store chemicals (e.g. flameproof, vented outdoors for storage of flammable and corrosive materials). Although the cabinets are currently used to store a few items, debris/staining was noted in several storage units; stains were also observed on shelves in the storeroom (Picture 9). Since spilled chemicals can emit odors, the storage units in the room should be cleaned to prevent odors over time. Any new spills should be cleaned immediately.

Chemical debris on shelf

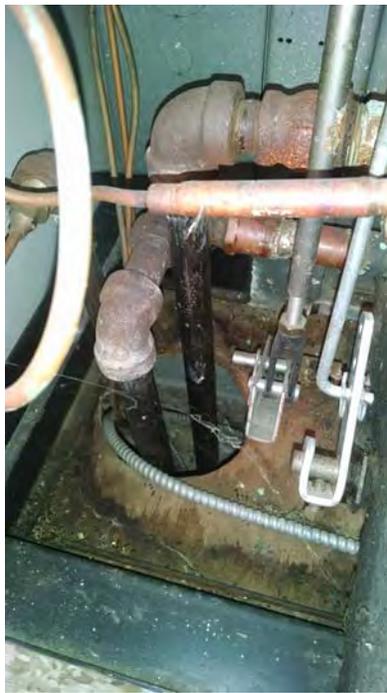
Picture 10

Another area of concern is room B111, where the occupant reported a musty odor. At the time of the assessment, BEH/IAQ staff detected an odor in the room. While examining the conditions within the univent cabinet, breaches were observed where the pipes penetrate through the floor (Picture 10). This breach not only allows for unconditioned air and odors from the crawlspace to be distributed into occupied areas, but also allow pests to enter into occupant areas. BEH/IAQ staff observed rodent waste (e.,g., droppings) within the univent cabinet (Picture 11). When operating, the univent can heat and magnify odors, which are subsequently distributed. At the time of the assessment, BEH/IAQ staff alerted Mr. Hardacker to this concern and provided recommendations for repair.

Breaches around pipes in univent cabinet

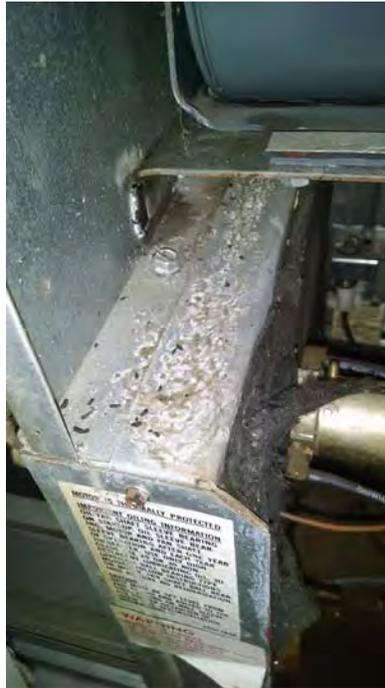
Picture 11

Rodent droppings univent cabinet

- a. Rinse out recycled food containers. Seal recycled containers in a tight fitting lid to prevent rodent access.
- b. Remove non-food items that rodents are consuming.
- c. Store food in tight fitting containers.
- d. Avoid eating at workstations. In areas where food is consumed, periodic vacuuming to remove crumbs is recommended.
- e. Regularly clean crumbs and other food residues from ovens, toasters, toaster ovens, microwave ovens, coffee pots and other food preparation equipment.
- f. Holes as small as ¼” are enough space for rodents to enter an area. Examine each room and the exterior walls of the building for means of rodent egress and seal. If

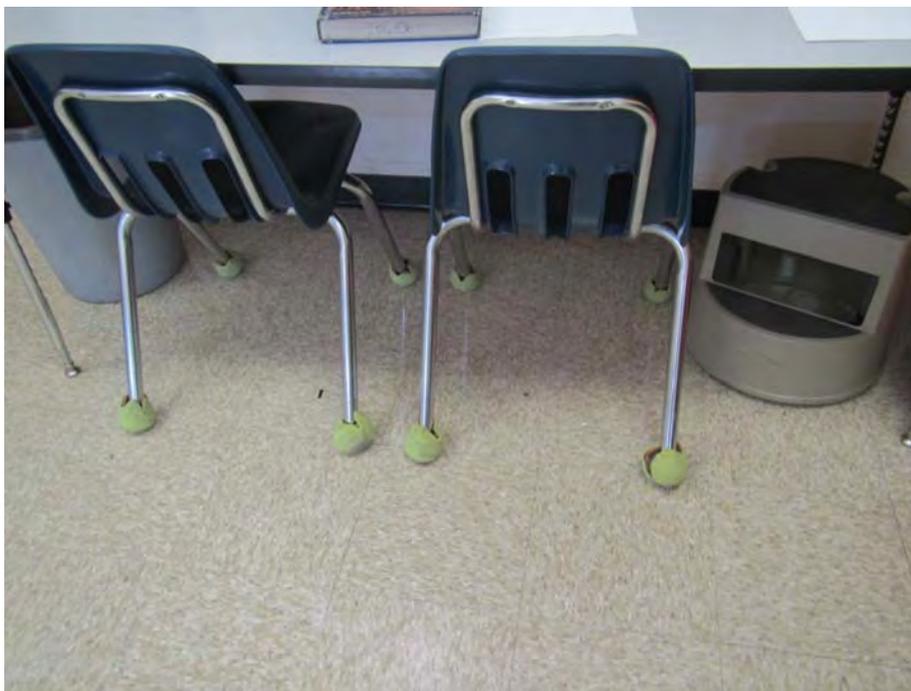
Picture 12

Tennis balls were observed on chair legs in a few classrooms (Picture 12, Table 1). These tennis balls were likely installed as an effort to reduce noise from sliding chairs. Tennis balls are made of a number of materials that are a source of respiratory irritants. Constant wearing of tennis balls can produce fibers and off gas VOCs. Tennis balls are made with a natural rubber latex bladder, which becomes abraded when used as a chair leg pad. Use of tennis balls in this manner may introduce latex dust into the school environment. Some individuals are highly allergic to latex (e.g., spina bifida patients) (SBAA, 2001). It is recommended that the use of materials containing latex be limited in buildings to reduce the likelihood of symptoms in sensitive individuals (NIOSH, 1997).

Tennis balls used as chair glides

27. Consider replacing tennis balls with latex-free chair glides.
28. Clean area carpets annually or semi-annually in soiled high traffic areas as per the recommendations of the Institute of Inspection, Cleaning and Restoration Certification (IICRC). Copies of the IICRC fact sheet can be downloaded at:
http://cleancareseminars.net/?page_id=185 . (IICRC, 2005)

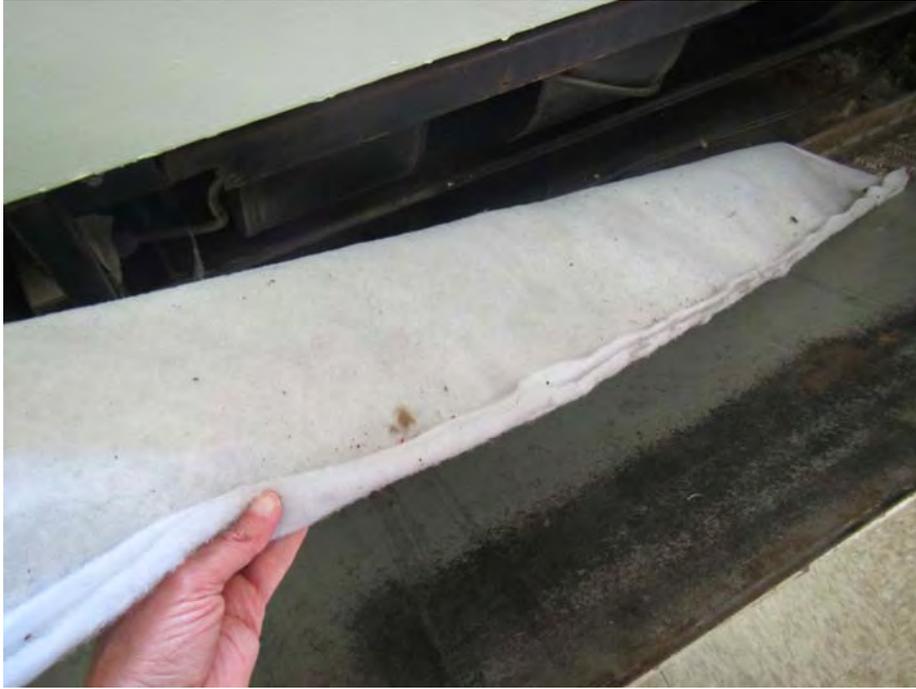
Picture 13

Sleeve of filter material for univent around frame

It is likely that disposable filters with a higher dust spot efficiency can be installed in place of the existing cages. Pleated filters with a Minimum Efficiency Reporting Value dust-spot efficiency of 9 or higher are recommended. Note that increasing filtration can reduce airflow (called pressure drop), which can subsequently reduce the efficiency of the unit due to

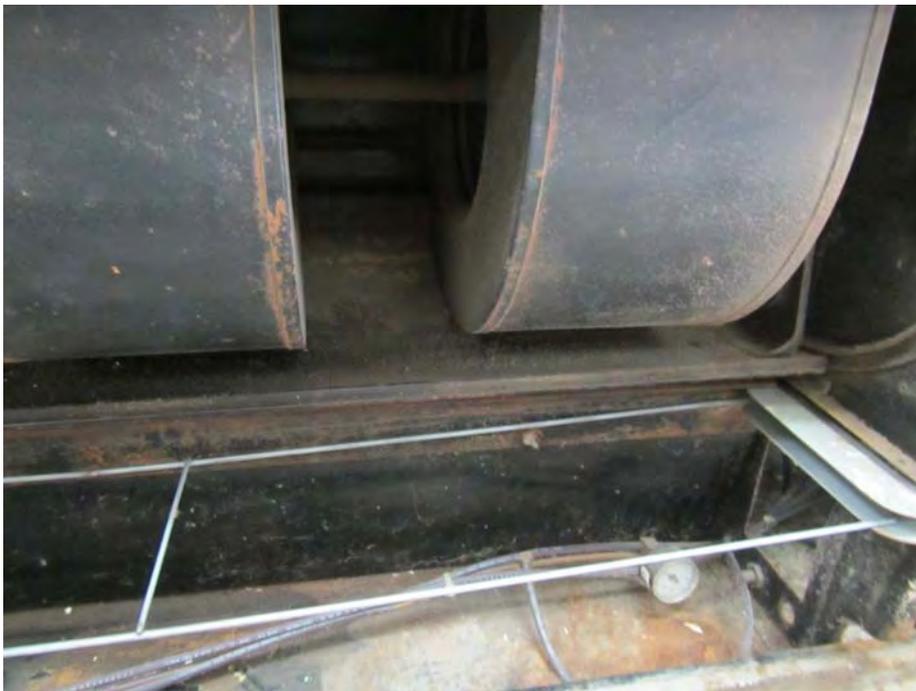
Picture 14

Univent filter frame with no filter

Univent filters should be changed as per the manufacturer's recommendations (typically 2-4 times a year). In addition, some of the univent cabinets and diffuser grills had debris in them which can lead to aerosolized particulate matter and odors. When filters are changed in the univents, cabinets should also be vacuumed out.
