INDOOR AIR QUALITY ASSESSMENT

**William Gould Vinal Elementary School
102 Old Oaken Bucket Road
Norwell, MA**

Prepared by:
Massachusetts Department of Public Health
Bureau of Environmental Health
Indoor Air Quality Program
June 2015

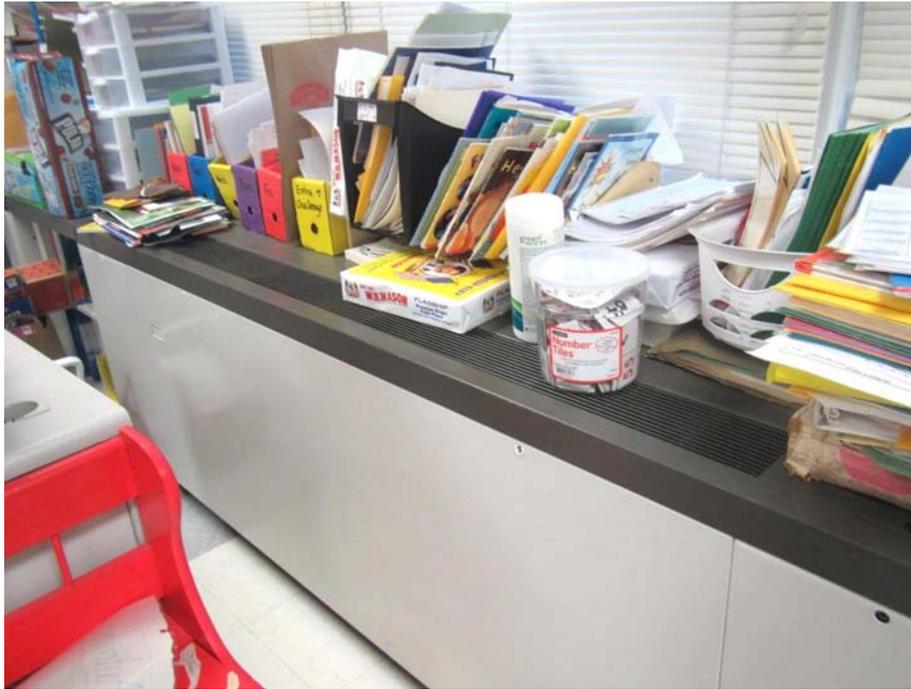
Picture 1

Fresh air in most classrooms is supplied by unit ventilators (univents) (Picture 1). A univent is designed to draw air from outdoors through a fresh air intake located on the exterior wall of the building (Picture 2). Return air is drawn through an air intake located at the base of each unit where fresh and return air are mixed, filtered, heated and provided to classrooms through an air diffuser located in the top of the unit ([Figure 1](#)). Univents were found obstructed with items in a few areas (Picture 1). In order for univents to provide fresh air as designed, they

must remain free of obstructions. Importantly, these units must remain on and be allowed to operate while rooms are occupied. Wall-mounted exhaust vents, some of which were also obstructed with items, remove stale air from classrooms (Picture 3).

Unit ventilator (univent); note obstructing items

1. Operate all supply and exhaust ventilation systems throughout the building continuously during periods of occupancy to maximize air exchange.
2. Remove blockages (e.g., items, furniture) from the front and top of univents and from the area of exhaust vents.
3. Examine univents dampers and adjust to provide more fresh air as needed.
4. Consider keeping classroom doors closed for better air exchange and exhaust function.
5. Ensure all exhaust vents/fans are operational and activated during occupied hours.
6. Change filters for air handling equipment (univents and AHUs) 2 to 4 times a year.

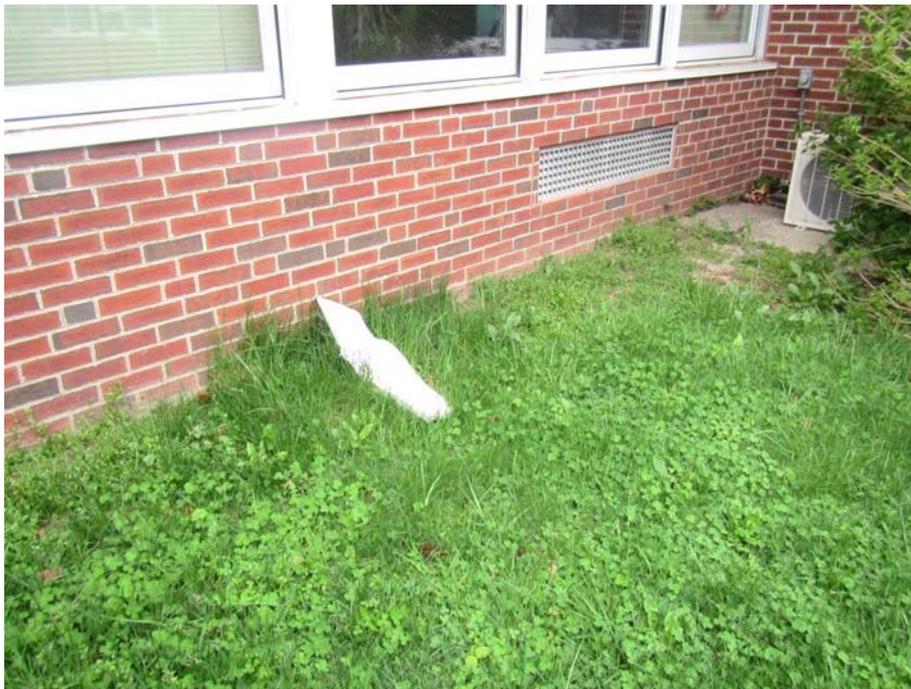
Picture 2

Univent air intake on side of building, note also piece of broken gutter or flashing

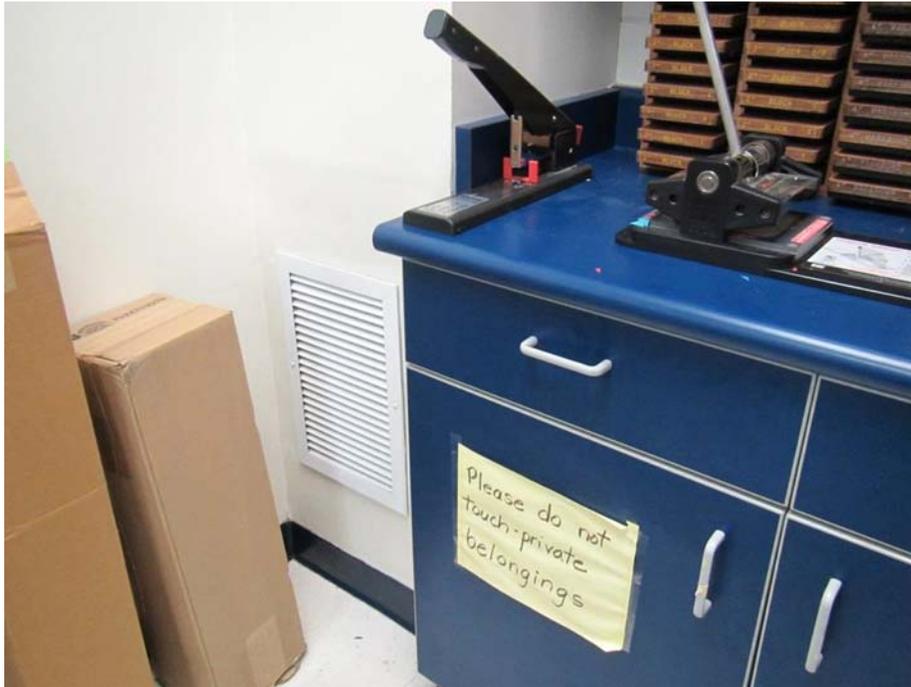
Picture 3

Wall-mounted exhaust vent, note partial obstruction with boxes

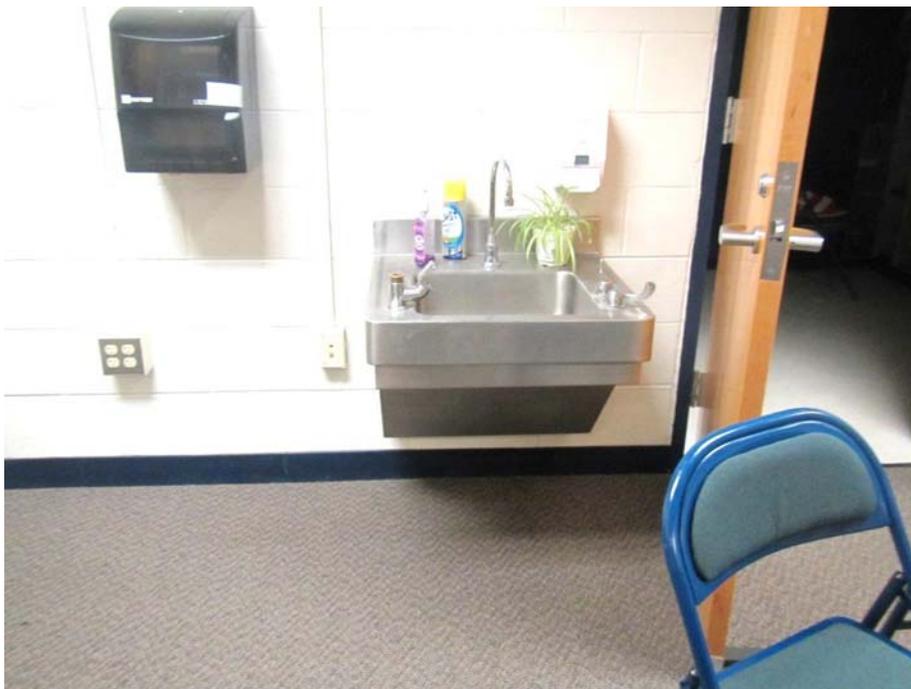
Picture 4

In one area a sink was located over carpeting (Picture 4). Overflow/spills from sinks and water dispensers can moisten carpeting. It is recommended that these items be located on/over non-porous flooring or a waterproof mat.

Sink over carpeting

11. Consider placing a waterproof mat under sinks, or replace carpeting in these areas with tile.
12. Clean staff refrigerators regularly. Clean refrigerator gaskets with an antimicrobial solution to remove debris and staining.

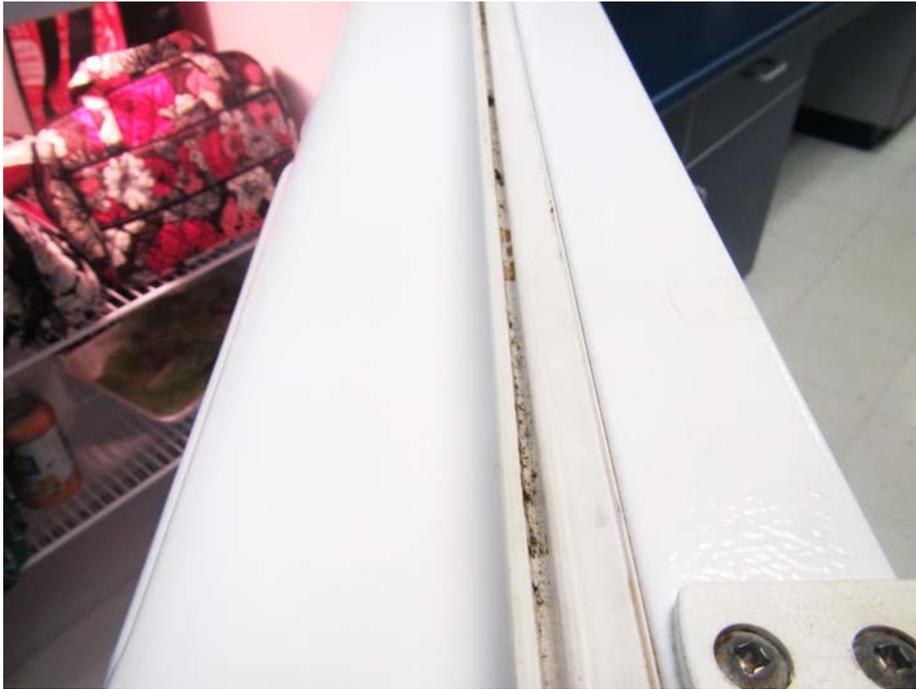
Picture 5

The refrigerator in the staff breakroom was examined and the gasket had visible staining/debris (Picture 5). This gasket should be cleaned with an antimicrobial solution. Refrigerators should be cleaned regularly to prevent odors and microbial growth.

Refrigerator gasket with debris/staining

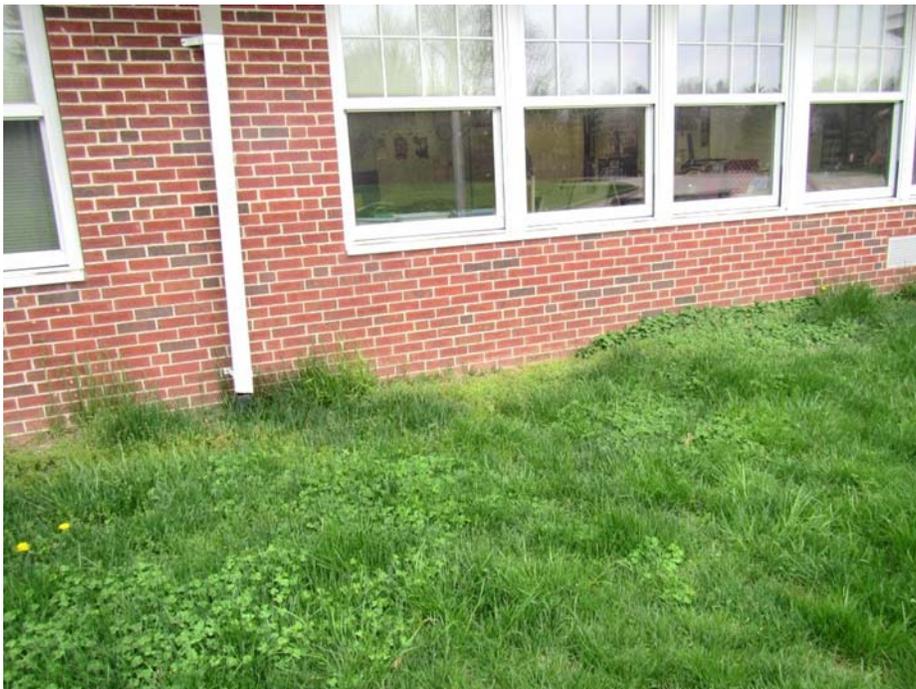
Picture 6

The exterior of the building was also examined for conditions that could lead to water infiltration or other sources of indoor air pollutants. Some downspouts were observed to be broken or missing parts (Picture 6) and some debris that appeared to be portions of a gutter/downspout or flashing was observed on the ground along the perimeter of the building (Picture 2). In addition, leaks were observed in joints in the gutters (Picture 7). Broken drainage channels can lead to water penetration along the base of the building and damage to the foundation. These items should be repaired.

Downspout without extension elbow

13. Repair the gutter system, including replacing missing or broken downspouts and leaks at joints. Repair any missing or damaged flashing.

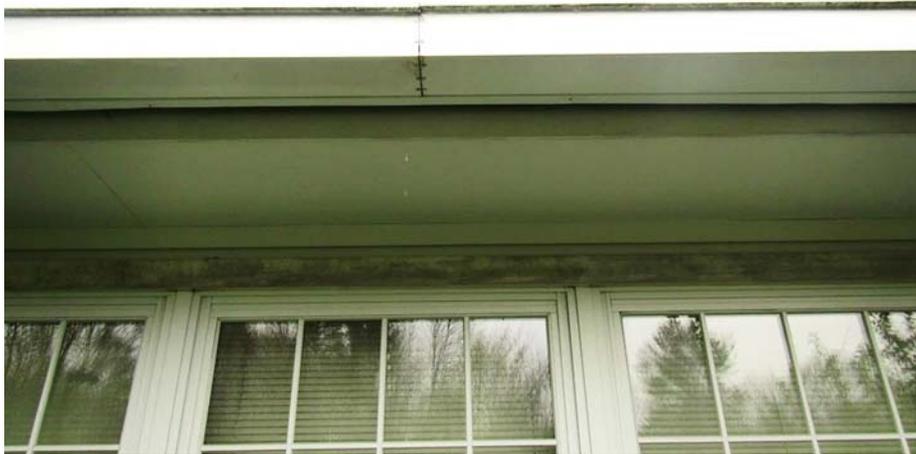
Picture 7

Water leaking through joint in gutter

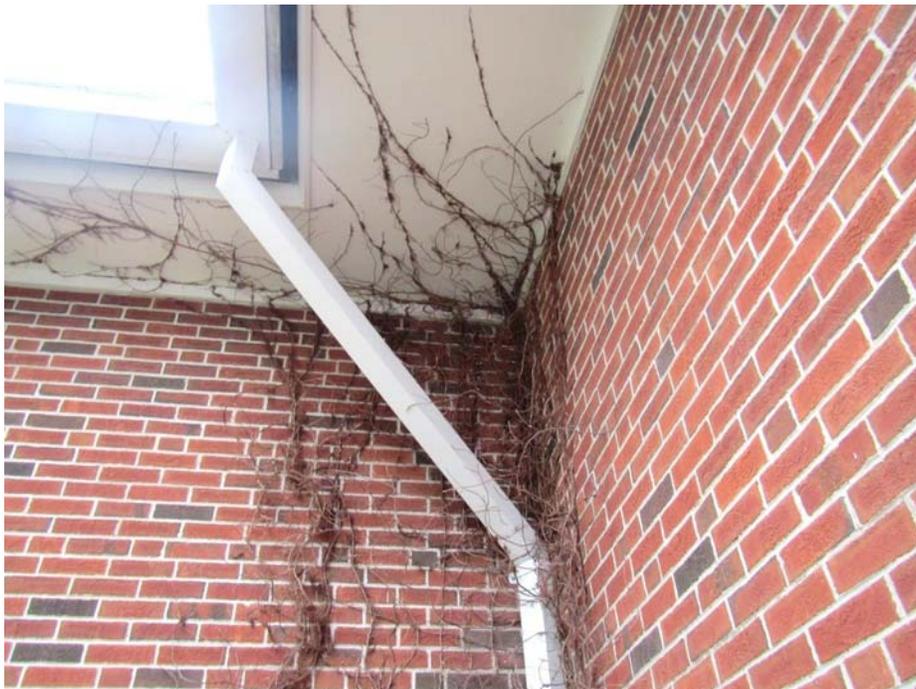
Picture 8

Plants were observed growing on exterior walls in a few areas (Picture 8). Vines and other plants can hold moisture against the building and lead to deterioration of the building envelope. Plants should be removed to five feet from the foundation.

Clinging plants growing on brickwork and gutters

14. Remove plants growing on exterior walls and trim plants near the base of the building to five feet away from the foundation.
15. Replace weather-stripping on doors so that they seal tightly. Monitor for gaps by observing for light or drafts.

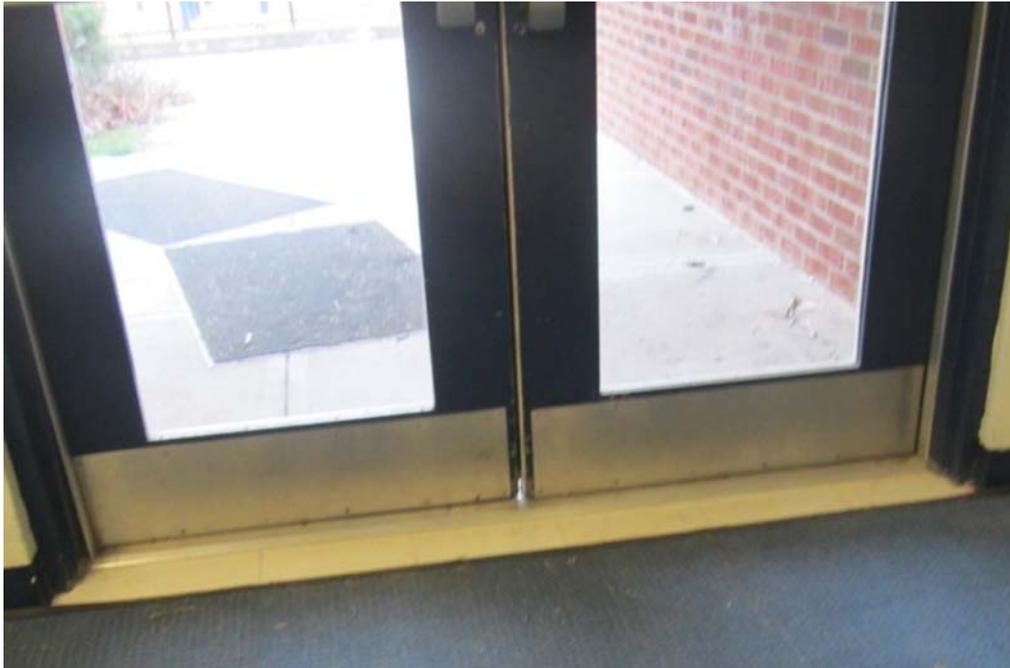
Picture 9

Gaps, as evidenced by visible light (Picture 9), were observed around some of the doors to the outside indicating that weather-stripping is worn or missing. These gaps can allow unfiltered air and pests into the building and should be repaired.

Light visible between doors to the outside

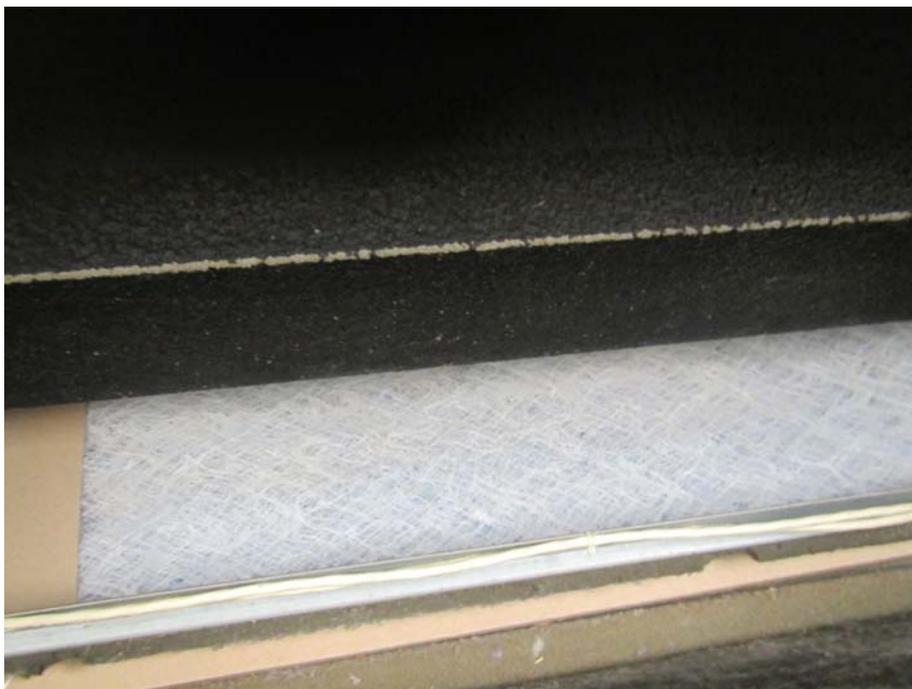
Picture 10

A univent was opened during the assessment in order to examine the filters. The filter was the correct size and was fit flush within the univent cabinet, but it was of a type that provides minimal filtration (Picture 10). It should be determined if filters with an increased dust spot efficiency can be installed. The dust spot efficiency is the ability of a filter to remove particulate matter of a certain diameter from air passing through the filter. Filters that have been determined by ASHRAE to meet its standard for a dust spot efficiency of a minimum of 40 percent would be sufficient to reduce airborne particulate matter (Thornburg, D., 2000; MEHRC, 1997; ASHRAE, 1992). Pleated filters with a Minimum Efficiency Reporting Value (MERV) dust-spot efficiency of 9 or higher are recommended. Note that increasing filtration can reduce airflow (called pressure drop), which can subsequently reduce the efficiency of the unit due to increased

resistance. Prior to any increase of filtration, each univent should be evaluated by a ventilation engineer to ascertain whether it can maintain function with more efficient filters.

Mesh filter with low removal efficiency in univent

7. Consider replacing existing univalent filters with a greater dust-spot efficiency (e.g., MERV 9). Prior to any increase of filtration, each piece of air handling equipment should be evaluated by a ventilation engineer as to whether it can maintain function with more efficient filters.

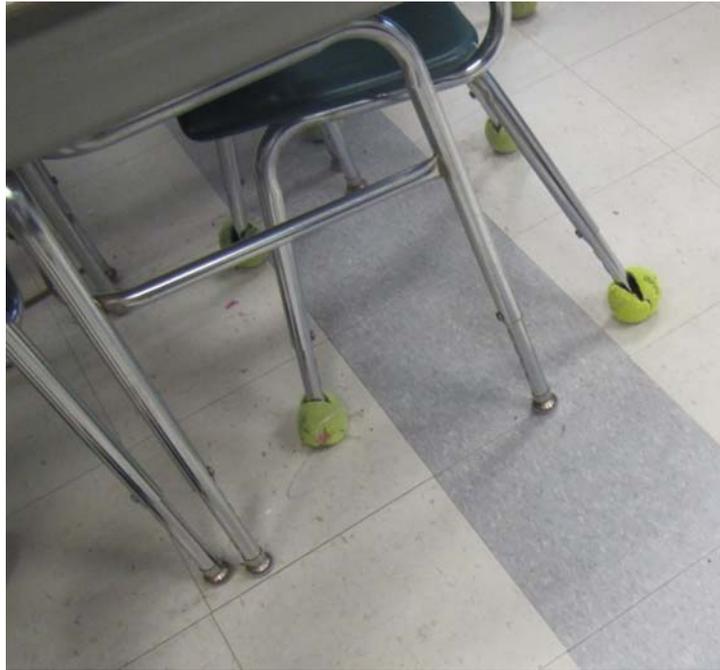
Picture 11

In a few classrooms, tennis balls were found sliced open and placed around chair legs to reduce noise (Picture 11). Tennis balls are made of a number of materials that are a source of respiratory irritants. Constant wearing of tennis balls can produce fibers and off-gas VOCs. Tennis balls are made with a natural rubber latex bladder, which becomes abraded when used as a chair leg pad. Use of tennis balls in this manner may introduce latex dust into the school environment. Some individuals are highly allergic to latex (e.g. spina bifida patients) (SBAA, 2001). It is recommended that the use of materials containing latex be limited to reduce the potential for symptoms in sensitive individuals (NIOSH, 1997). Latex-free glides should be used for this purpose.

Open tennis balls used as chair glides

16. Replace tennis balls with latex-free glides.
17. Ensure local exhaust ventilation for the kiln is operating as designed, make repairs/adjustments as needed. Remove any items from direct contact with the kiln. Consider only firing the kiln during unoccupied hours.

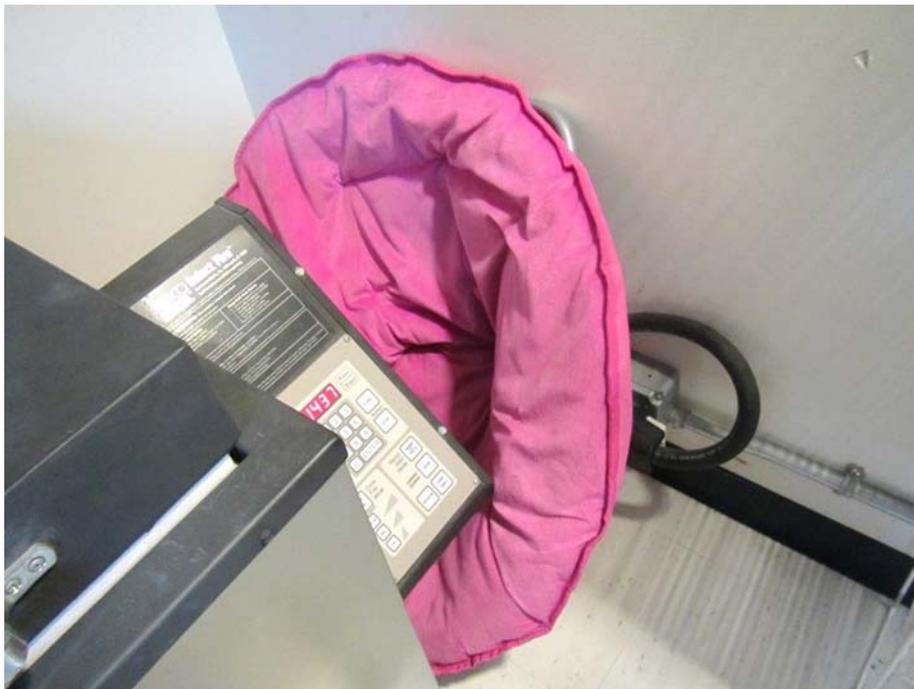
Picture 12

An operating kiln was observed (Picture 12), which was generating excess heat into the art room. The kiln had a vent above it to remove waste heat and other pollutants, but appeared to be drawing weakly. In addition, a cushion was observed next to the kiln. Flammable items should not be stored next to kilns as this is a fire risk. If a dedicated kiln room is unavailable, consider only operating the kiln when the classroom is unoccupied.

Kiln with cushion

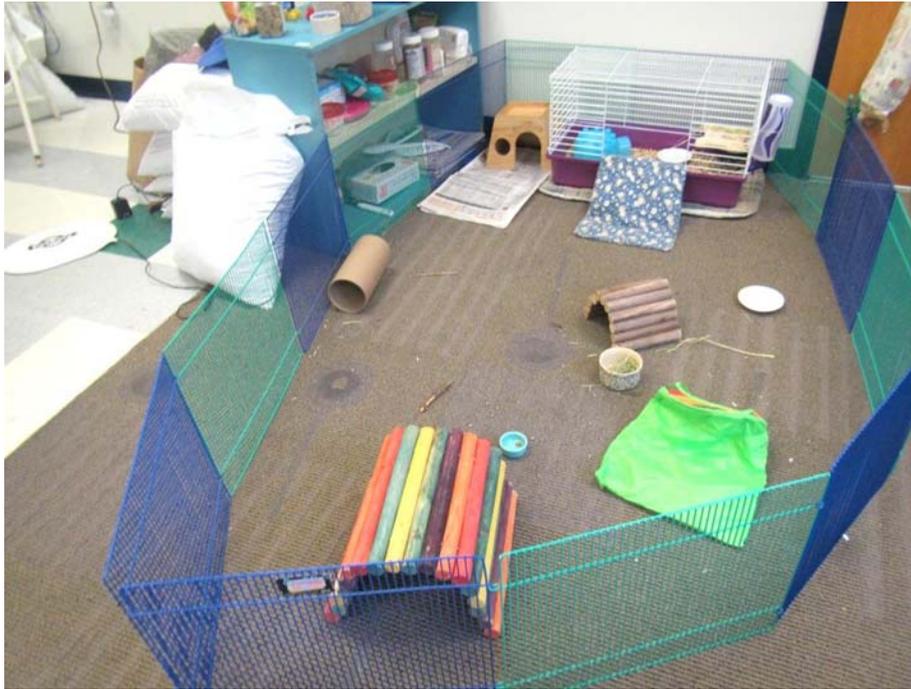
Picture 13

A pet guinea pig was observed in one classroom in a penned area on carpeting (Picture 13). Pets and pet wastes can be a source of allergens and pet food and water can be attractive to pests. Pets and their living areas should be kept as clean as possible including removal of wastes, old food and accumulations of hair. Further, this carpeting should not be used for student seating or general classroom activities; consider discarding it at the end of the school year.

Guinea pig pen

18. Seal holes in overhangs where birds nest and clean bird waste from the exterior of the building with an antimicrobial solution.
19. Keep pets and associated living spaces clean and remove any waste promptly. Do not use carpeting from pet areas for general classroom purposes.

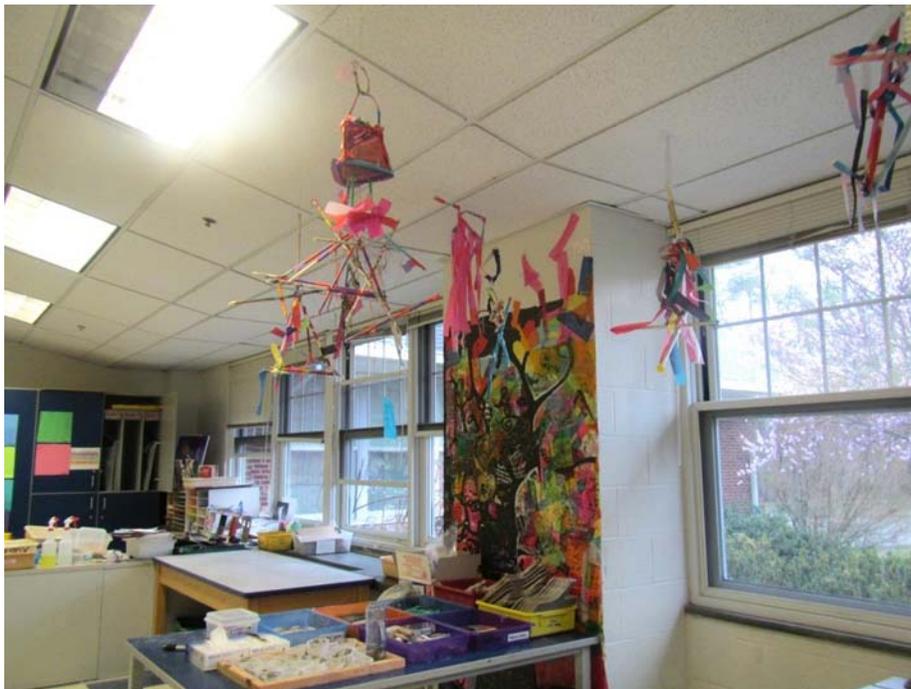
Picture 14

Items were observed hanging from the ceiling tile system in one classroom. In some areas, items were observed to be hanging from the ceiling (Picture 14). These items can be a source for dusts to accumulate as well as disturbing the ceiling tile system, allowing for dust and debris from the ceiling tile system/plenum to enter occupied space.

Items hanging from the ceiling

21. Refrain from hanging items from the ceiling tile system.
22. Clean upholstered furniture annually or more frequently if needed.
23. Clean carpeting regularly in accordance with The Institute of Inspection, Cleaning and Restoration Certification (IICRC) recommendations (IICRC, 2012). Discard any worn out area rugs.
