INDOOR AIR QUALITY ASSESSMENT

**Seekonk Human Services Department
320 Pleasant Street
Seekonk, MA**

Prepared by:
Massachusetts Department of Public Health
Bureau of Environmental Health
Indoor Air Quality Program
June 2015

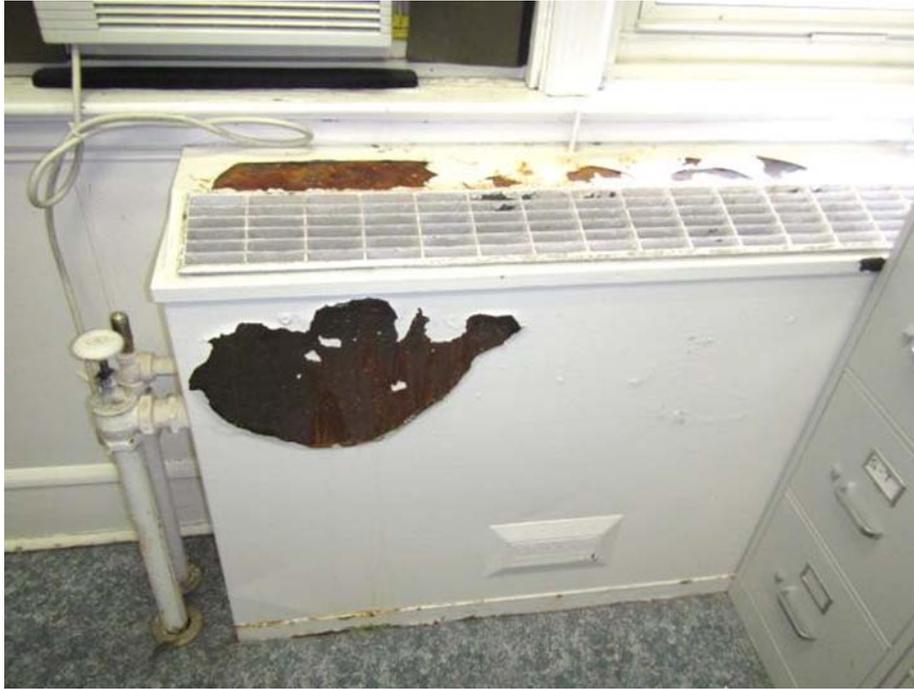
Picture 1

It can be seen from Table 1 that carbon dioxide levels were above 800 parts per million (ppm) in all areas surveyed at the time of the assessment, indicating a lack of air exchange. It is important to note that the building was originally designed to provide mechanical ventilation through the use of unit ventilators (univents), which have largely been abandoned (Picture 1). Although coils within the univents provide heat, the motors which draw in outside air are not operational.

It is also important to note that the univents are original to the building's construction, which makes them over 70 years old. Efficient function of equipment of this age is difficult to maintain, since compatible replacement parts are often unavailable. According to the American

Society of Heating, Refrigeration and Air-Conditioning Engineering (ASHRAE), the service life¹ for a unit heater, hot water or steam is 20 years, assuming routine maintenance of the equipment (ASHRAE, 1991). Despite attempts to maintain the equipment, the optimal operational lifespan of this equipment has been exceeded.

Other conditions that can affect IAQ were observed during the assessment. In some areas items were on floors, windowsills, tabletops, counters, bookcases and desks, which provide a source for dusts to accumulate. These items (e.g., papers, folders, boxes) make it difficult for custodial staff to clean. Items should be relocated and/or be cleaned periodically to avoid excessive dust build up. In addition, dust and debris can accumulate on flat surfaces (e.g., desktops, shelving and carpets) in occupied areas and subsequently be re-aerosolized causing further irritation. Dirt, dust and debris was also observed in the interior of the univent, which can be aerosolized if uncontrolled drafts are forced through it.

Early 1940s univent, note peeling paint

1. Consider relocating Ms. DosSantos's work space away from the univent.
2. If original function of univents is not to be restored consider sealing fresh air intakes to prevent uncontrolled drafts and aerosolization of dust/debris.

3. Consider replacing vintage univents with modern units.
4. Reactivate exhaust vents in closets, make repairs as needed.
5. Occupants are encouraged to open windows (weather permitting) where operable, to temper rooms and provide fresh air. Care should be taken to ensure windows are properly closed at night and on weekends to avoid the freezing of pipes and potential flooding.

7. Particular attention should be paid to thoroughly clean in/around univent and surrounding surfaces (e.g., windowsills, floor) as needed.
8. Clean/refinish or replace windowsill below AC in Ms. DosSantos's office. Ensure AC is installed as airtight as possible to prevent drafts and/or water infiltration around unit.

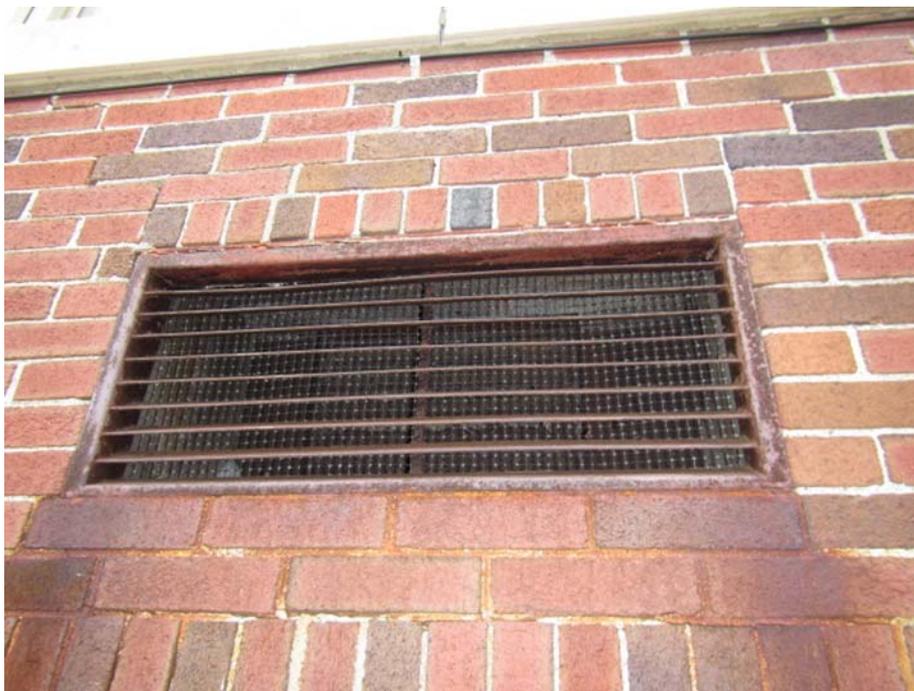
Picture 2

A univent draws air from the outdoors through a fresh air intake located on the exterior wall of the building (Picture 2) and returns air through an air intake located at the base of the unit. Fresh and return air are mixed, filtered, heated and provided through an air diffuser located in the top of the unit ([Figure 1](#)). Due to the age of the units at the SHS, the amount of fresh air must be adjusted by hand, using a knob attached to a louver inside the unit. Without motors to draw in outside air, fresh air being brought in by these units is limited to convection due to heating, and incidental air penetration (drafts).

Fresh air intake for univent

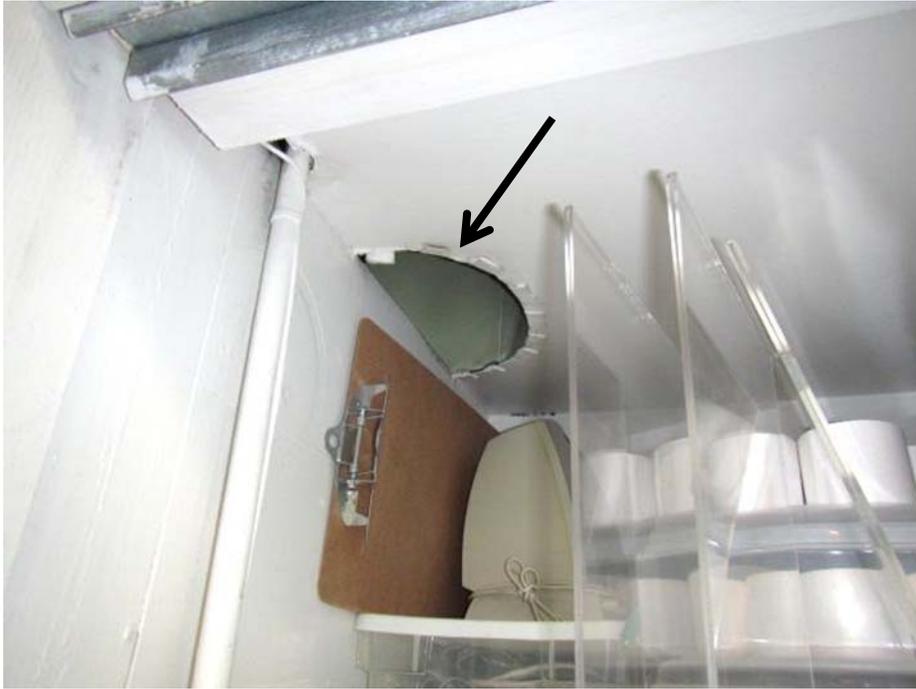
Picture 3

Exhaust ventilation was designed to be provided by vents located in closets (Picture 3). These exhausts were not drawing air at the time of the assessment. Without supply and exhaust ventilation, pollutants can build up and lead to IAQ and comfort complaints.

Exhaust vent (arrow) located in ceiling of closet

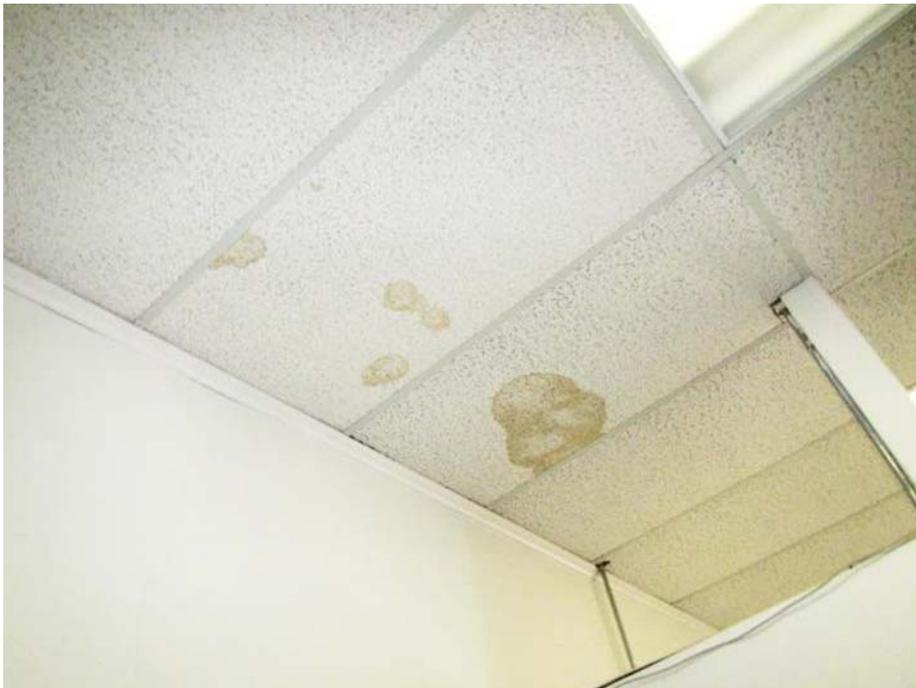
Picture 4

A few water-damaged ceiling tiles were observed in the main office area (Picture 4; Table 1), indicating current/historic roof leaks, plumbing leaks or other water infiltration. Water-

damaged ceiling tiles can provide a source of mold and should be replaced after a water leak is discovered and repaired.

Water-damaged ceiling tiles

9. Ensure roof/plumbing leaks are repaired and replace any remaining water-damaged ceiling tiles and other building materials. Disinfect areas of water leaks with an appropriate antimicrobial, as needed.

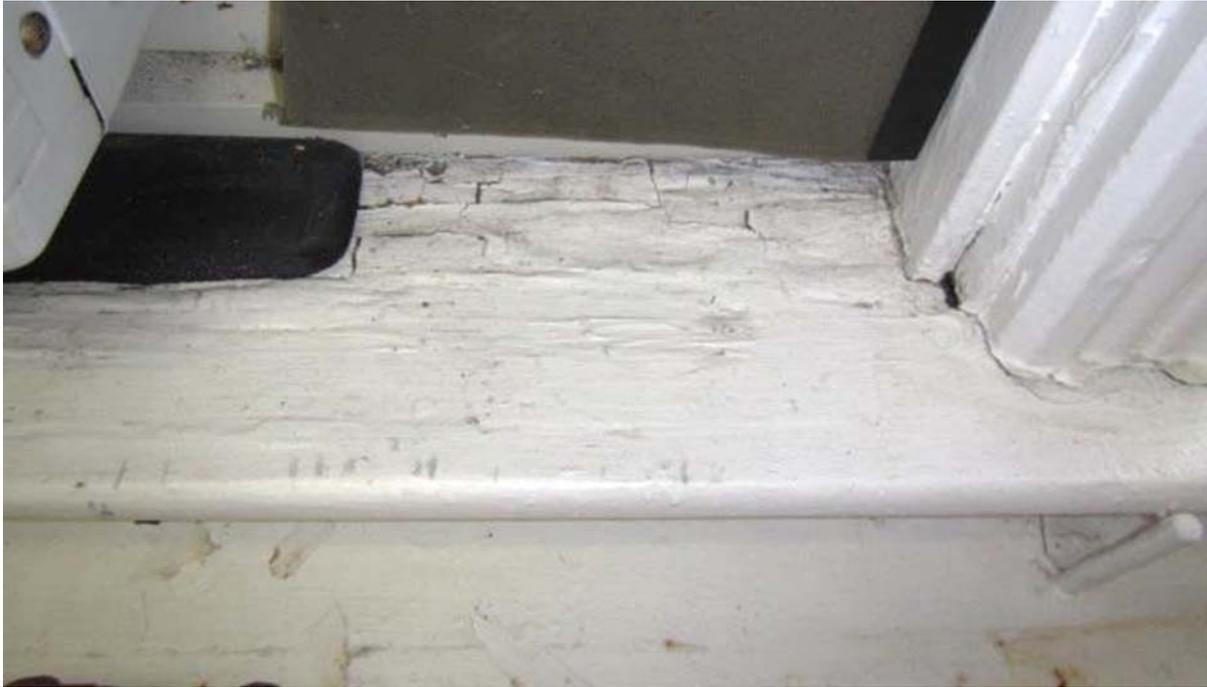
Picture 5

The wooden windowsill beneath the AC in Ms. DosSantos's office exhibited peeling paint and water damage. Although moisture testing at the time of the assessment deemed the wood dry, it is recommended that the windowsill be cleaned/refinished or replaced and that the seal around the AC be made as watertight as possible.

Water-damaged/peeling paint on wooden windowsill
