INDOOR AIR QUALITY ASSESSMENT

**Massachusetts Department of Mental Health
Gifford Building
Taunton, MA**

Prepared by:
Massachusetts Department of Public Health
Bureau of Environmental Health
Indoor Air Quality Program
June 2015

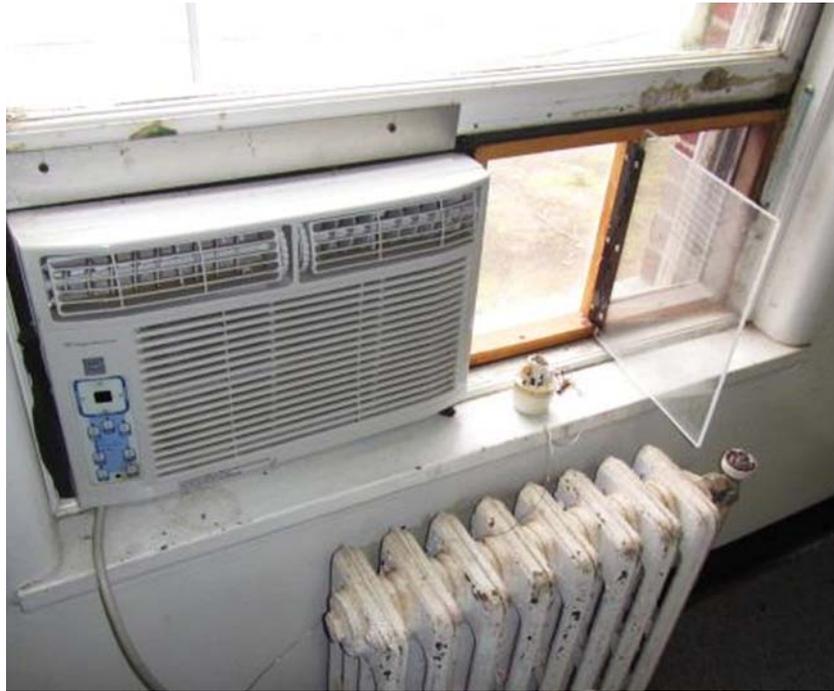
Picture 1

It can be seen from Table 1 that all carbon dioxide levels were below 800 parts per million (ppm), indicating adequate air exchange in all areas surveyed at the time of the assessment (Table 1). Note that the building does not have a means of mechanical ventilation but uses windows to introduce fresh outside air. As mentioned, in some areas windows were unopenable due to the installation of ACs, however in most areas, a second window was openable or windows were modified by facilities staff to open (Picture 1).

Modified window

2. In areas where windows were rendered unopenable in occupied areas, they should be restored to working order or fresh air must be provided via mechanical means such as operating window-mounted ACs in the “fan only” “fresh air” mode.

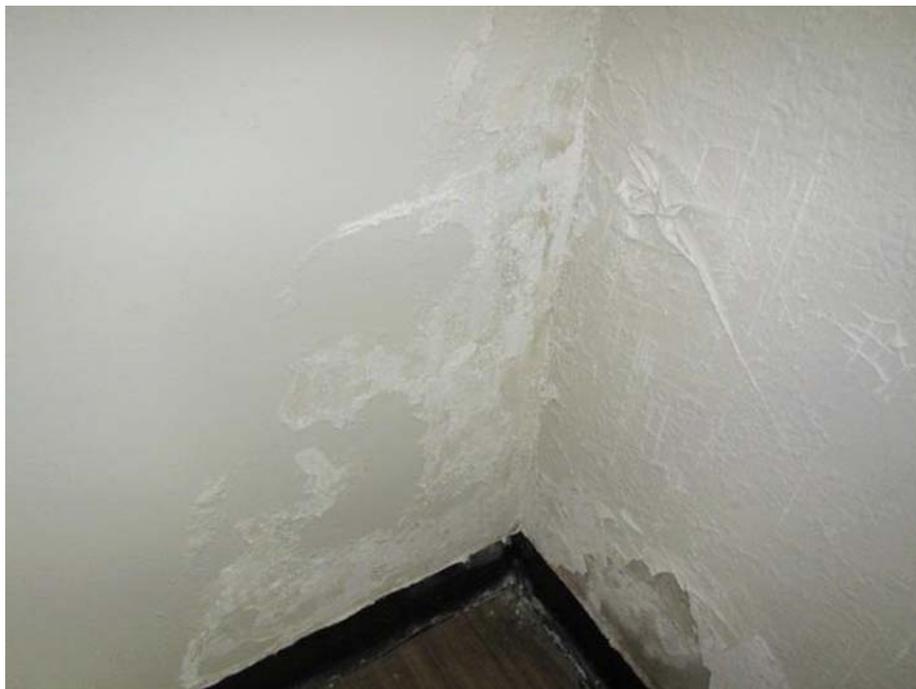
Picture 2

Signs of water infiltration were noted as evidenced by damaged plaster, peeling paint and efflorescence on interior walls (Pictures 2 and 3). Efflorescence is a characteristic sign of water damage to brick and mortar, but it is not mold growth. As moisture penetrates and works its way through mortar, brick or plaster, water-soluble compounds dissolve, creating a solution. As the solution moves to the surface of the material, the water evaporates, leaving behind white, powdery mineral deposits.

Peeling paint and efflorescence on plaster walls

4. Explore the source of chronic moisture causing peeling paint and efflorescence and make repairs as necessary. Clean/scrape loose paint and efflorescence; the room/stairwell should be sealed and under negative ventilation during these activities. Clean areas with a HEPA filter equipped vacuum cleaner in conjunction with wet wiping of all surfaces.

6. Consider consulting with an architect, masonry firm or general contractor regarding the integrity of the building envelope, primarily focusing on water penetration through the roof/exterior walls.

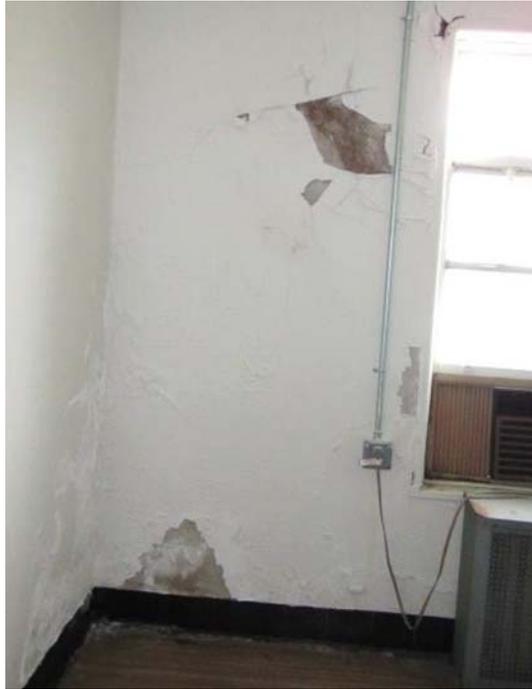
Picture 3

Peeling paint and efflorescence on interior plaster walls

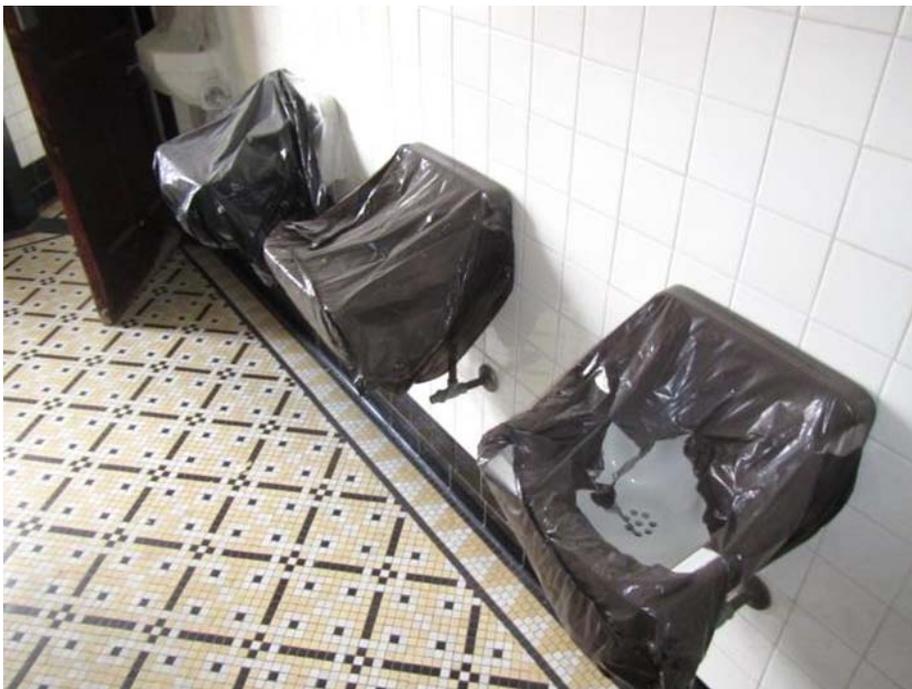
Picture 4

Other conditions that can affect indoor air quality were observed during the assessment. Abandoned sinks were observed in restrooms. Instead of properly sealing the drains or removing the fixtures, they were covered with plastic trash bags (Picture 4). Drains are designed with traps in order to prevent sewer odors/gases from penetrating into occupied spaces. When water enters a drain, the trap fills and forms a watertight seal. Without a periodic input of water (e.g., every other day), traps can dry, breaking the watertight seal. Without a watertight seal, odors/sewer gases can travel up the drain and enter the occupied space.

Abandoned sinks sealed with trash bags

7. Plants should be properly maintained and equipped with drip pans to prevent water damage to porous building materials.
8. Remove and properly cap any unused utilities (e.g., sinks, toilets, water fountains) to prevent the release sewer gas into occupied areas.

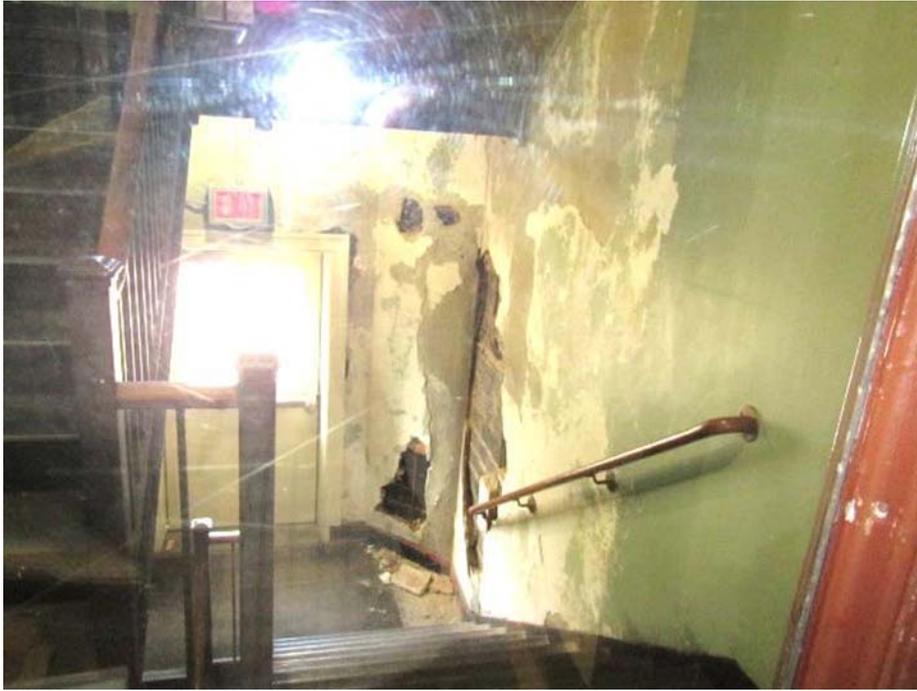
Picture 5

Severely damaged walls and damaged/missing floor tiles were observed in one of the main staircases (Pictures 5 and 6). Due to their age, these floor tiles may contain asbestos. As a precaution, this staircase has been deemed "off-limits" to building staff, for use in emergency only. Intact asbestos-containing material (ACM) does not pose a health hazard. If damaged,

Peeling paint and damaged wall plaster in stairwell

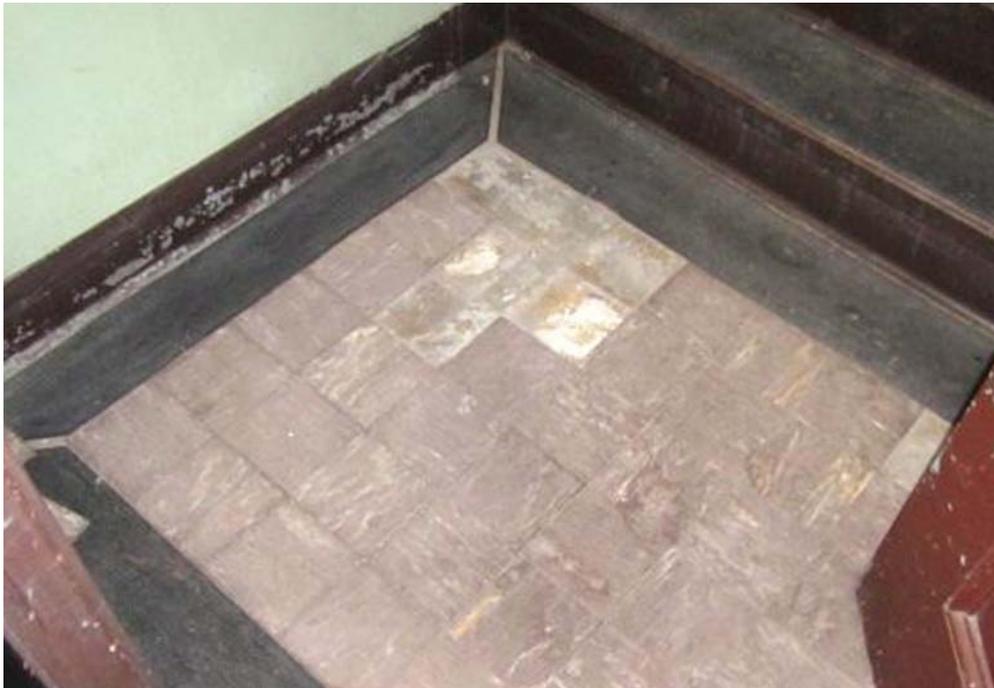
Picture 6

ACM can be rendered friable and become aerosolized. Friable asbestos is a chronic (long-term) health hazard, but will not produce acute (short-term) health effects (e.g., headaches) typically associated with buildings believed to have indoor air quality problems. Where asbestos-containing materials are found damaged, these materials should be removed or remediated in a manner consistent with Massachusetts asbestos remediation laws (MDLI, 1993).

Missing/damaged floor tile in stairwell

11. Determine if damaged floor tiles in stairwell consist of ACM. Remediate any damaged ACM (e.g., floor tiles, pipe insulation) throughout the building in conformance with Massachusetts asbestos remediation and hazardous waste disposal laws and regulations.
12. Refer to resource manual and other related indoor air quality documents located on the MDPH's website for further building-wide evaluations and advice on maintaining public buildings. These documents are available at <http://mass.gov/dph/iaq>.
