INDOOR AIR QUALITY ASSESSMENT

**Commonwealth of Massachusetts
MassHealth Office
21 Spring Street
Taunton, Massachusetts**

Prepared by:
Massachusetts Department of Public Health
Bureau of Environmental Health
Indoor Air Quality Program
April 2015

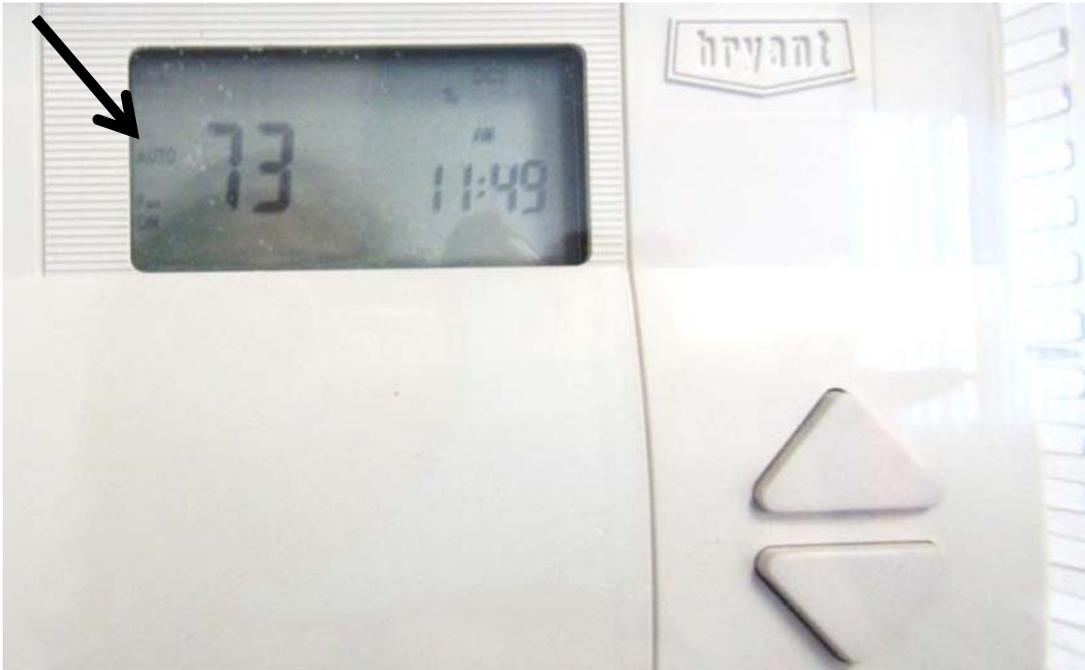
Picture 1

Thermostats were examined on each floor. On the first floor, thermostats were set to the “automatic” setting rather than the “on” setting (Picture 1). When the fan is set to *on*, the system provides a continuous source of air circulation and filtration. The *automatic* setting on the thermostat activates the HVAC system at a preset temperature. Once the preset temperature is reached, the HVAC system is deactivated. Therefore, no mechanical ventilation is provided until the thermostat re-activates the system. The MDPH typically recommends that thermostats be set to the fan *on* setting during occupied hours to provide continuous air circulation. Without a continuous source of fresh outside air and removal of stale air via the exhaust/return system, indoor environmental pollutants can build up and lead to indoor air quality/comfort complaints. The thermostats on the second floor were too old/worn for the settings to be determined.

Thermostat with setting to “auto” rather than “on” (arrow)

1. Operate all ventilation systems throughout the building continuously during periods of occupancy to maximize air exchange. This would include leaving thermostat fan settings in the "on" mode (**not auto**) for continuous airflow.

2. Consider upgrading old/malfunctioning thermostats with digital/programmable ones.
3. Use the switch-activated exhaust systems in kitchens and conference/training rooms where available, to remove stale air and odors when these rooms are in heavy use.

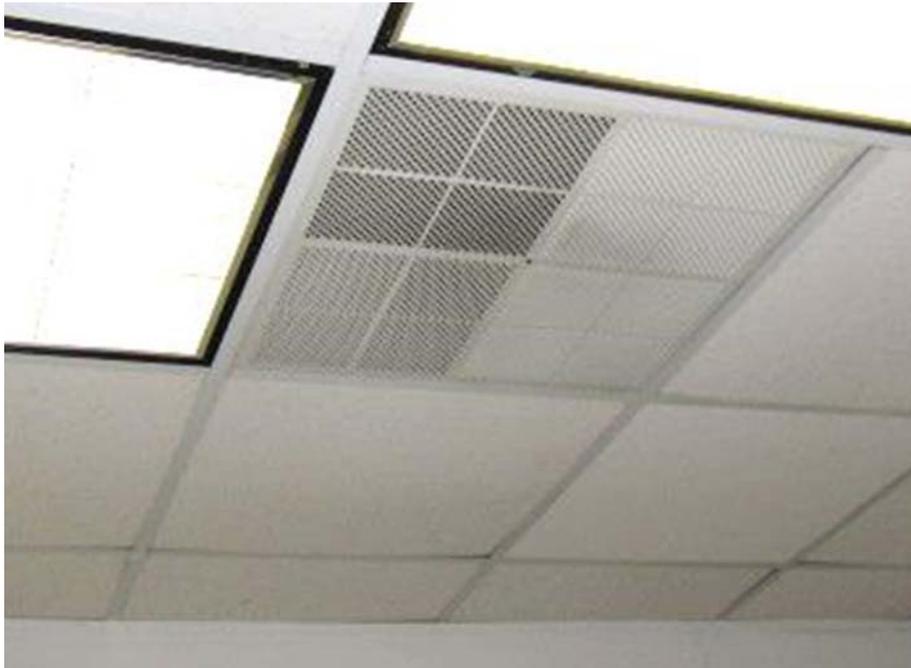
Picture 2

Fresh air is provided by rooftop air handling units (AHUs) ducted to ceiling-mounted supply diffusers (Picture 2). Return air is drawn back into wall (Picture 3) or ceiling vents (Picture 4) and returned to the AHUs. Additional exhaust ventilation in restrooms and some common areas (kitchen, conference room) is provided by switch-activated exhaust vents (Picture 5). It is important to note that due to low outside temperatures on the day of the assessment and over several previous weeks, fresh air supplies to buildings may be automatically or manually

Supply diffuser

15. Have the fire suppression system inspected/maintained in accordance with manufacturer's instructions.
16. Regularly clean supply diffusers, exhaust vents and personal fans to avoid re-aerosolizing any accumulated debris.

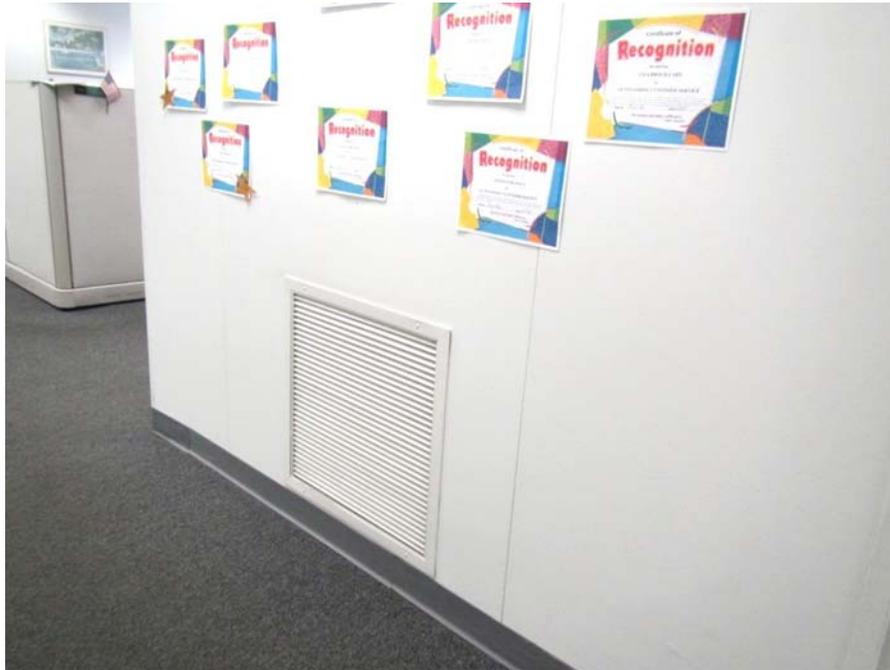
Picture 3

Wall-mounted exhaust/return vent

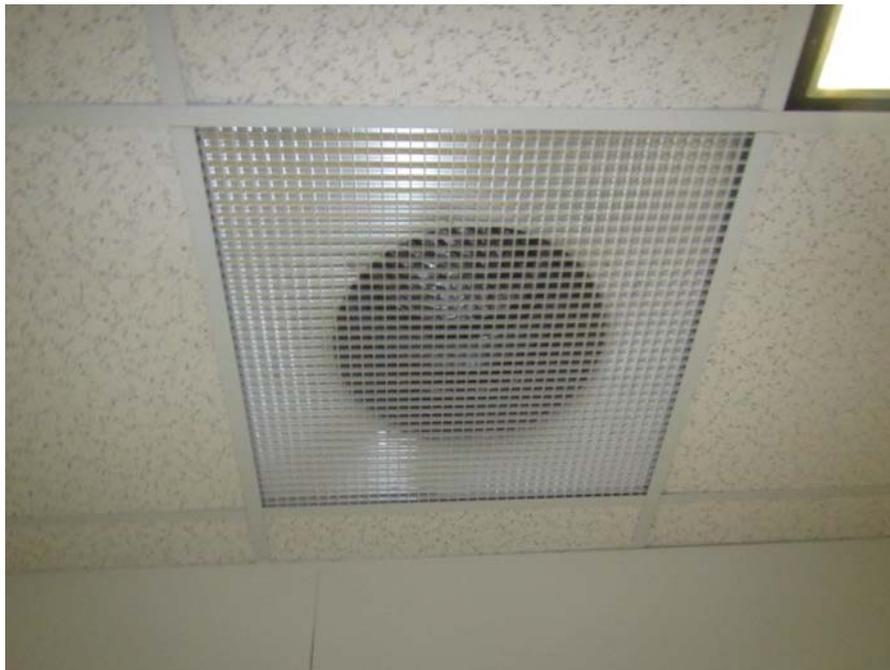
Picture 4

Ceiling-mounted exhaust/return vent

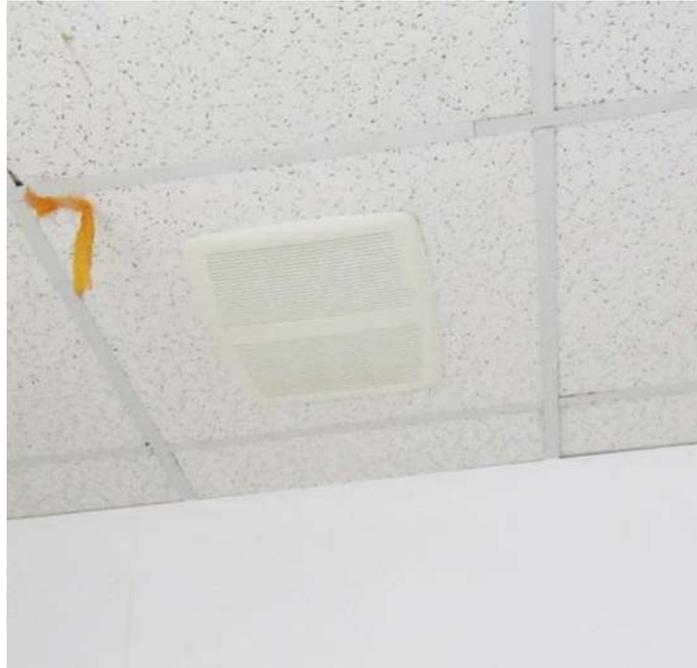
Picture 5

Switch-activated exhaust vent in lounge area

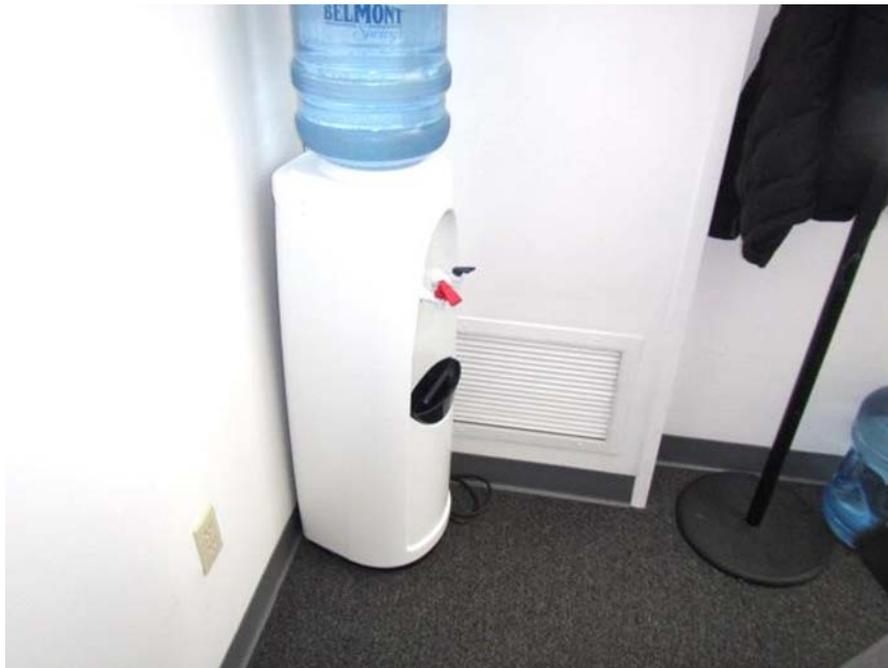
Picture 6

Water coolers were observed in carpeted areas (Picture 6). Spills or leaks from these appliances can moisten carpeting. They should be located in a non-carpeted area or on waterproof mats.

Water cooler on carpet

7. Place water coolers/dispensers in areas without carpeting or place on a waterproof mat.
8. Regularly inspect the ductless air conditioning units for proper condensation drainage.

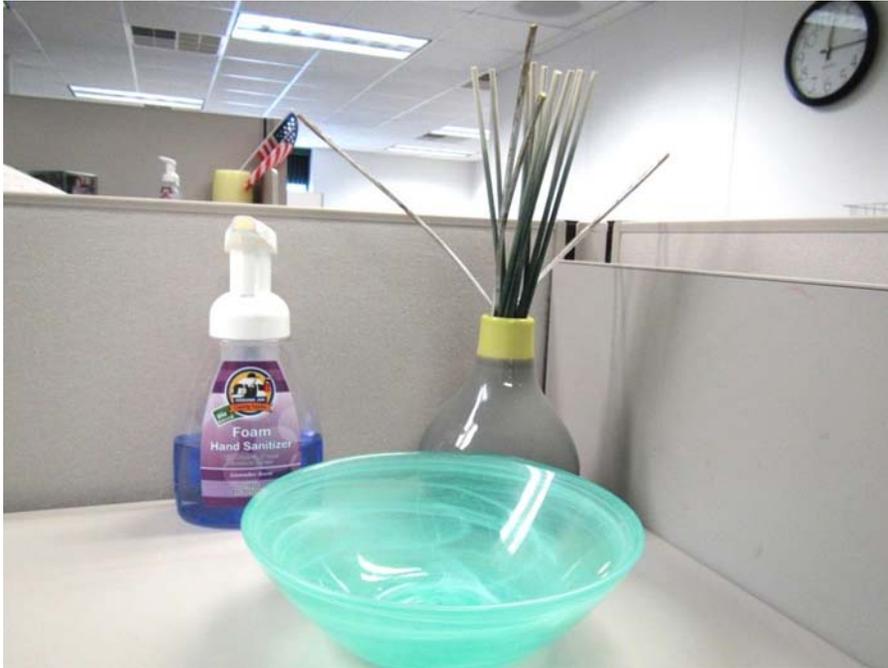
Picture 7

Hand sanitizer was also observed in the space (Picture 7, Table 1); these products may contain ethyl alcohol and/or isopropyl alcohol, which are highly volatile and may be irritating to the eyes and nose. Sanitizing products may also contain fragrances to which some people may be sensitive.

Cleaning products, air freshening sprays and scented products were also found in the office (Pictures 7 and 8, Table 1). Plug-in air fresheners and other air deodorizers contain chemicals that can be irritating to the eyes, nose and throat of sensitive individuals. Many air fresheners contain 1,4-dichlorobenzene, a VOC which may cause reductions in lung function (NIH, 2006). Furthermore, deodorizing agents do not remove materials causing odors, but rather mask odors that may be present in the area. Many cleaning products contain chemicals that can be irritating to the eyes, nose and throat of sensitive individuals. Cleaning products should be properly labeled and stored in an appropriate area. In addition, a Material Safety Data Sheet (MSDS) should be available at a central location for each product in the event of an emergency.

Hand sanitizer and air freshener reeds

11. Use dry erase markers only in well ventilated areas. Clean dry erase boards and trays to prevent accumulation of materials.
12. Reduce the use of hand sanitizing products especially those containing fragrances.

13. Avoid the use of air freshener sprays, solids and diffuser reeds to avoid exposure to VOCs and fragrance compounds.
14. Use task lighting on workstations to adjust light levels for occupants and tasks as needed.

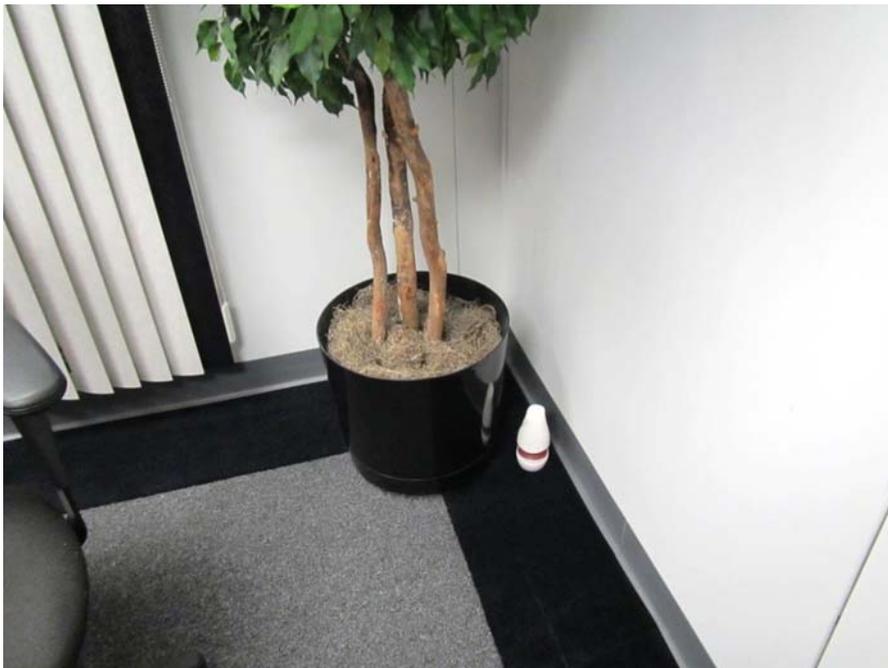
Picture 8

Air freshener in office

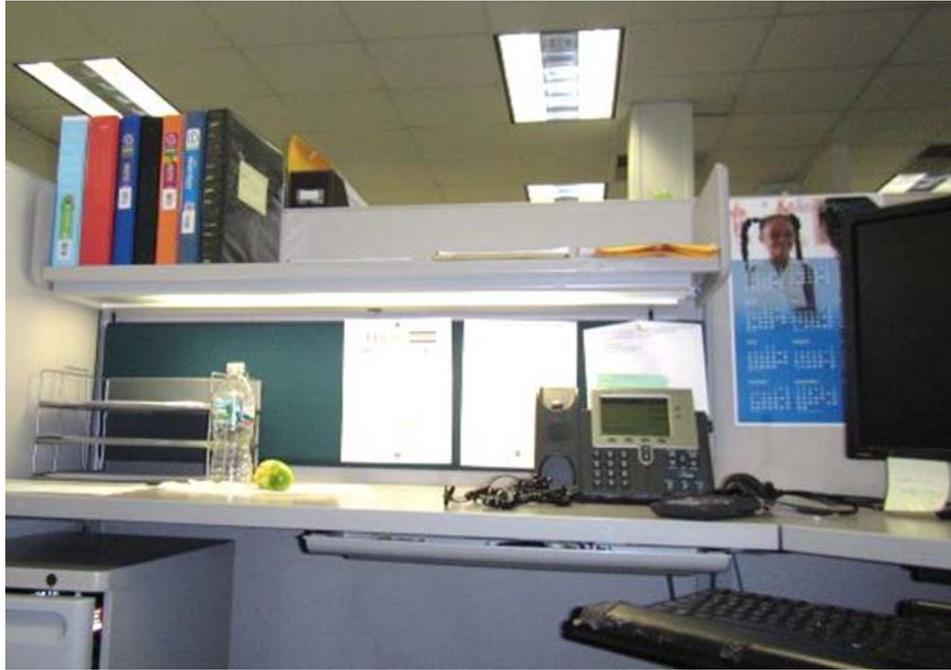
Picture 9

Levels of ambient light in offices and workstations ranged from 19 to 79 foot-candles (FC) and most light levels measured in offices were below 50 FC (Table 1). However, prior to the BEH/IAQ visit, employees had reported that lights in the offices were *too bright*. In response, building management, working in conjunction with MH administrators and staff, had systematically removed the middle of three light ballasts in most light fixtures in workstations and offices (Picture 9). These levels of light are reportedly more comfortable for the majority of occupants. Note that workstations are also equipped with under-shelf task lights (Picture 9),

which can be switched on and off to locally increase light levels to meet the needs of occupants and tasks. As an example, BEH/IAQ staff measured typical lighting conditions in workstation 215, a centrally located cubicle, which measured 28 FC. A second measurement was taken with the under-shelf task light on, which measured 51 FC.

Light fixtures in workstation area, note middle of three ballasts is off/removed
