Massachusetts Department of Public Health
Occupational Health Surveillance Program
Fatality Assessment and Control Evaluation Project

Police Officer Dies when Struck by a Car at Night while Directing Traffic at a Local Fair - Massachusetts

Investigation: # 08-MA-037-01

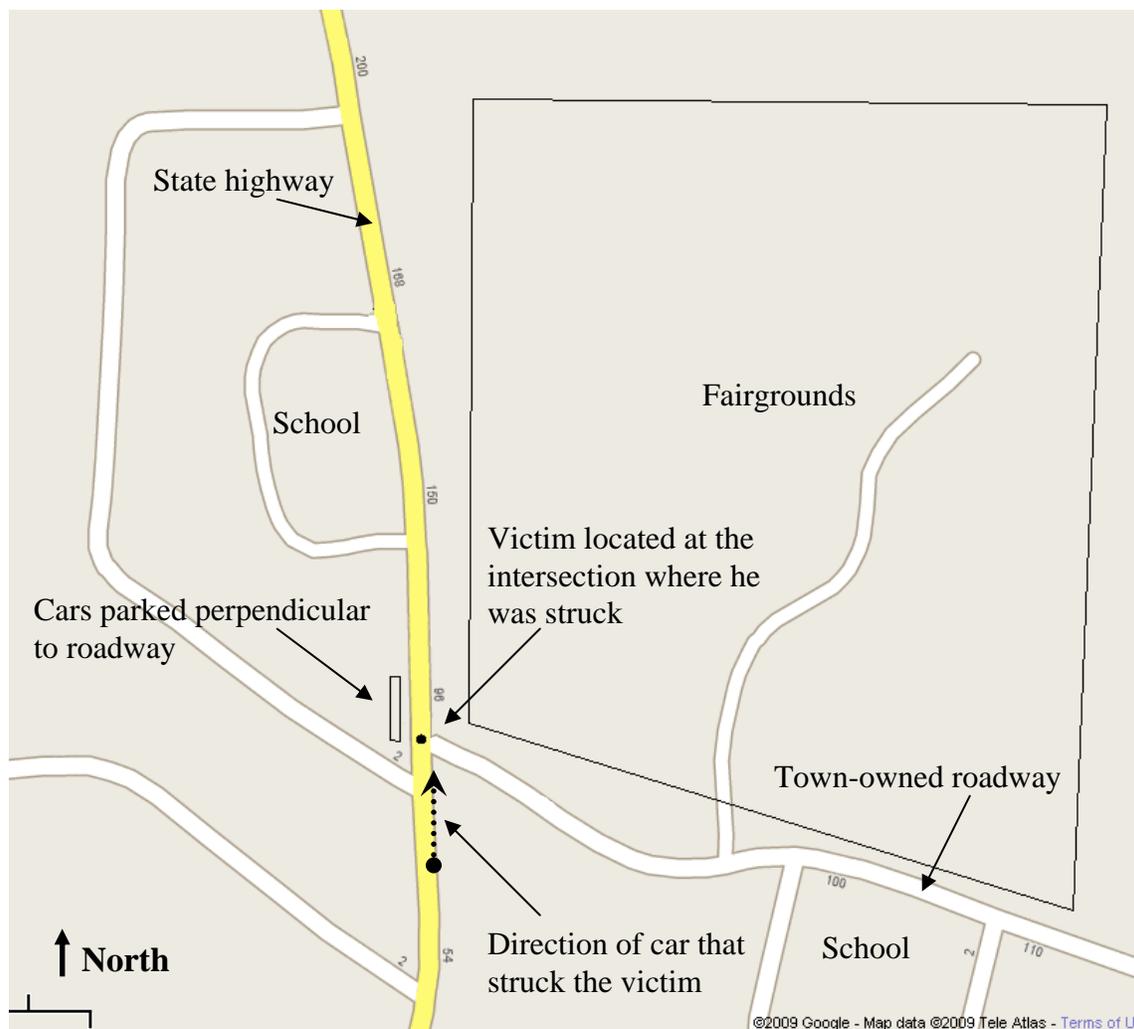
At the time of the incident, a local annual fair was in town. This fair draws large crowds to the town-owned fairgrounds located at the intersection of a state highway and town-owned roadway (Figure #1). The fair is a family and agricultural fair that has been occurring for over 140 years. During the month of August, the fair runs for ten days, and it's estimated that approximately 180,000 visitors attend the fair. Due to large crowds during the fair, the town allows property owners in the immediate area of the fairgrounds to apply for parking lot permits from the town. This enables these property owners, who are the closest to the fairgrounds, to charge fair attendees a fee to park on their lawns and property.

Figure 1 – Diagram of the incident location.

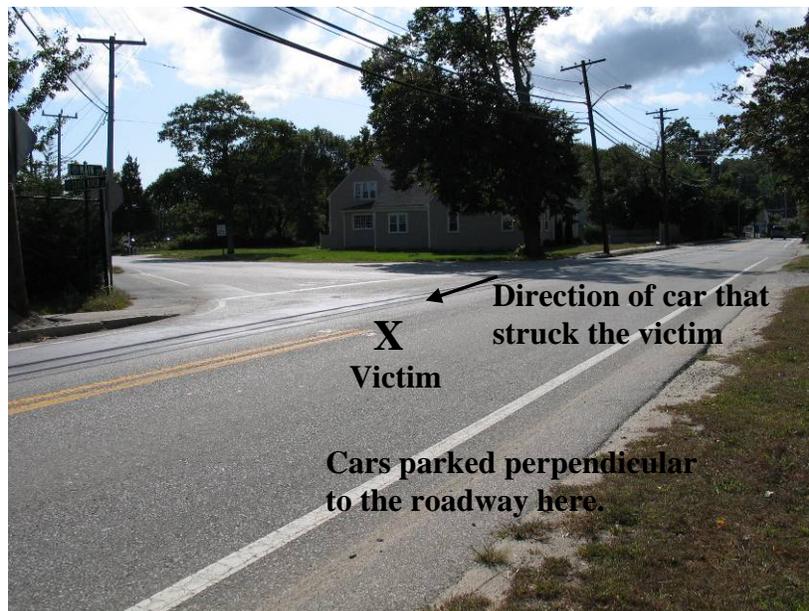
incident location. These officers also assist motorists entering and exiting the parking lots. The third officer was stationed at a T-shaped roadway intersection near the fairgrounds' main entrance, the incident location (Figure #2).

The two roadways that make up this intersection are the same state highway and town-owned roadway that the two schools are located on. The section of the state highway is a two lane undivided asphalt roadway that runs north and south. The state highway pavement markings consisted of solid double center yellow line and white fog lines. The speed limit at this section of the state highway is 30 miles per hour. The town-owned roadway runs east and west and the roadway terminates at the intersection. The pavement markings of the town-owned roadway consist of white fog lines, and at the intersection, a white stop line with the word stop painted in white on the roadway. The speed limit on this roadway is 25 miles per hour.

Figure 2 – The intersection where the incident occurred. The state highway is the roadway with the solid double yellow lines.

Recommendation #1: Municipalities should install signs indicating when there are police officers ahead in the roadway and/or pedestrians are crossing ahead.

Discussion: Signs indicating there is a police officer in the roadway and/or pedestrians crossing ahead should be placed at one or more locations approaching the main crossing and intersections at the fairgrounds. The Manual on Uniform Traffic Control Devices (MUTCD) recommends that on a roadway, such as the state highway in this case, these signs be placed approximately 4-8 times the speed limit distance away, which in this case would be approximately 100-250 feet

away from the intersection where the incident occurred. If more than one sign is used, the distance between the signs is typically 100 feet.¹

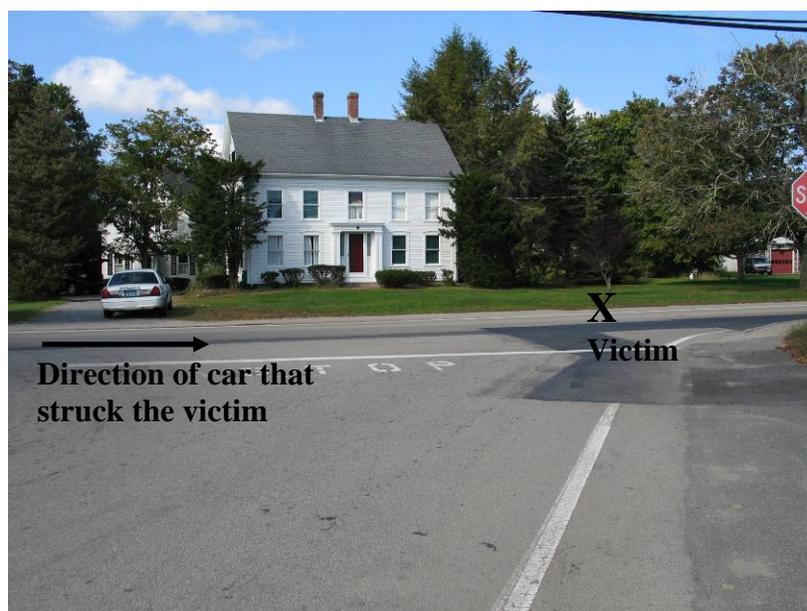
There is also a stop sign at this intersection for the motorists on the town-owned roadway heading west towards the intersection. The officer assigned to this intersection location, which was the victim's location at the time of the incident, assists traffic in both directions on the state highway and the town-owned roadway, directs cars to stop along the state highway to allow cars to enter and exit the town-owned roadway, and watches for and assists crowds of pedestrians crossing both the state highway and the town-owned roadway. In addition, the officer was directing cars that were entering and exiting the lawns of the multiple houses located directly across from the intersection (Figure #3).

Figure 3 – Property adjacent to the intersection where cars were parked perpendicular to the main roadway. The location of the car in the photograph is how close the cars were to the roadway and were parked all the way across the front lawn of the house.

To minimize the number of cars entering the state highway at this intersection, the town modified some of the parking requirements of the private properties closest to the intersection. These modifications include the specification that cars can not enter the state highway from the private yards and have to use a town-owned side street located to the south of the properties. Also cars can no longer park up to the property line for these private yards, which places the cars within a couple of feet of the state highway. To allow for better visibility, the cars are now required to be parked ten feet in from the property line.

In this case, the town Selectman's Office, which issues the parking permits in conjunction with the Police Department, should carefully review the eligible properties surrounding the fairgrounds prior to issuing the permits allowing fairground visitors to park cars on these properties. The property review should extensively look at all the possible parking layouts and traffic flow options for each property that applies for a permit. The properties that are issued permits should have a documented specific traffic and parking layout. As the town started to implement after the incident, these layouts should prohibit traffic from exiting the private

properties directly onto main roadways, especially the properties closest to roadway intersections. Prohibiting cars from entering private properties located closest to intersections directly from main roadways should also be considered.

The Police Department and Selectman's Office should have the authority to determine how parking on these lots will be allowed such that there is minimal impact on public safety. If a traffic and parking layout for a property cannot be designed to eliminate cars exiting the property directly onto the main roadway or other public safety hazards, then these properties should be ineligible to obtain permits.
