WATER DAMAGE/MOLD INVESTIGATION

Massachusetts Life Science Center
1000 Winter Street
Waltham, Massachusetts

Prepared by:
Massachusetts Department of Public Health
Bureau of Environmental Health
Indoor Air Quality Program
July 2014

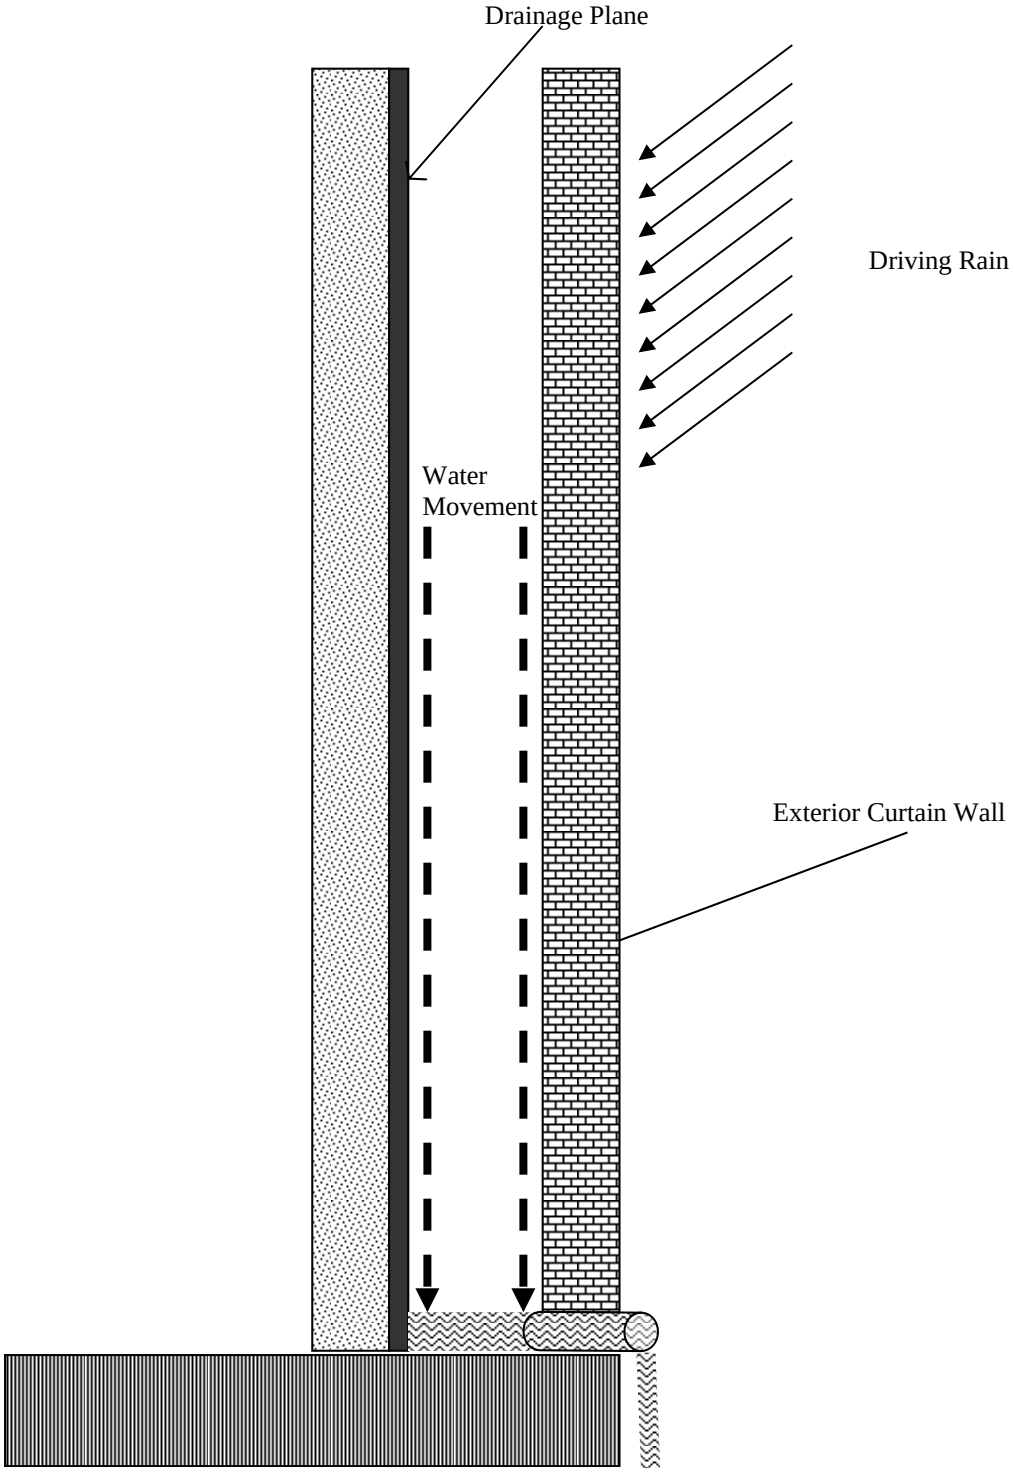
Figure 1

Drainage Plane Function: Weep Holes Drain Water from the Wall System to Prevent Moisture Penetration into the Interior

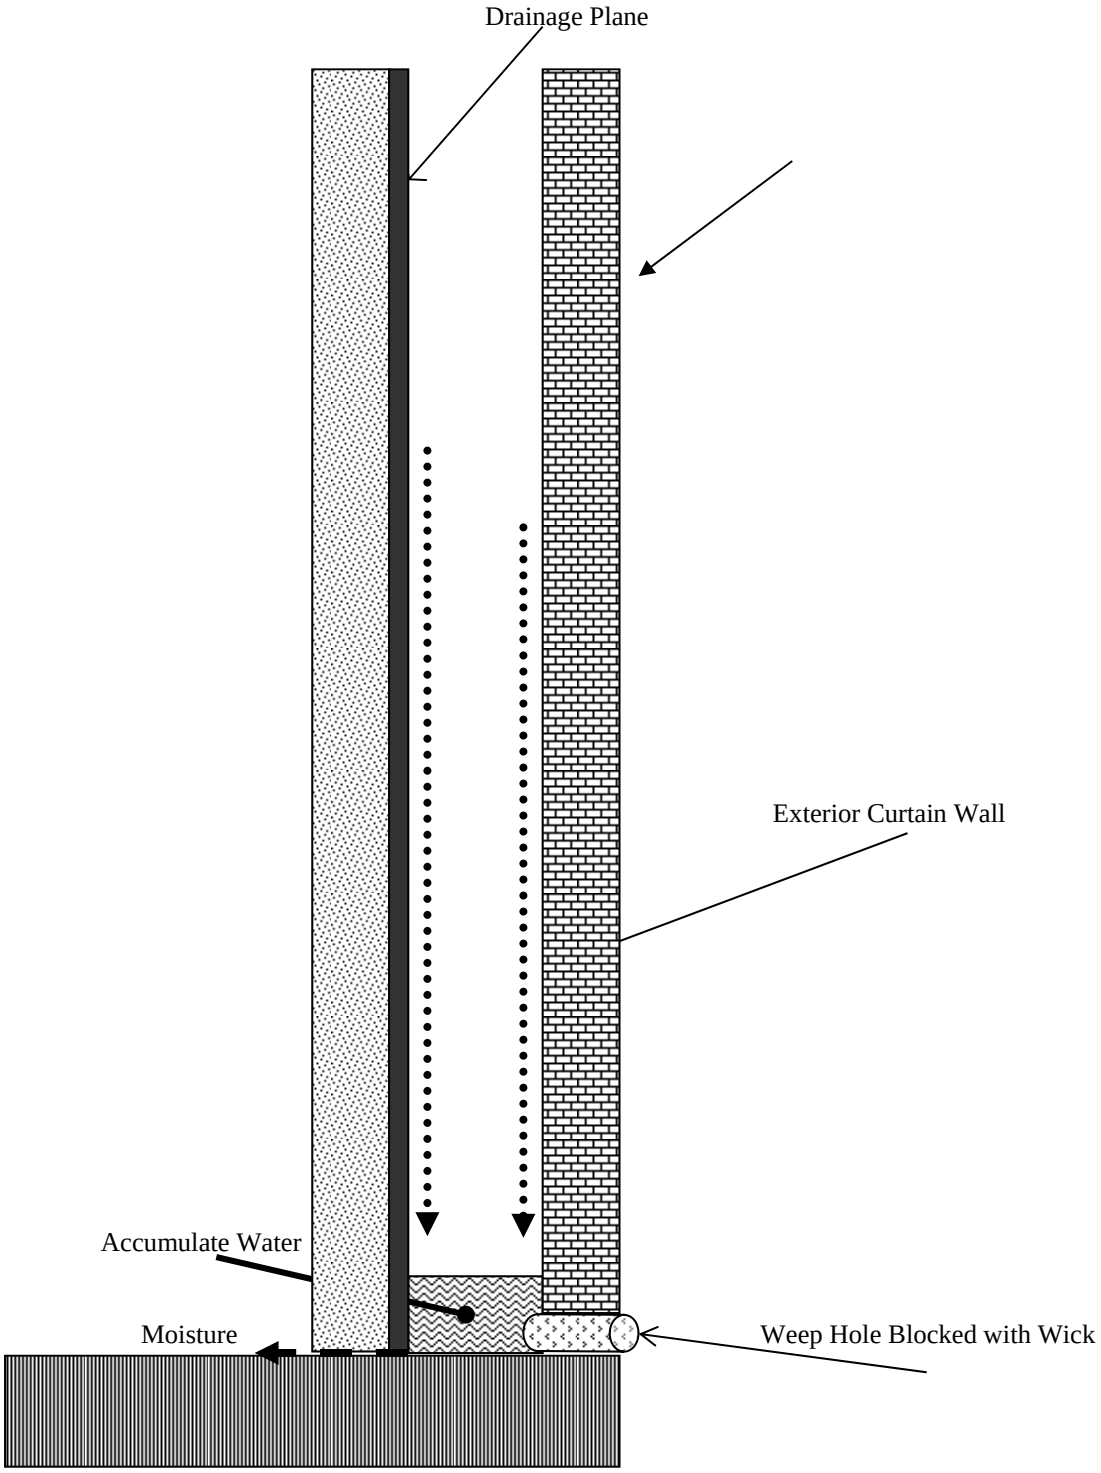
Figure 2

- Flashing to direct water to weep holes is typically installed around breaks/penetrations in the drainage plane (e.g., window systems, door systems, and fresh air intakes). If the drainage plane is discontinuous, missing flashing, or lacking an air space, rainwater can accumulate inside the wall cavity and penetrate the building.
- Weep holes at the base of the curtain wall that allow for water drainage. Weep holes are customarily installed at or near the foundation slab/exterior wall system junction (Figure 1). Weep holes allow for accumulated water to drain from a wall system (Dalzell, 1955). Lack of weep holes in brickwork, burial of weep holes below grade, or sealing of weep holes with cement will allow water to accumulate in the base of walls, resulting in seepage and possible moistening of building components (Figure 2).

Blocked Weep Hole: Water Accumulates in the Drainage Plane
