Massachusetts Department of Conservation and Recreation

Nantasket Beach Reservation Facilities Utilization Report

Hull, MA

April 2014

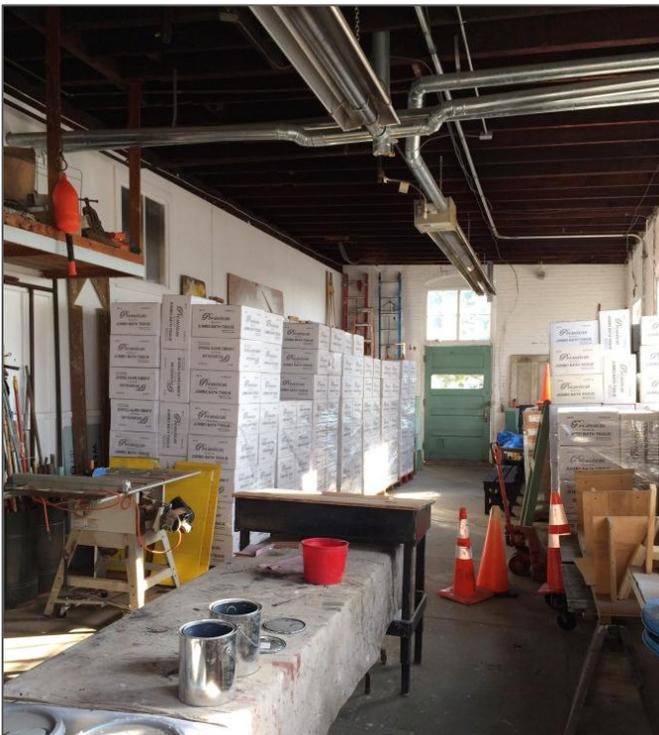
Figure 2: Lower Garage storage area

The Lower Garage (Figures 1 and 11) has an area of approximately 5,000 square feet and is in overall good condition. Its major use is vehicle and maintenance storage but the facility also provides heated storage and houses the carpentry shop. The building is not prone to flooding, making it ideal for storage of sensitive goods such as toilet paper and waste oil. There are two bathroom facilities and a shower in the building.

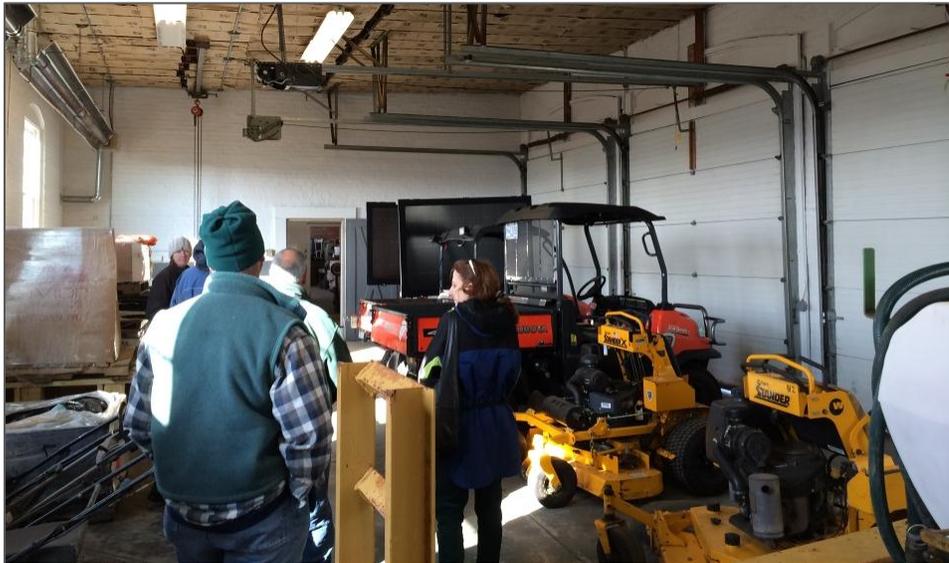
Figure 5: Upper Garage interior

The Upper Garage (Figures 4 and 12) has an area of approximately 2,750 square feet and is in overall good condition. Its major use is vehicle and maintenance storage. Due to current space restrictions, the garage cannot accommodate a truck equipped with a plow and sander. The building is prone to flooding; during large storm events up to 1.5 feet of water may be seen on the floor. This may be due to the overhead doors on the Nantasket Avenue side of the building that do not seal well with the concrete slab floor. There is no bathroom located in this building.

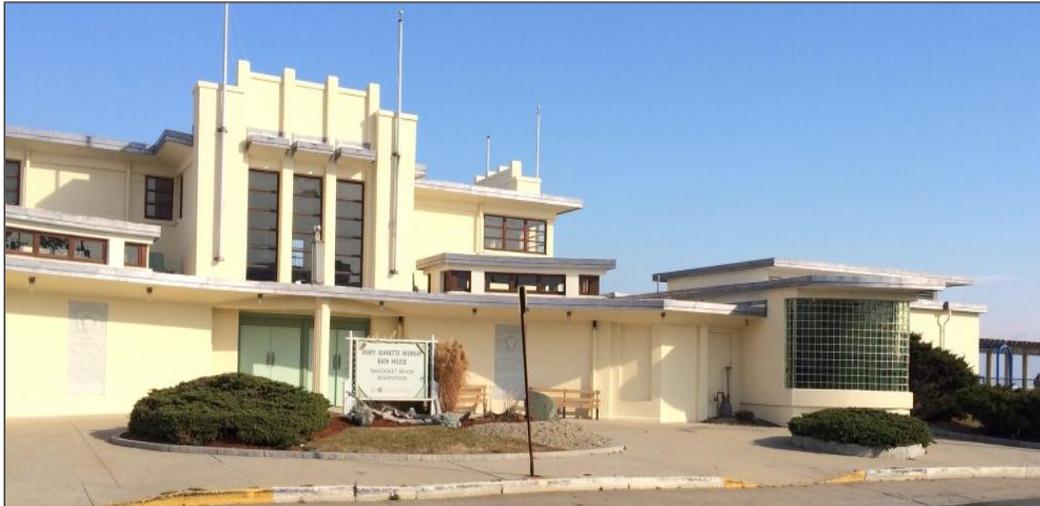
Figure 16: MJM Bath House Building exterior

The Mary Jeanette Murray (MJM) Bath House (Figure 16) has an area of approximately 3,460 square feet and is in good condition overall. It was recently renovated.

The MJM Bath House is currently underutilized by the public as the main doors are locked when there are no scheduled events. As an alternative, local art and historic relics could be displayed in the large open space with the main doors left open to invite visitors in during normal operating hours rather than just during special events. Another option could be to sell parking permits from a stand within the MJM during the summer which would require a phone line for credit card transactions. The wings of the building, which contain restrooms and changing rooms, are currently open to visitors regardless of event scheduling.
