# Spring Pond

Jamaicaway, Boston, MA  
 Inspection Date: 09/05/2013

## IDD Test Results Manhole 37205:

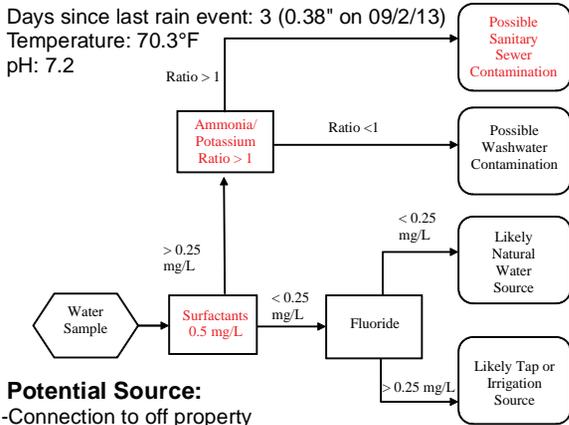
Dry weather flow was investigated in manhole 37205 on Jamaicaaway in Boston. A trickle from a 12" clay pipe that runs underneath the property at 242 Jamaicaaway was observed as well as a more significant flow from an 18" cast iron pipe appearing to originate from the direction of Castleton Street. Further investigation of two manholes on Castleton Street found that the manholes had been sealed under their metal covers with asphalt and were unable to be investigated. The sealed manholes are off of DCR property and were marked with "sewer" covers. Survey results indicated that one or both of the manholes located on Castleton Street may be contributing to the flow observed in manhole 37205 that then flows downstream to raised manhole 12956. This raised manhole has been outfitted with a hinged cover that overflows during some rain events and contributes to erosion and sedimentation issues around Spring Pond. The overflow was documented during a rain event four days before this IDDE survey through photos forwarded to DCR from Mass Fish and Wildlife. Test results performed on the flow from Castleton Street yielded results that indicate possible sanitary sewer contamination. A desktop review of video footage taken in this system displayed results consistent with the findings of this survey.
