DEPARTMENT OF PUBLIC UTILITIES

PIPELINE ENGINEERING AND SAFETY DIVISION

INCIDENT REPORT

Webster Street, Needham, Massachusetts

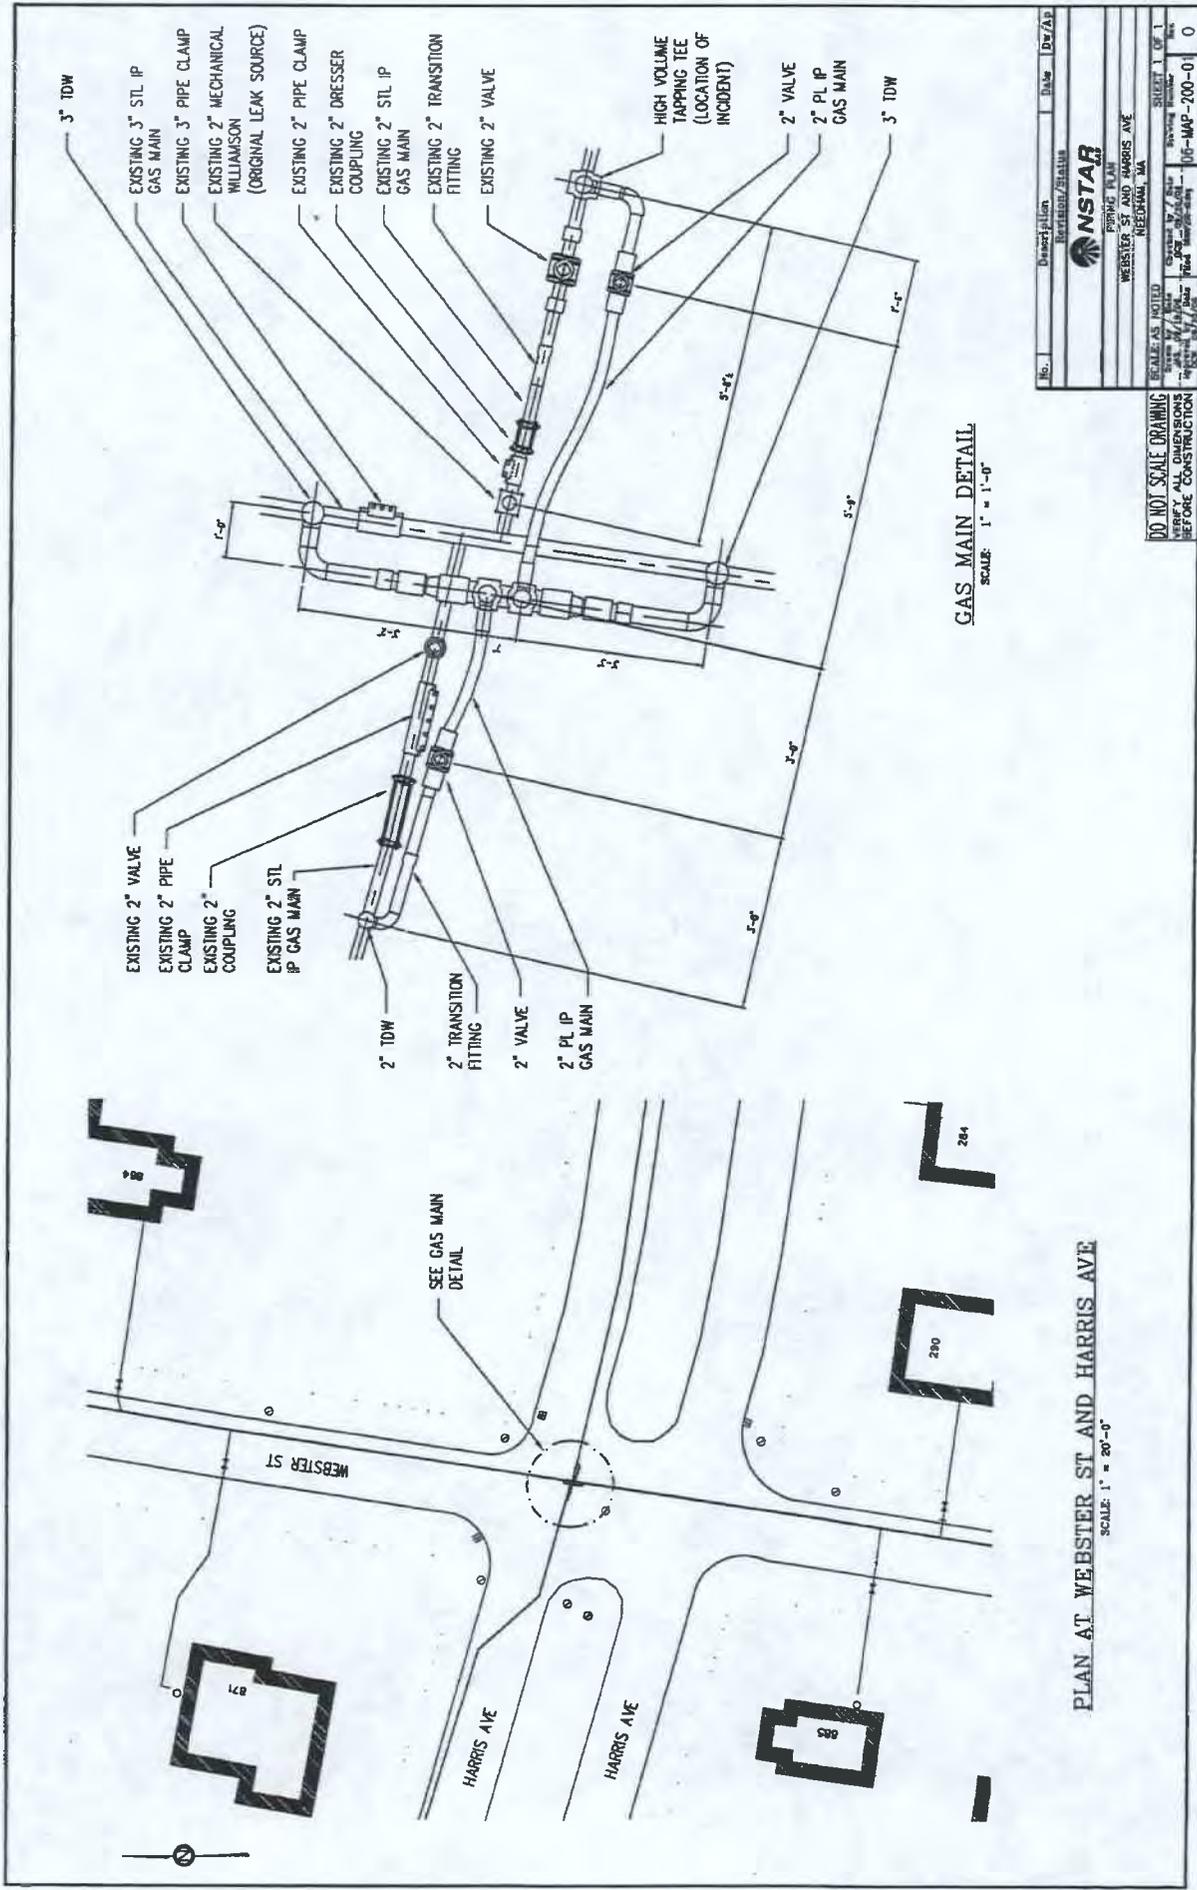
IR-PESD-2-7

Sketch of Proposed Main Repair

Mr. Arsenault stated he was working with a crew at this location to make permanent repairs to a main in the intersection which had a history of gas leaks. There had been a Grade 2 leak in this area for awhile, but he believed gas had migrated to the sewer and become a Grade 1 leak. He was not present the first two days when a crew excavated to expose the mains in the intersection. He came on the third day when the crew was to stop, tap and blank the leaking section of main and install a permanent bypass.

The new sections of main had been prefabricated and placed in the trench. Williamson stopping equipment and bypass piping had been installed on the existing main prior to cutting out the section to be replaced. A Central Plastics 2"IPS x 2"IPS HV TAP TEE was electrofused to the existing two-inch plastic main in Harris Avenue on the west side of the intersection.
