INDOOR AIR QUALITY ASSESSMENT

**The Ralph J. Froio Senior Center
330 North Street
Pittsfield, Massachusetts 01201**

Prepared by:
Massachusetts Department of Public Health
Bureau of Environmental Health
Indoor Air Quality Program
October 2008

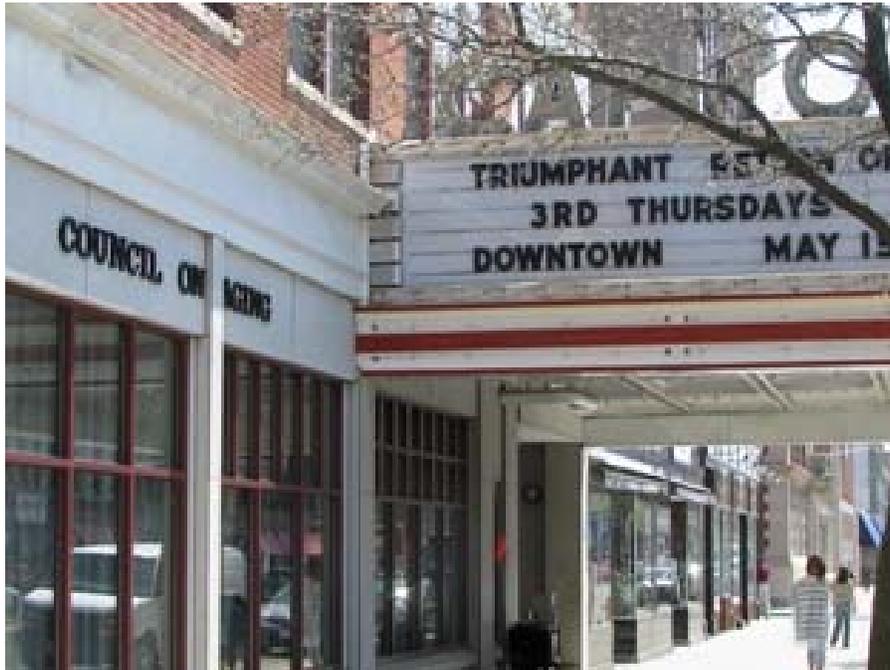
Picture 1

Marquee on front of Senior Center

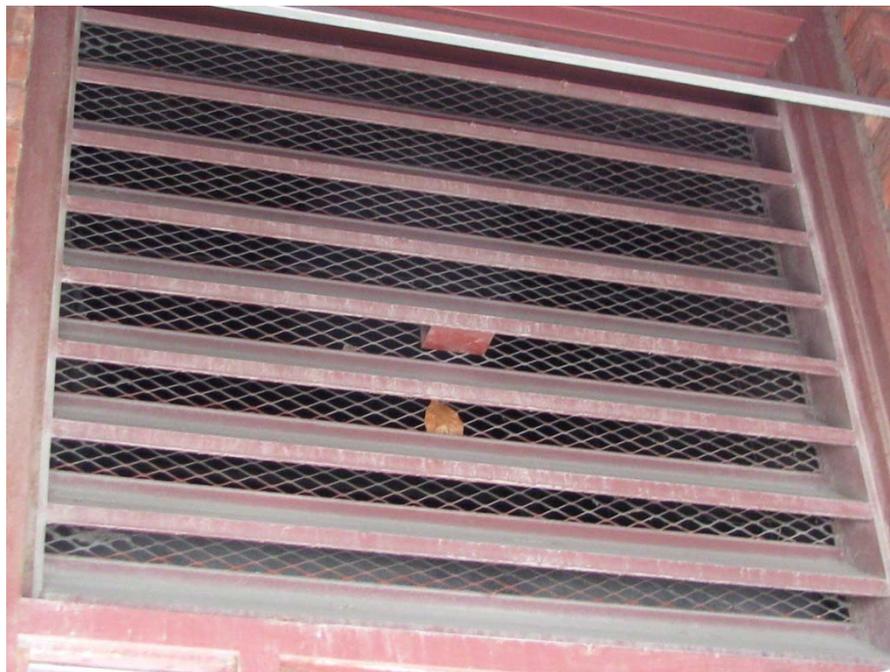
Picture 2

An air handling unit (AHU) located within the first floor ceiling plenum provides air to the first floor and basement. Fresh air is introduced by an air intake on the exterior wall of the building, located above the main entrance and below an awning covering the building entrance (Figure 1; Pictures 2 and 3). Fresh air is distributed to occupied areas via ceiling-mounted air diffusers (Picture 4). Return air is ducted back to the AHU via ceiling-mounted return vents located in the main hallways on the first floor, and in the boardroom in the basement (Map 1). Maintenance staff reported that this AHU does not exhaust air to the outdoors; rather, it recirculates air back to each floor. It is important to note that the sole exhaust for the basement is in the boardroom; therefore, when the doors to this and surrounding rooms are closed, return air cannot be removed from the basement. Local exhaust ventilation systems exist in both the wood shop and ceramics room located in the basement. In the wood shop, the local exhaust system removes sawdust/pollutants from wood-working equipment. A canopy hood exhausts the kiln in the ceramics room. These systems are described in detail under the *Other Conditions* section of this report.

Fresh air intake located below awning

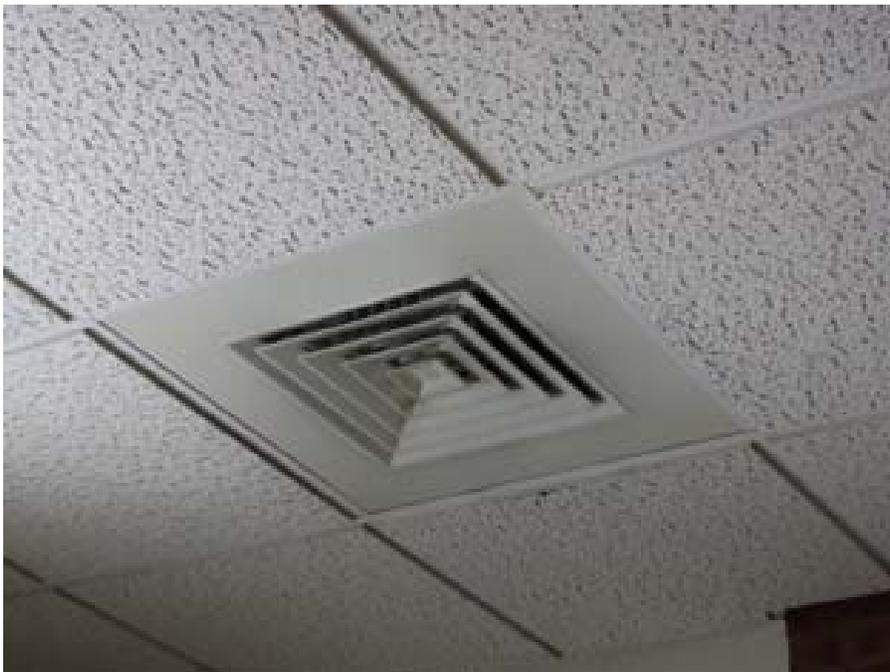
Picture 4

Ceiling-mounted air supply diffuser

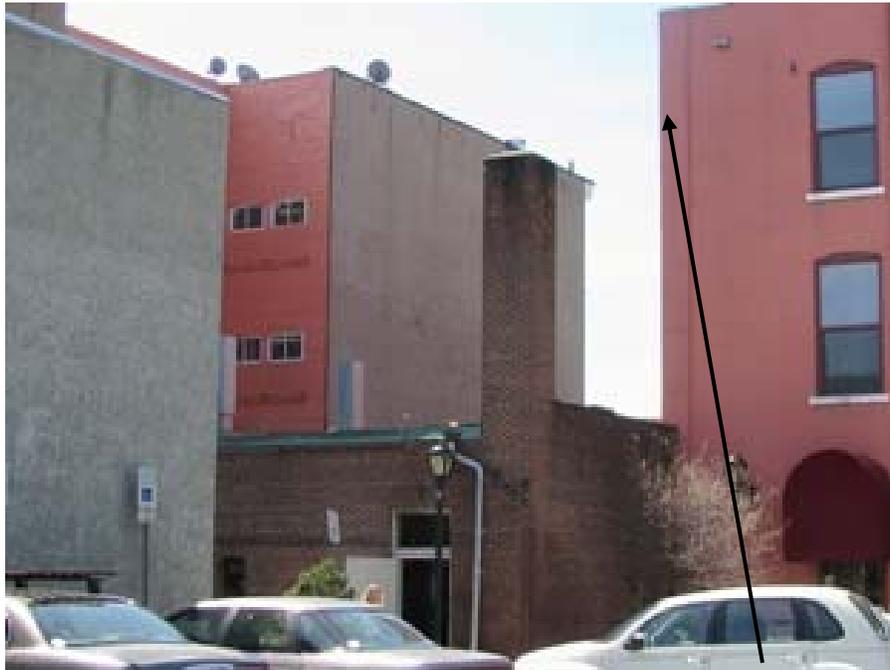
Picture 7

Rainwater is drained from the roof by means of a scupper. Scuppers collect water from the roof and drain it through the building's parapet to the exterior of the building. The RFSC does not supplement its scupper with a gutter/downspout; therefore, water empties against the exterior of the building and pools on the ground at the base of the building. As a result, surface discoloration and possible mold colonization were observed on the exterior brick at the base of the building (Pictures 7 and 8). Further, discoloration of the exterior brick was noted around the scupper (Picture 9).

Rooftop scupper used to drain rainwater
