INDOOR AIR QUALITY ASSESSMENT

**Pittsfield City Hall
70 Allen Street
Pittsfield, MA 01201**

Prepared by:
Massachusetts Department of Public Health
Bureau of Environmental Health
Indoor Air Quality Program
December 2009

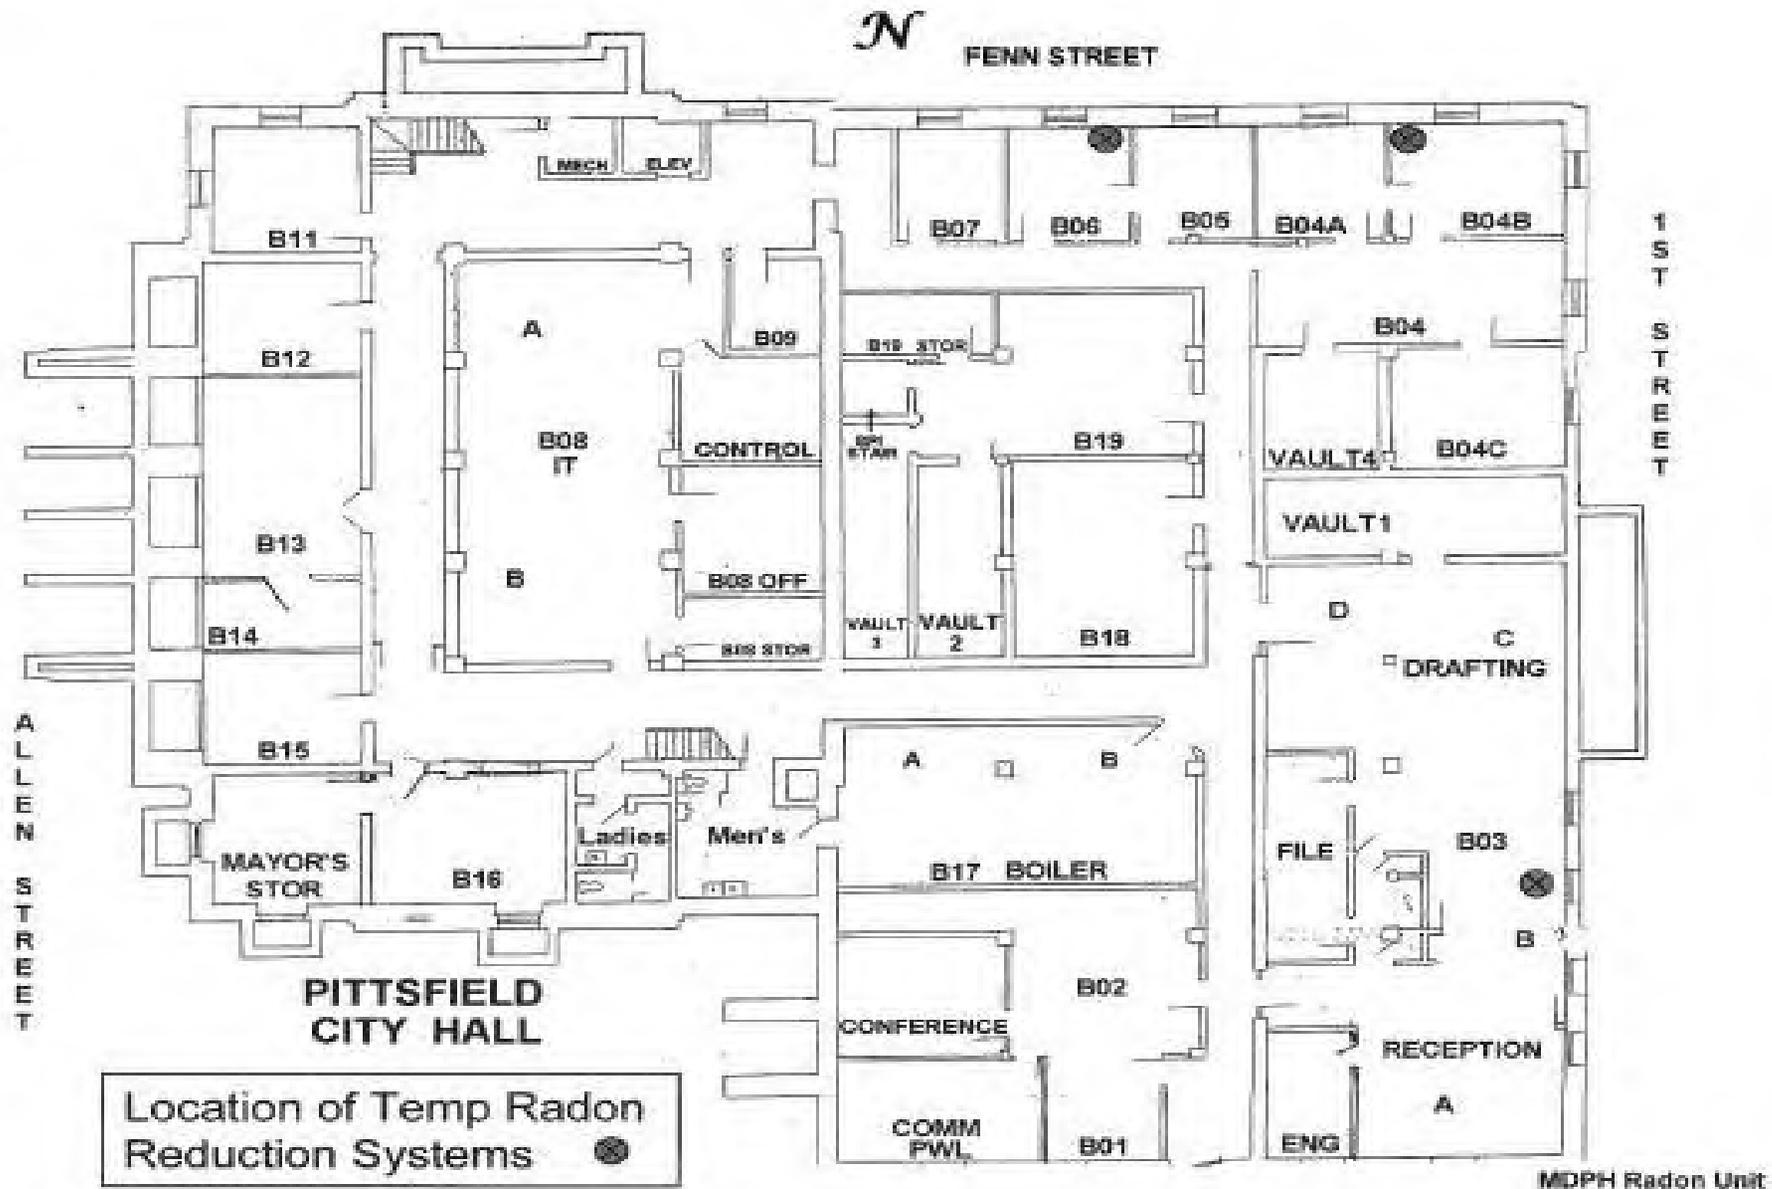
**Map 2
Pittsfield City Hall
Location of Temporary Radon Reduction Systems**

BEH/RCP RU staff collaborated with City health and facilities staff in the investigation of mitigation options. Three separate temporary active soil depressurization (ASD) systems were installed in Rooms B03 reception, B04B and B06 between November 2008 and January 2009 (Map 2; Pictures 25 and 26).

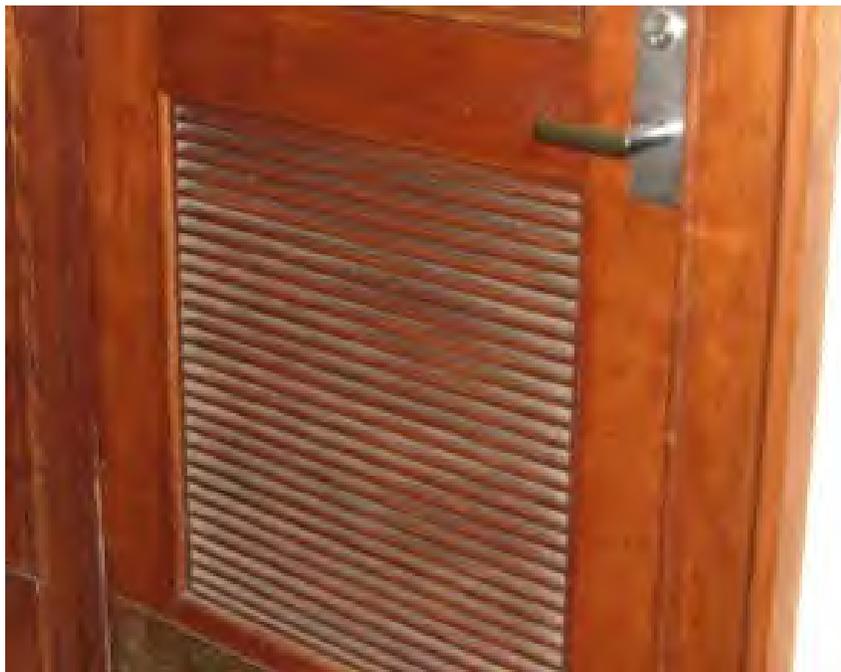
Picture 1

Hallway Door with Passive Vent

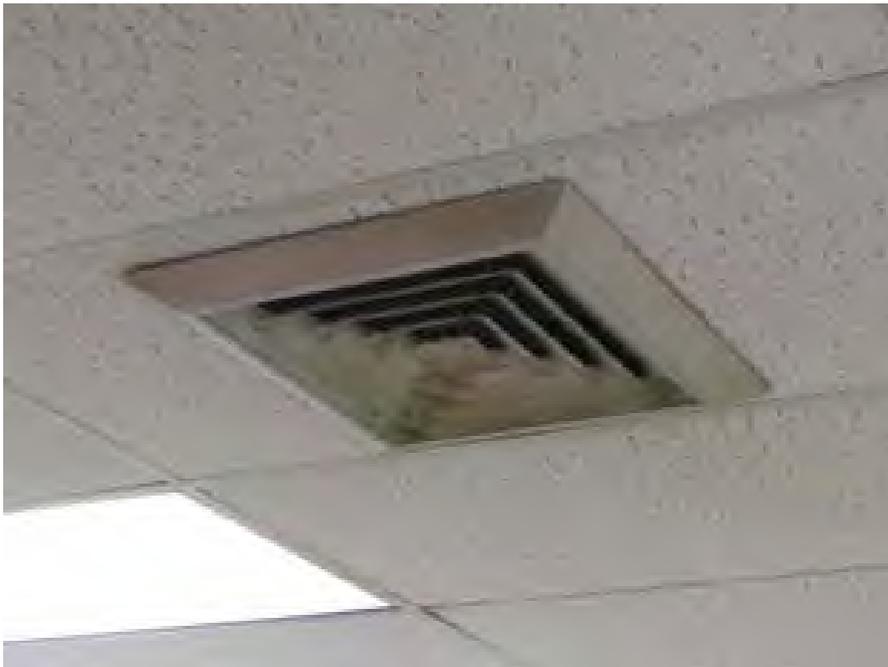
Picture 6

A rooftop air handling unit supplies fresh air to interior offices through ceiling diffusers (Picture 6). These areas include the City Clerk's Suite and Tax Collector's office on the first floor, the City Council Chamber on the second floor, and the IT office in the basement. Return air is ducted back to the AHU via ceiling/wall-mounted grills (Picture 7).

Ceiling Air Diffuser

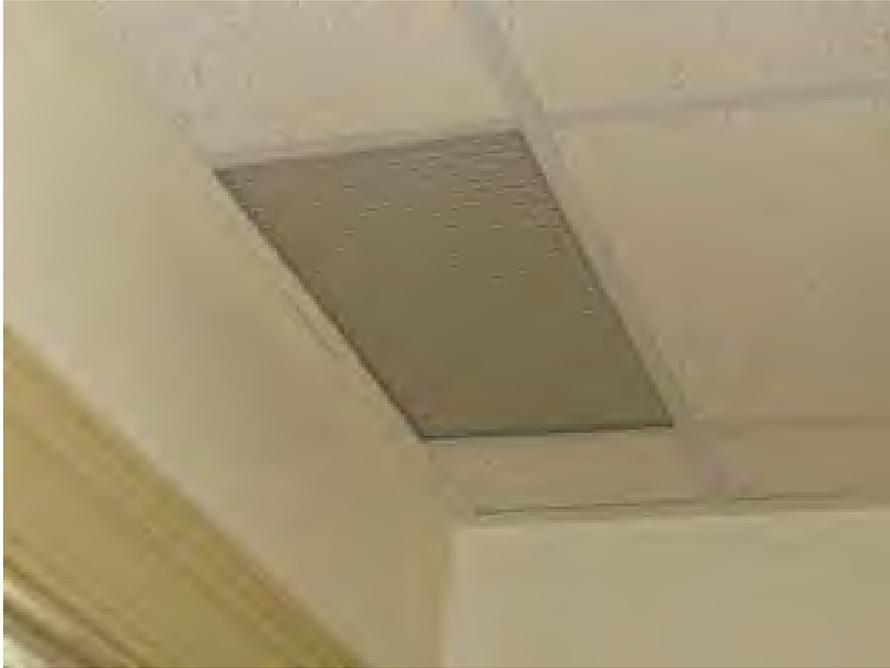
Picture 7

Ceiling-mounted Exhaust Grill

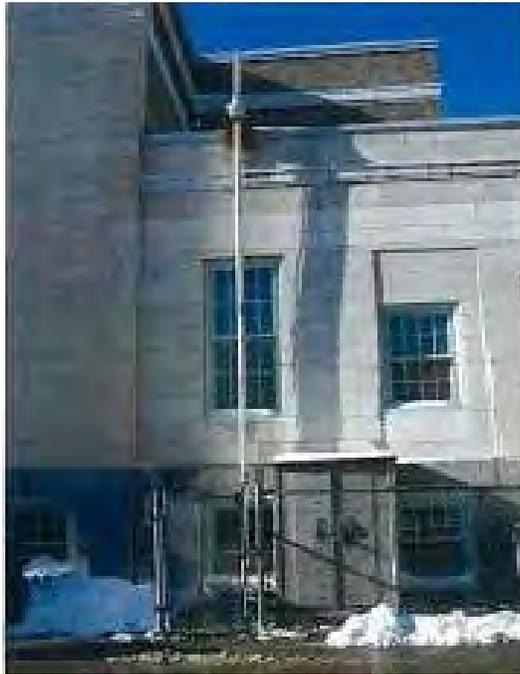
Picture 25

Exterior View of Temporary Radon Reduction System Room B-03
(Picture by BEH Radon Unit)

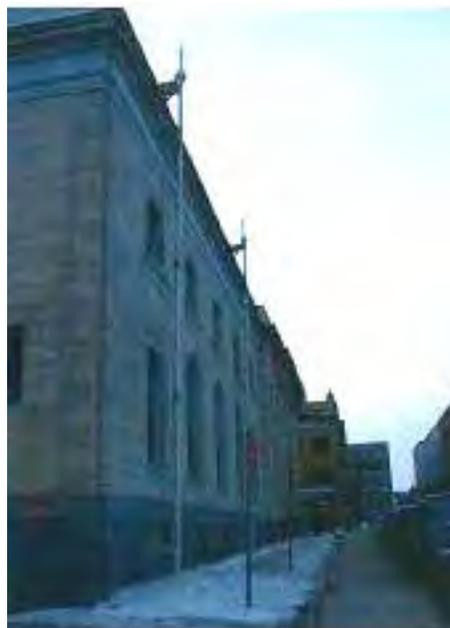
Picture 26

Exterior View of Temporary Radon Reduction System, Rooms B-04 (near) and B-06
(Picture by BEH Radon Unit)

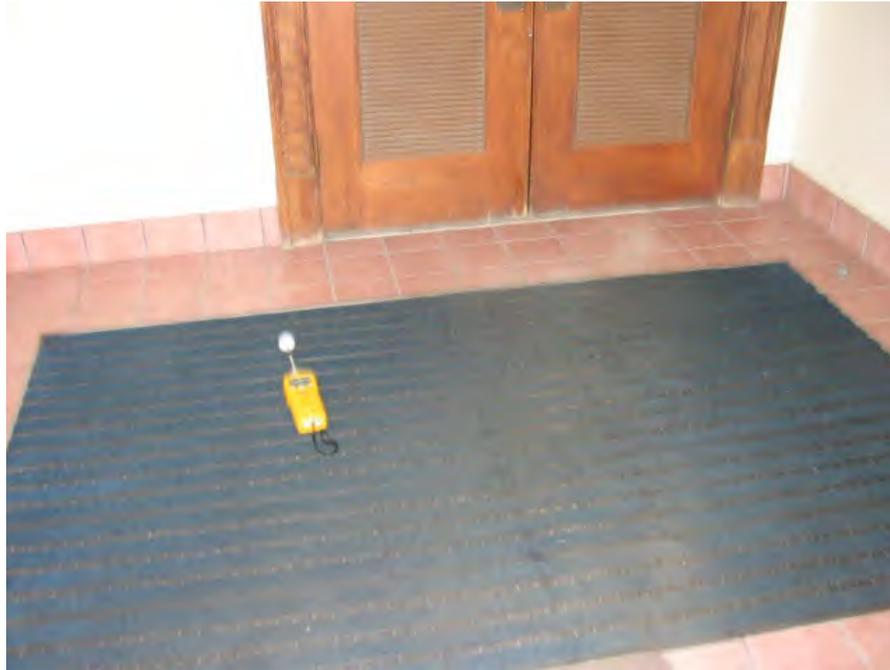
Picture 27

BEH staff conducted TVOC sampling in offices and all common areas throughout PCH (Table 1). On the day of assessment, outdoor TVOC levels were non-detect (ND). No measurable levels of TVOCs were detected in offices or the basement. However, elevated VOC levels were detected in an unvented foyer at the rear entrance of the PCH (Picture 27). VOCs were emanating from a mat on the floor in the foyer. It is likely the adhesive used for this mat had not adequately cured prior to installation, resulting in the release of VOCs and a strong odor.

Floor Mat in Foyer of Rear Entrance of PCH
