INDOOR AIR QUALITY ASSESSMENT

**West Street School
14 West Street
Granby, Massachusetts**

Prepared by:
Massachusetts Department of Public Health
Bureau of Environmental Health
Indoor Air Quality Program
October 2010

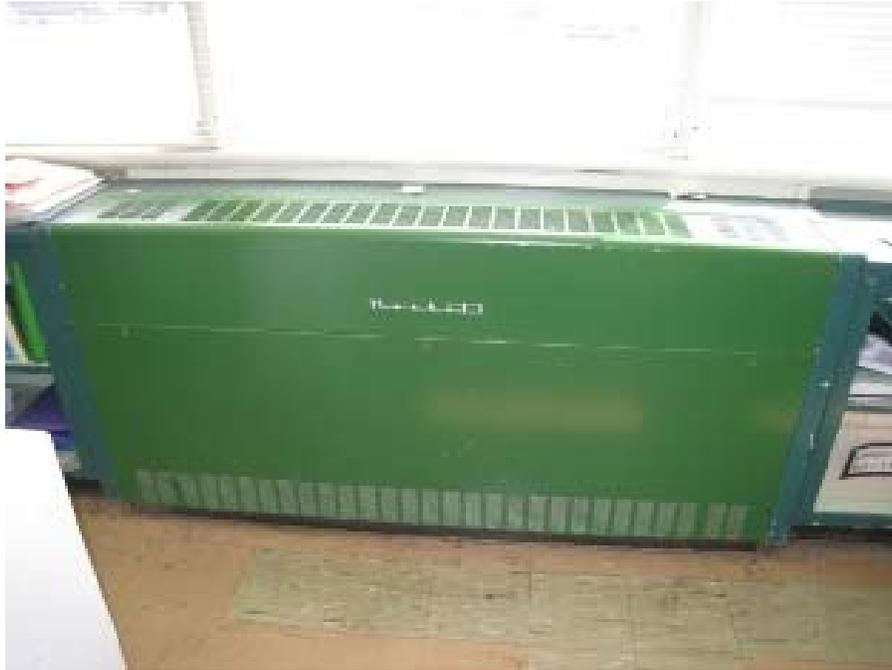
Picture 1

Fresh air in classrooms is supplied by unit ventilator (univent) systems (Picture 1). A univent draws air from the outdoors through a fresh air intake located on the exterior wall of the building and returns air through an air intake located at the base of the unit. Fresh and return air are mixed, filtered, heated and provided to classrooms through an air diffuser located in the top of the unit ([Figure 1](#)). Univents appear to be original equipment. The ventilation equipment in this building was likely installed when the building was constructed (i.e., over 60 years ago). According to the American Society of Heating, Refrigeration and Air-Conditioning Engineering (ASHRAE), the service life¹ for a unit heater, hot water or steam is 20 years, assuming routine maintenance of the equipment (ASHRAE, 1991). Despite reported attempts to maintain the univents (cleaning univents and changing filters regularly), the operational lifespan of this

Unit Ventilator (Univent)

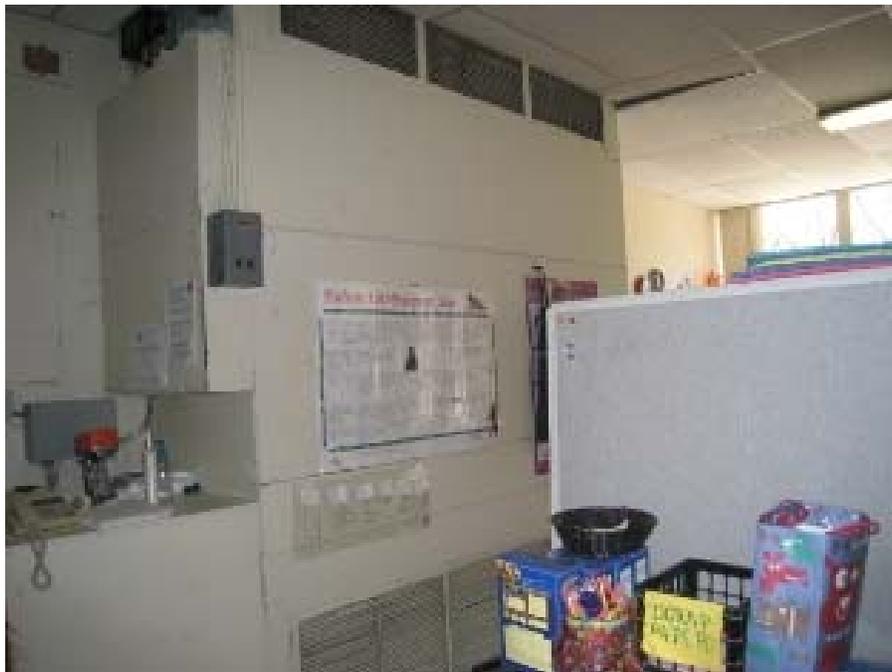
Picture 2

Air handling units (AHUs) provide fresh air to the cafeteria, library and lower level classrooms and exhaust air via rooftop exhaust fans. The lower level classrooms have passive vents located near each doorway that lead to an exhaust vent in the hallway (Pictures 2 through 4). It was reported that the AHU in the library had a failed heating coil.

AHU in Cafeteria

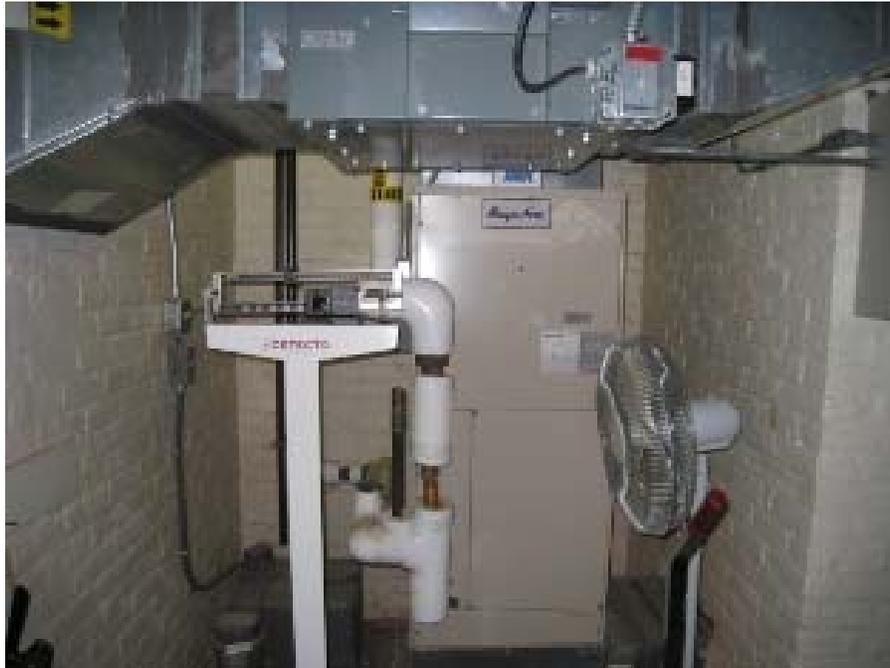
Picture 3

AHU for Lower Level Classrooms

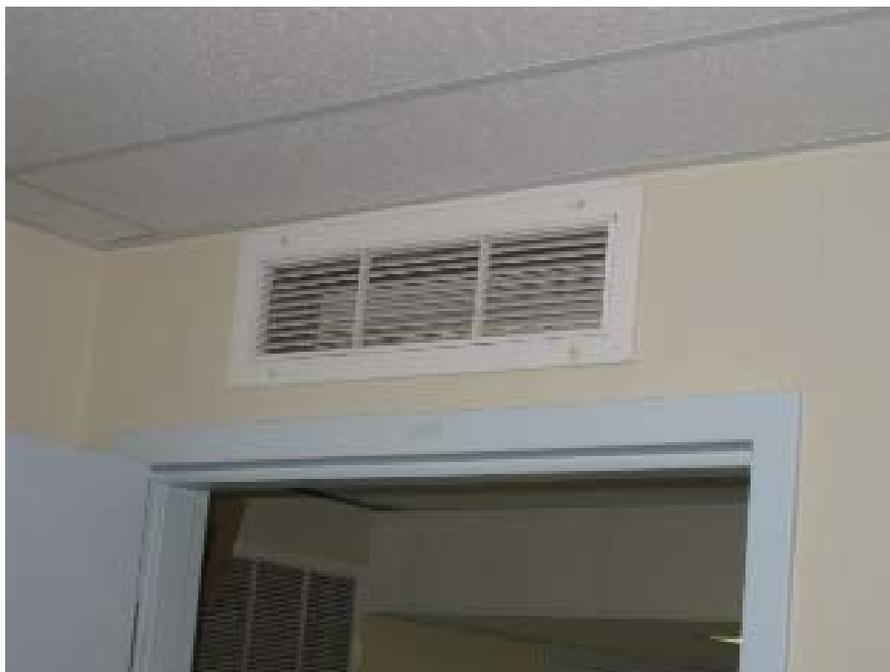
Picture 4

**Passive Vent Above Door Casing
Note Exhaust Vent in Hall Outside Door**

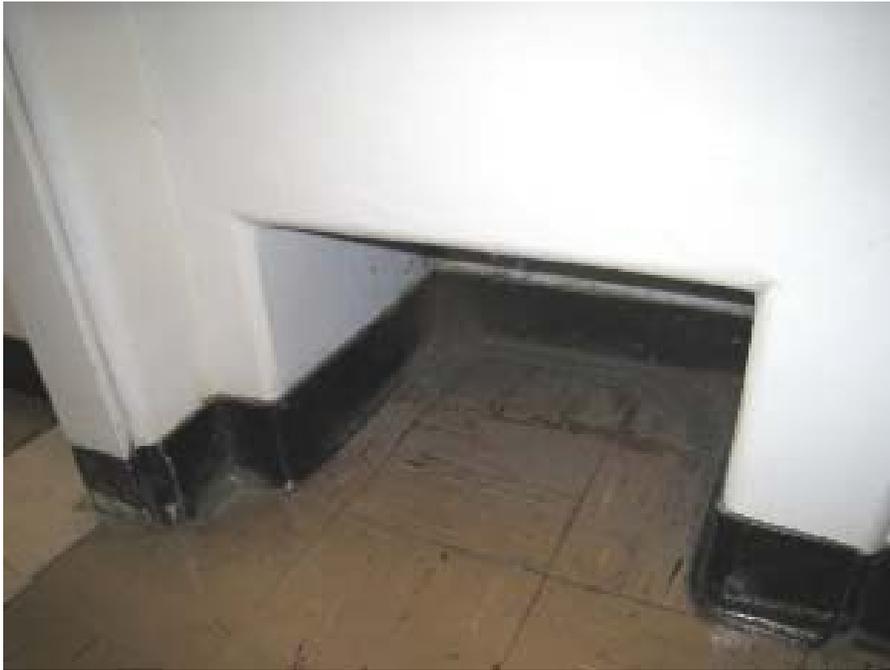
Picture 5

Exhaust for classrooms is provided by gravity exhaust vents located near the floor in the original building and ducted rooftop vents in the subsequent additions (Pictures 5 and 6). Some of the dampers for the original building's exhaust vents were not open and/or were obstructed on the day of the assessment (Pictures 7 and 8). It is difficult to control temperature and maintain comfort without operating the ventilation equipment as designed.

Exhaust Vent

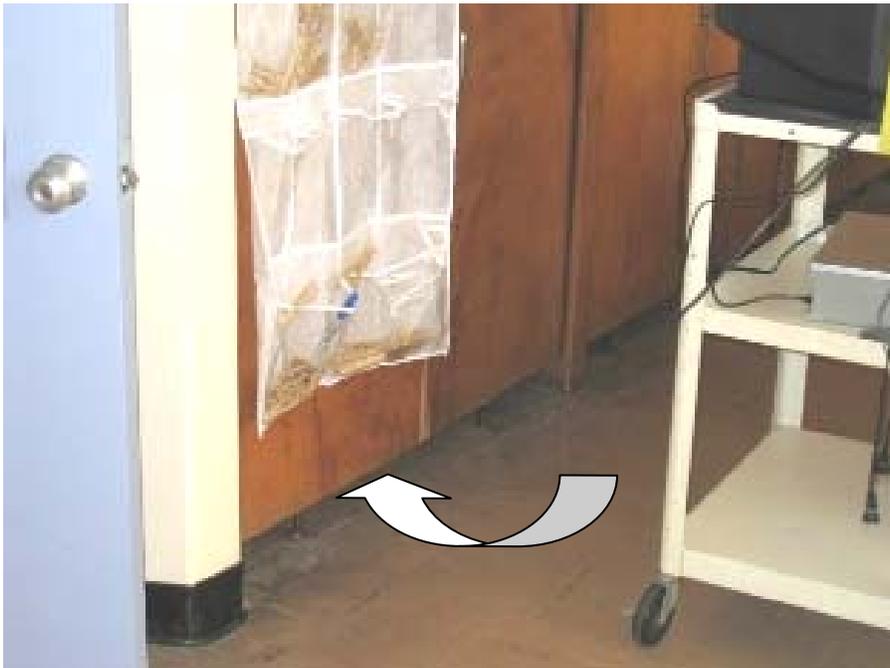
Picture 6

Undercut Door which Leads to Exhaust in Closet

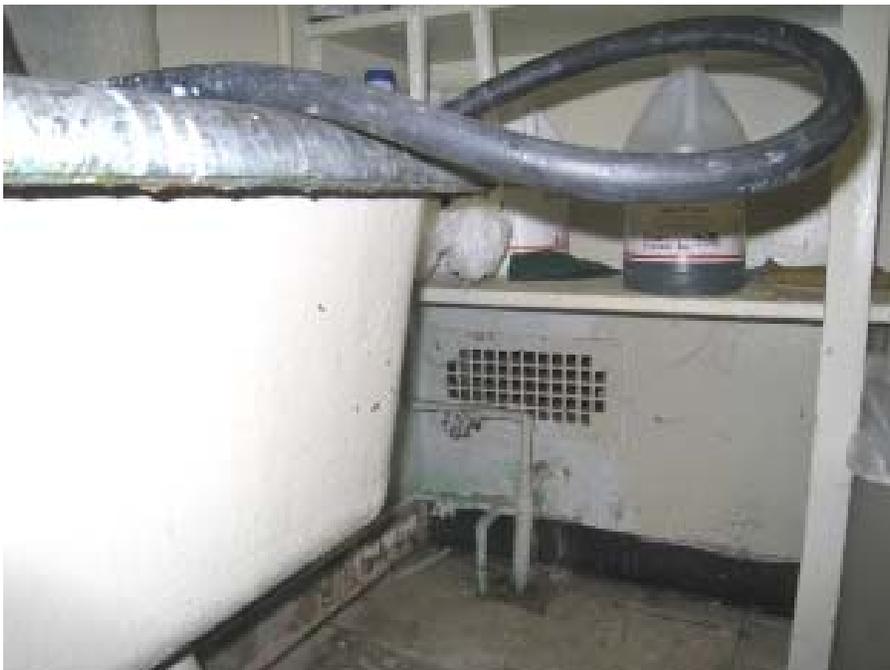
Picture 20

closet had wall mounted vents located in the same wall cavity (Pictures 20 and 21). These vents appeared to be either passive or nonfunctioning on the day of the assessment. Chemical odors and potential VOCs from supplies in the custodial closet as well as sewer gas from a dry drain trap may be migrating through the vents to the Nurse Leader Room.

Vent Observed in Custodial Closet

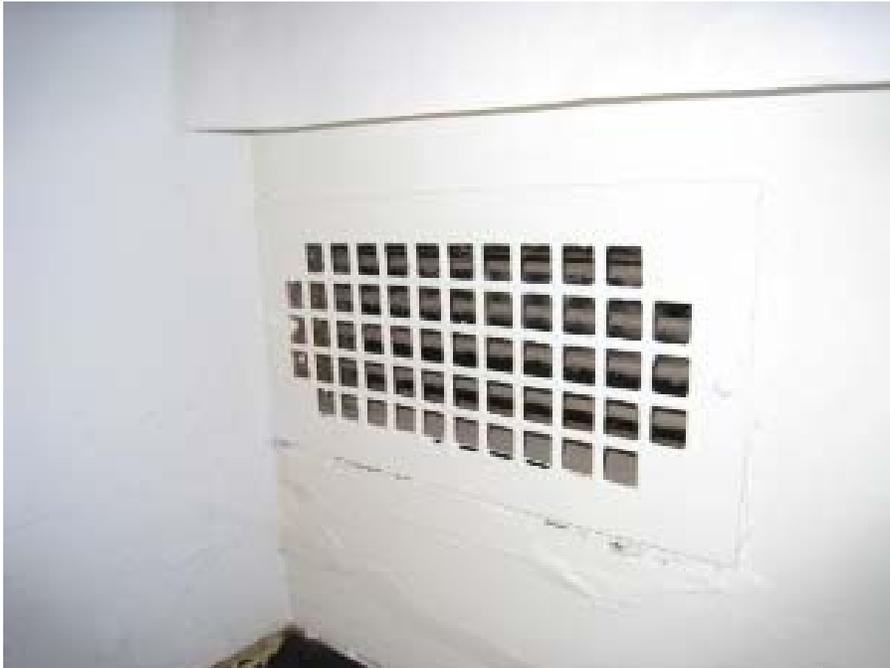
Picture 21

Vent Observed in Nurse Leader Room

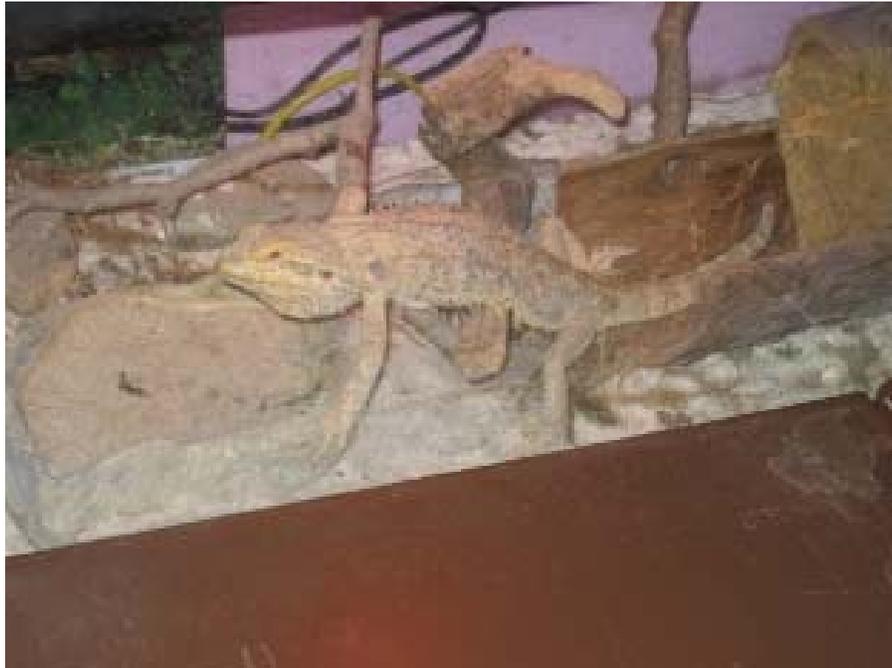
Picture 25

One classroom contained a number of animals such as amphibians and reptiles (Picture 25). Keeping animals in the classroom, while providing educational opportunities, can also result in the spread of communicable disease if appropriate precautions are not in place. Some

Iguana

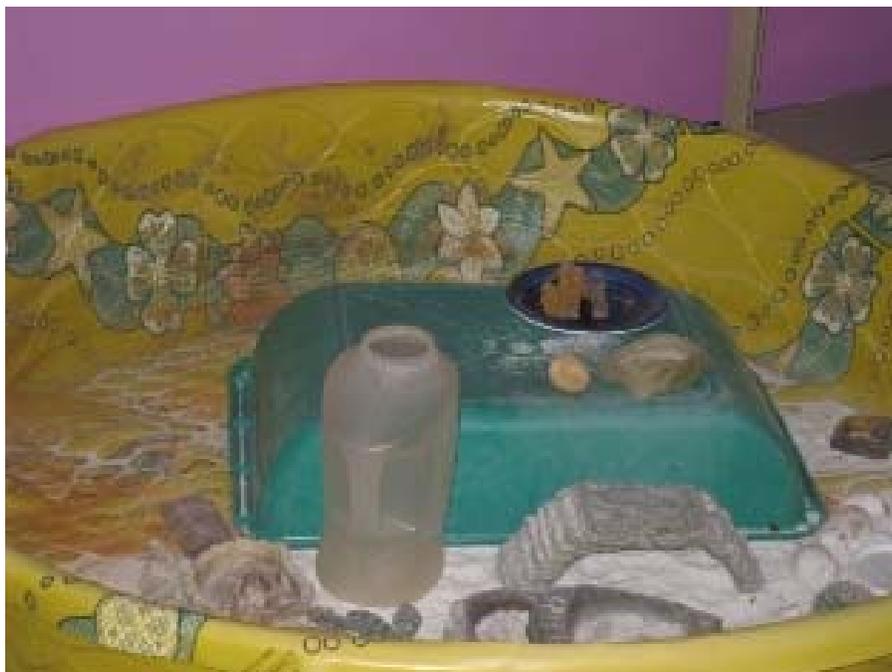
Picture 26

animals should not be kept in facilities in which children under five years of age are attending (MMWR, 2009). A plastic swimming pool appeared to be in use as a place for some of the animals to wander outside of their enclosures (Picture 26). Additionally, no hand washing facility was visible in the room for individuals to utilize after handling the animals. For further information, consult MMWR Guidelines for Animals in School and Child-Care Settings in Appendix C. The same room contained aquariums and terrariums. Aquariums should be properly maintained to prevent microbial/algae growth, which can emit unpleasant odors. Similarly, terrariums should be properly maintained to ensure soil does not become a source for mold growth.

Plastic Sandbox in Room, Presumably Used by Iguana and Other Animals
