# **INDOOR AIR QUALITY ASSESSMENT**

**Pickering Middle School  
70 Conomo Avenue  
Lynn, Massachusetts**

Prepared by:  
Massachusetts Department of Public Health  
Bureau of Environmental Health  
Indoor Air Quality Program  
June 2010

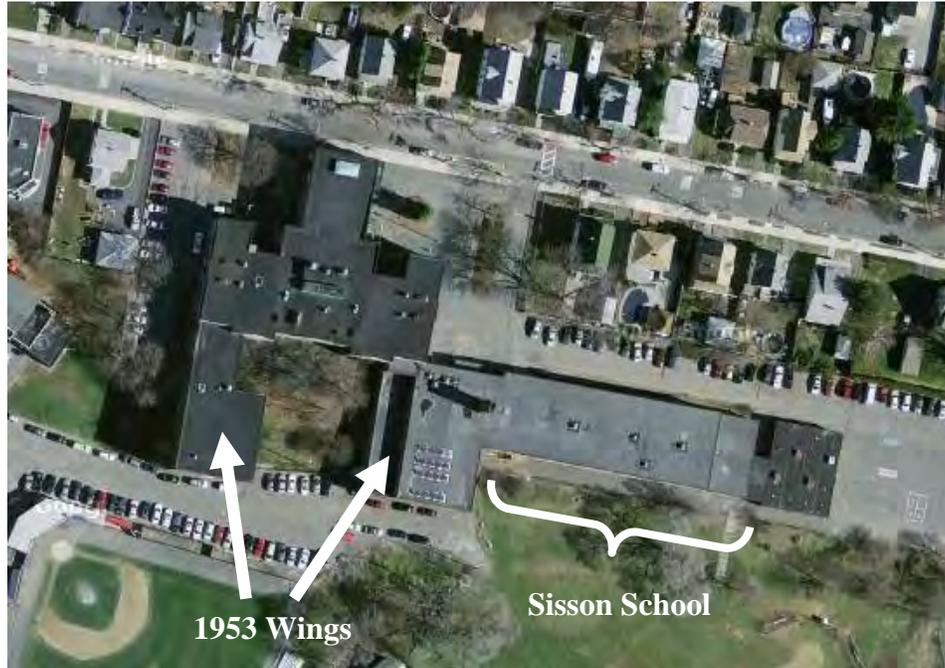
**Picture 1**

The school is a two-story brick building constructed in 1916. Two wings were added to the building in 1953 when the adjacent Sission Elementary School was constructed (Picture 1; Figure 1). Renovations made to the building during the 1970s and 1980s include the conversion of the gymnasium located on the lowest occupied level of the building into six classrooms (A-E). Windows throughout the building are openable.

**Pickering Middle School/Sisson Elementary School Complex**
