INDOOR AIR QUALITY ASSESSMENT MOLD INVESTIGATION

**Executive Office of Health and Human Services
600 Washington Street
Boston, Massachusetts**

Prepared by:
Massachusetts Department of Public Health
Bureau of Environmental Health
Indoor Air Quality Program
February 2011

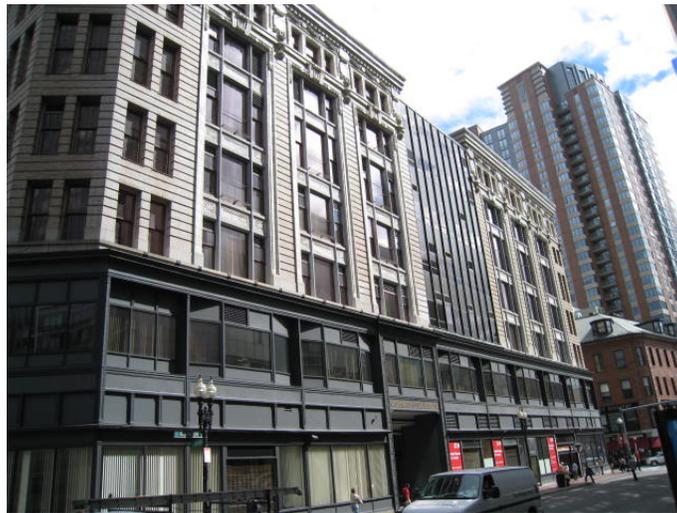
The building was constructed originally in a U-shape design. The building was renovated in the 1970s to fill in the open space, which is behind a metal/glass exterior on the front of the building (Picture 1). The area with the water penetration is directly below the metal/glass exterior wall. The building was retrofitted into office space with the installation of an HVAC system above the suspended ceiling. With the exception of the rear of the building, windows in the EOHHS space do not open.

**Exterior Metal/Glass Wall Installed above 2nd Floor Offices
Experiencing Water-Damaged Ceiling Tiles**

1. Examine the exterior wall assembly above the second floor offices with water damaged ceiling tiles and repair damaged caulking/sealant. Any re-caulking work should be done when the building is not occupied and measures need to be taken to reduce/minimize building occupant exposure to caulking odors.
