INDOOR AIR QUALITY ASSESSMENT

**Commonwealth of Massachusetts
Department of Transitional Assistance
21 Spring Street
Taunton, MA**

Prepared by:
Massachusetts Department of Public Health
Bureau of Environmental Health
Indoor Air Quality Program
March 2014

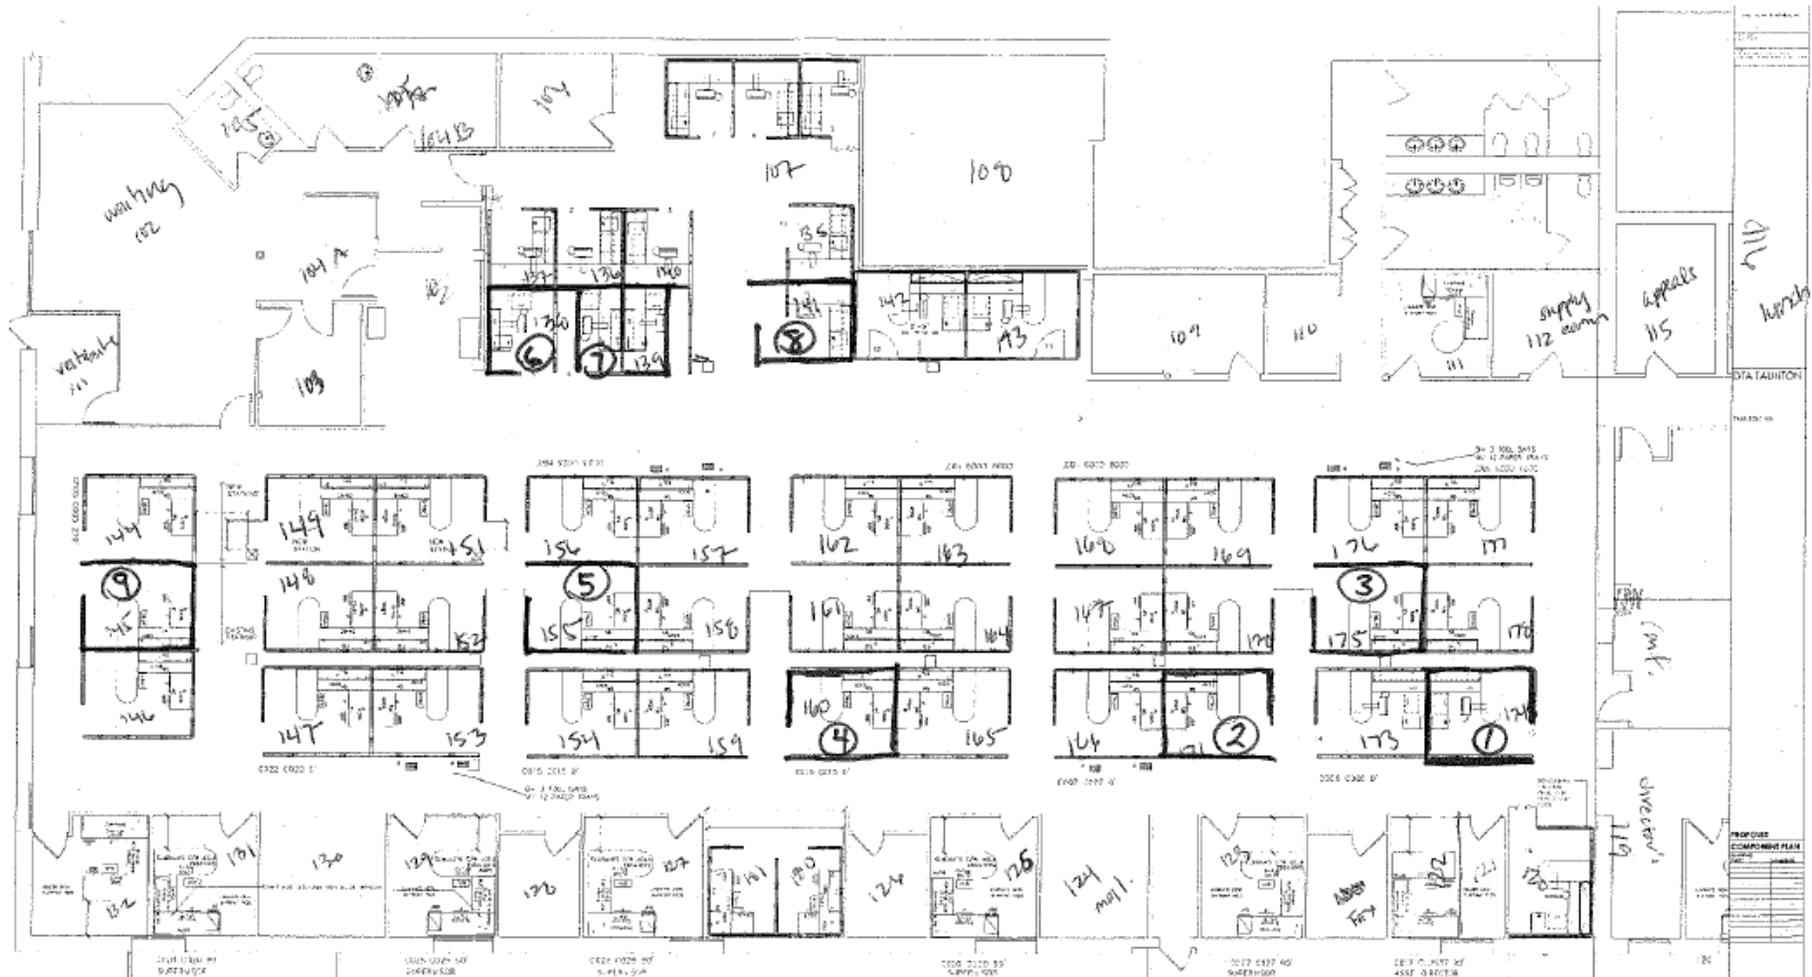
Picture 1

The DTA has an employee population of approximately 50 with up to 70 members of the public conducting business at the office daily. Test results appear in Table 1 and are listed by numerical designation on the floor plan attached as Picture 1. Windows are not openable in the DTA space.

Floor Plan, Taunton Area DTA 21 Spring Street

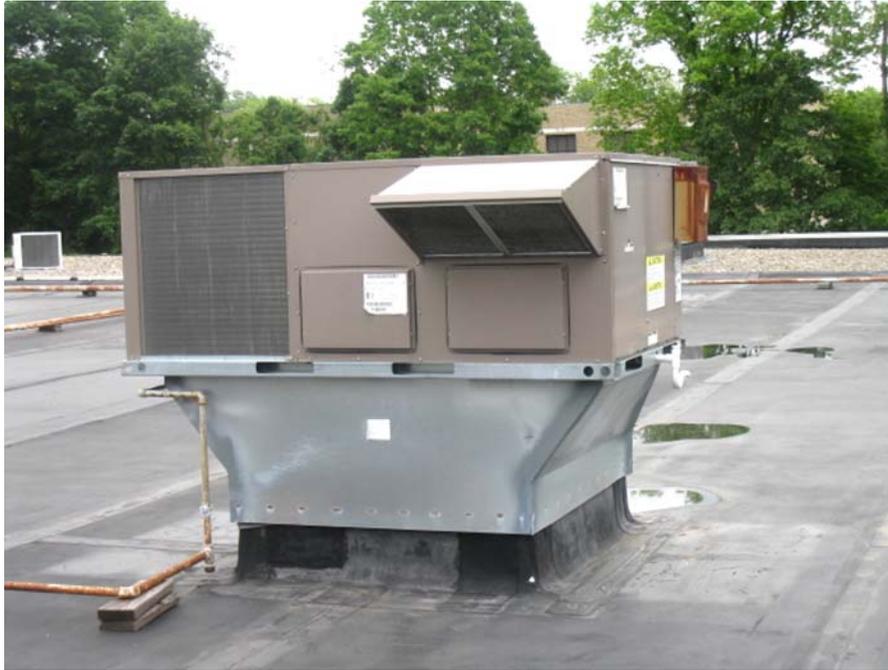
Picture 2

Fresh air is provided by rooftop air-handling units (AHUs; Picture 2). Fresh air is drawn into the AHUs through a bank of high efficiency pleated air filters, heated or cooled, and delivered to occupied areas via ducted air diffusers (Picture 3). Return air is drawn into ceiling or wall-mounted vents and ducted back to the rooftop AHUs (Picture 4). It was noted that there

Example of rooftop air handling unit

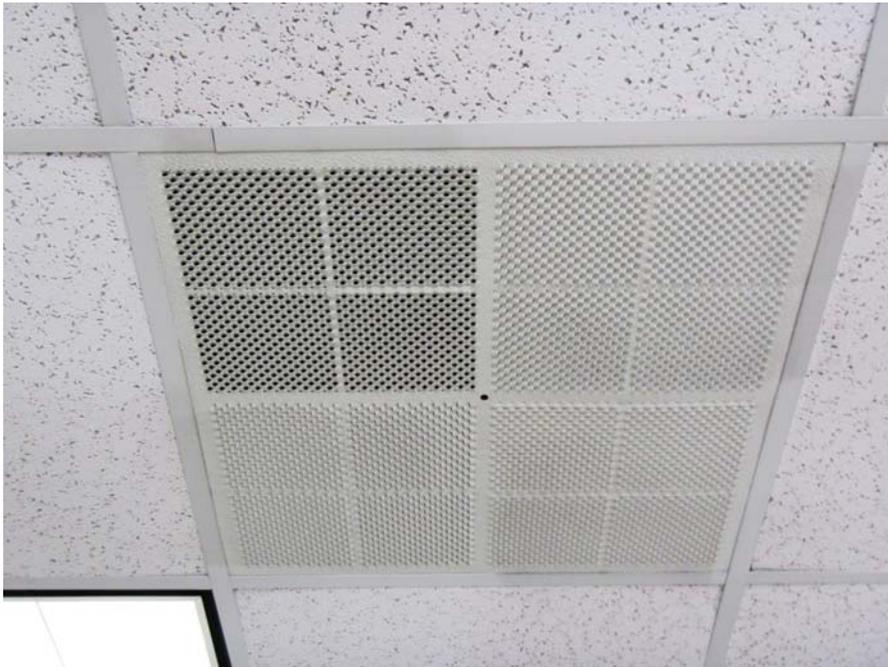
Picture 3

Ceiling-mounted air diffuser

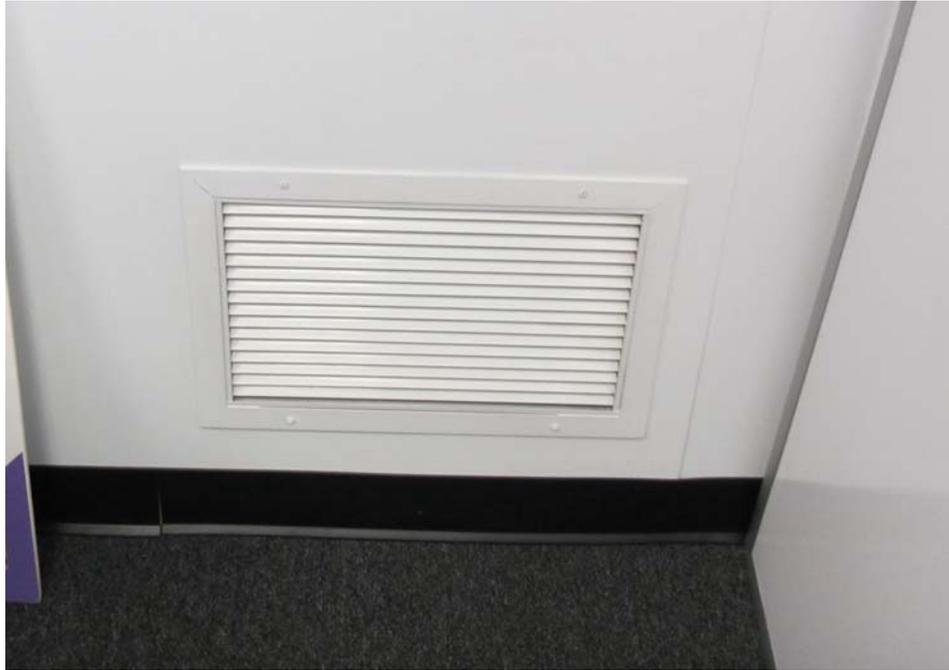
Picture 4

Wall-mounted return vent

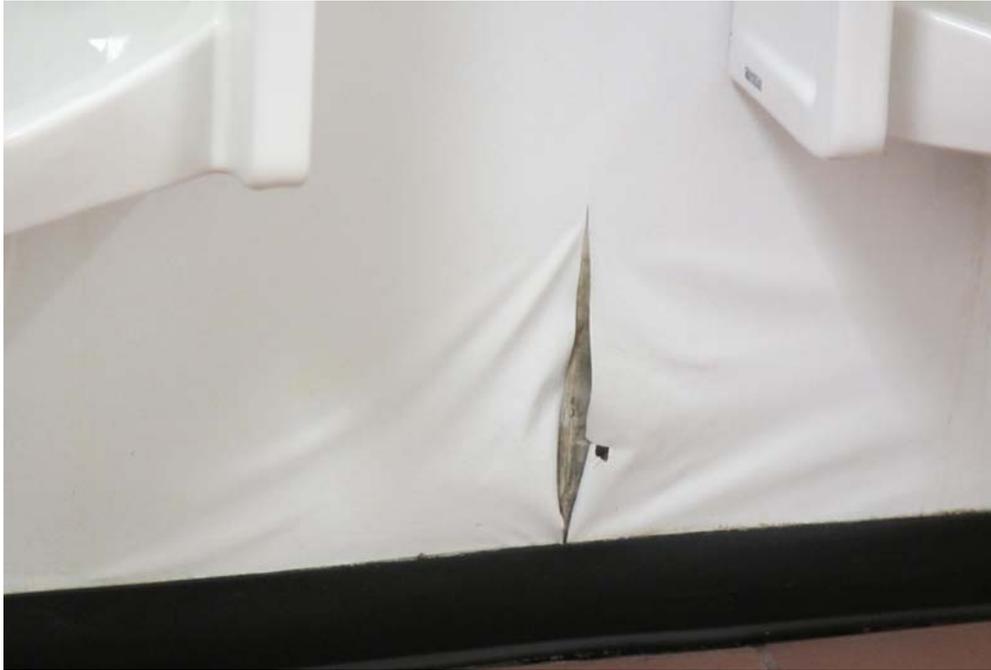
Picture 12

Visible mold growth from chronic moisture exposure was observed in both the men's and women's employee restrooms. Walls in these areas, as well as other perimeter walls throughout the space (e.g. Area Director's office), consist of gypsum wallboard (GW) panels sealed with vinyl wallpaper (Picture 12). BEH/IAQ staff peeled back the material in several areas along the restroom floor near water sources (e.g., toilets, pipes) and found GW water-damaged and colonized with mold (Pictures 13 through 15). Since GW is a porous material prone to mold growth, use of it along restroom walls that can experience repeated moisture exposure is not recommended. Since the vinyl covering serves as an impermeable barrier, the GW cannot dry; moisture trapped behind the vinyl wallpaper can result in further damage.

Vinyl covered wall panels
