INDOOR AIR QUALITY ASSESSMENT ODOR INVESTIGATION

**North Shore Community College
Health Professions Building
Danvers Campus
1 Ferncroft Road
Danvers, Massachusetts**

Prepared by:
Massachusetts Department of Public Health
Bureau of Environmental Health
Indoor Air Quality Program
May 2015

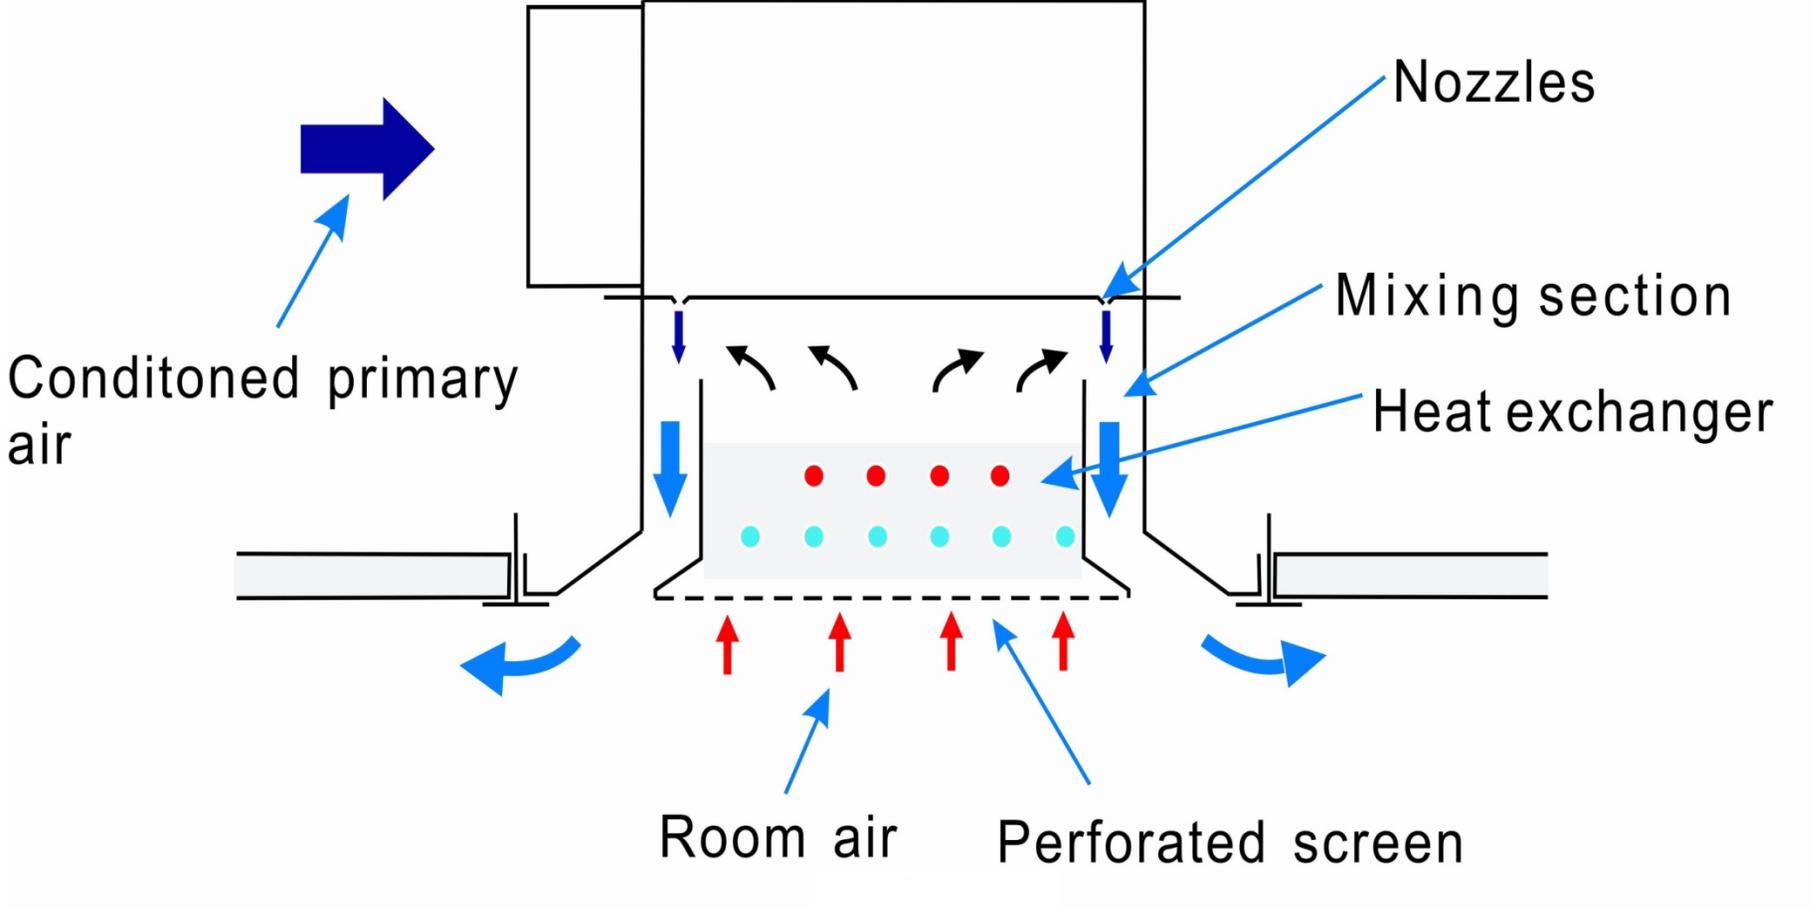
Figure 1
Configuration of an Active Chilled Beam

It can be seen from Table 1 that carbon dioxide levels were below 800 parts per million (ppm) in all areas tested indicating adequate air exchange at the time of the assessment. Fresh air for the third floor of the HPSSB building is provided by an air handling unit (AHU) via ducted vents connected to active chilled beam units throughout the space. Active chilled beam units have an internal water coil over which supply and room air passes to further condition the air within a space. Supply air is ejected through nozzles and out of the side chamber vents thereby

creating low pressure which draws in mixed room air through the coil/heat exchanger (Figure 1, Pictures 1 to 3).

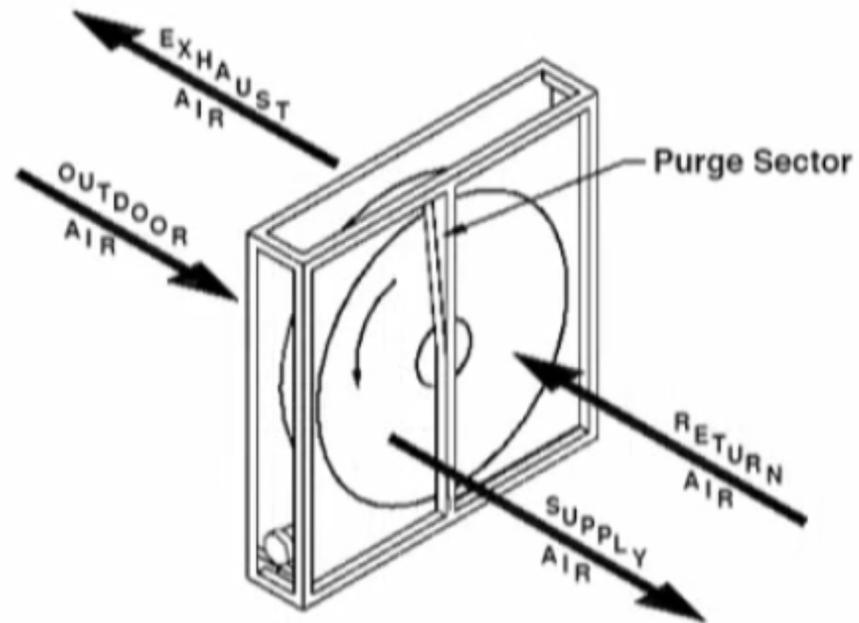
Figure 2
Energy Recovery/Desiccant Wheel

As previously mentioned, exhaust air from high humidity sources such as bathrooms and kitchen areas may undermine the ability of the AHU to control humidity in occupied spaces since this humid air is used in a heat recovery/desiccant wheel where supply air is also introduced. This configuration could contribute to condensation issues and associated odors at the chilled beam units. A heat recovery/desiccant wheel is designed to remove moisture from incoming humid outside air and recover heat or cooling energy from exhausted air (Figure 2). According to the manufacturer of the heat recovery/desiccant wheel, when the exhaust air stream is more humid than the supply air stream, the wheel may transfer that moisture to the supply side of the air stream. The manufacturer also states that routine maintenance, inspection, and cleaning of the wheel are required. This maintenance should include inspecting the seals on the wheel especially where they divide the supply air from the exhaust air streams to minimize water vapor intrusion (Rotorsource, 2005). It may also be prudent to inspect the main supply side air ducts for any debris and signs of chronic moisture which could foster the growth of mold in the ducts. The inspection of the exhaust air connectivity to the AHU should be performed by a qualified third party HVAC contractor with proven experience in this technology to ensure proper configuration and settings.
