# **INDOOR AIR QUALITY ASSESSMENT WATER DAMAGE INVESTIGATION**

**Henry B. Burkland Intermediate School  
41 Mayflower Avenue  
Middleborough, Massachusetts**

Prepared by:  
Massachusetts Department of Public Health  
Bureau of Environmental Health  
Indoor Air Quality Program  
January 2015

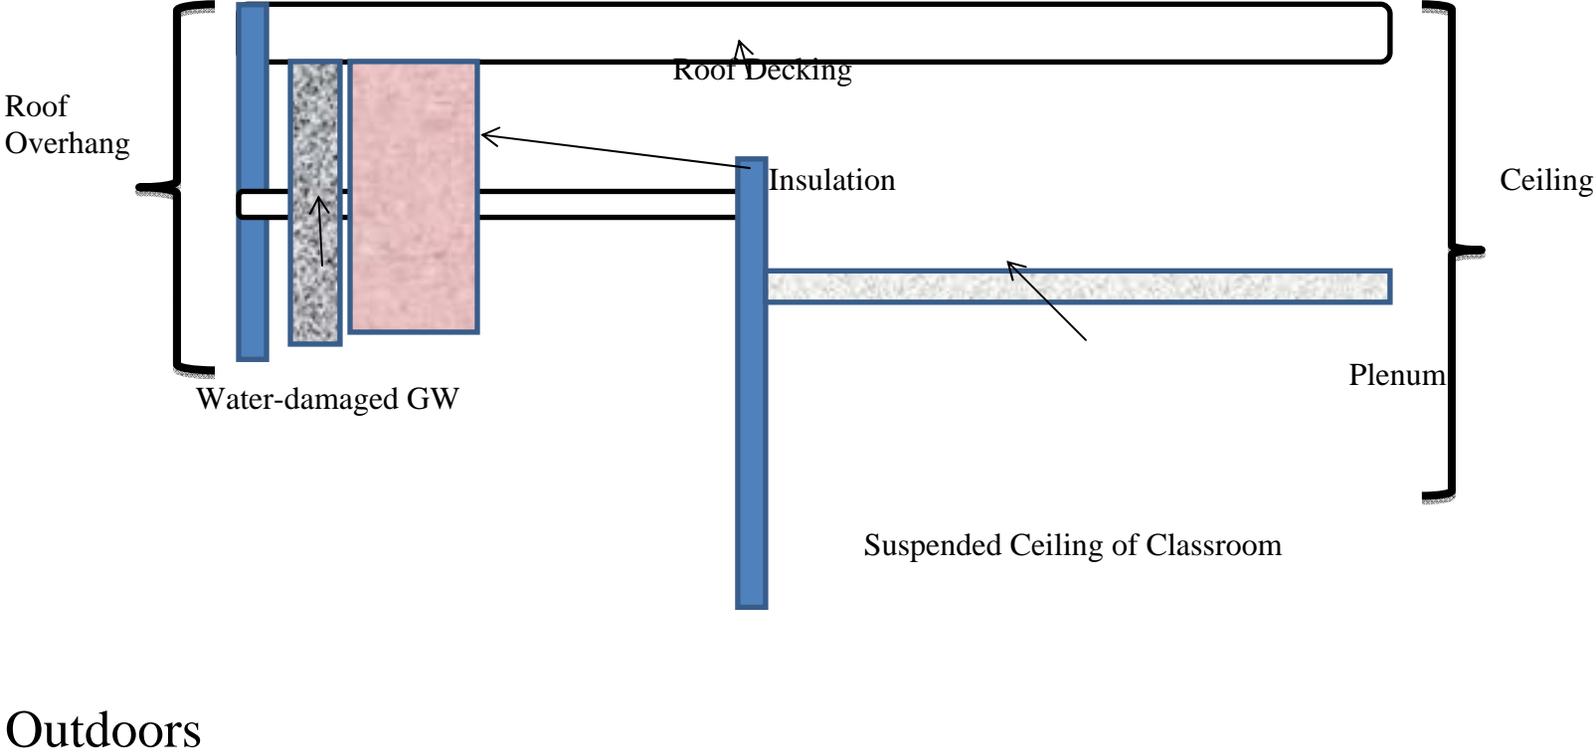
**Figure 1**  
**Schematic of the Ceiling Plenum Components**  
**(Not to scale)**

It is noteworthy that the insulation surfaces that face into the ceiling plenum do not appear to be water-damaged. Also of note is the structure of the heating ventilating and air-conditioning (HVAC) system in the building. The space between the roof deck and suspended ceiling plenum is not part of the HVAC system and therefore should not be subject to air movement that would result in aerosolization of microbes or spores from water damaged materials. The combination of the covering of the water-damaged materials and neutral air pressure within the ceiling plenum would limit the opportunity for microbes and associated particles to enter into classrooms below the suspended ceiling.
