INDOOR AIR QUALITY ASSESSMENT

**Goodell Hall
University of Massachusetts
140 Hicks Way
Amherst, Massachusetts**

Prepared by:
Massachusetts Department of Public Health
Bureau of Environmental Health Assessment
February 2010

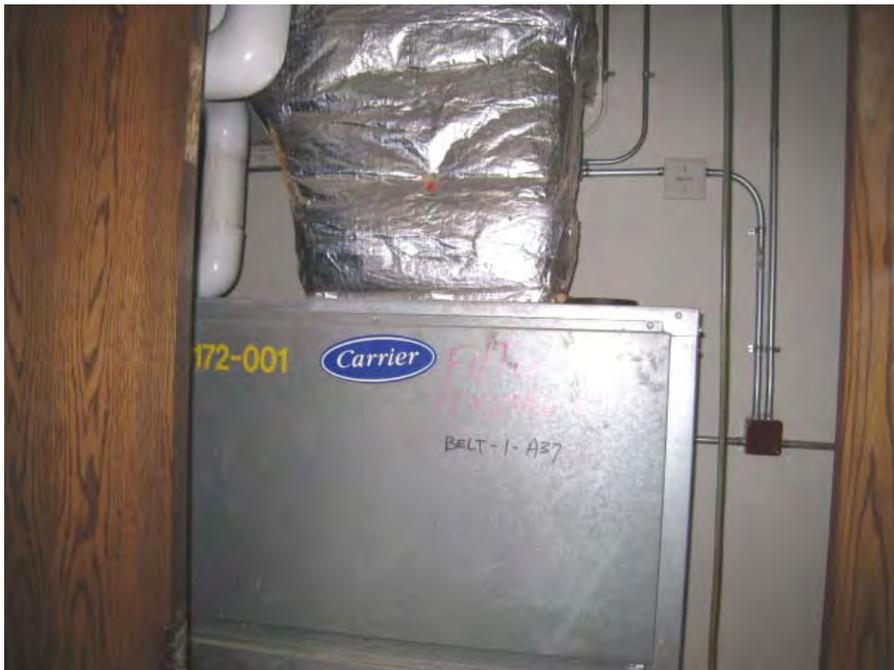
Picture 2

AHUs in Closets

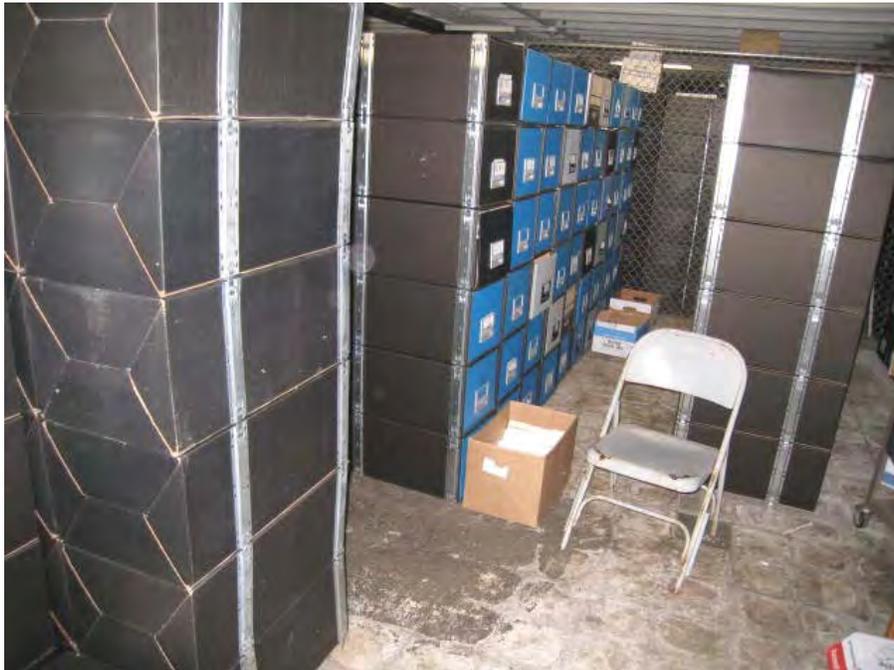
Picture 3

The lowest level of the building is used for record storage. This area has been subdivided using cyclone fencing, which allows for free air movement. A large number of paper records are stored in this area in filing cabinets constructed of heavy cardboard (Picture 3). A distinct, pungent odor of moistened cardboard was detected in this space. Located in this area are a fresh air supply and return vent that are likely connected to the general HVAC system (Picture 4). Odors from the stored materials in the lower level can be captured by the HVAC system and distributed into other areas of the building.

Records Stored In Basement

A decision should be made concerning the water-damaged and in some cases likely mold-contaminated materials stored in the basement. If not addressed, these boxes, documents, books and other stored materials will continue to be a source of mold associated particulates. Under current conditions, ventilation alone cannot serve to reduce or eliminate mold growth in these materials. As an initial step, options concerning the preservation of materials stored in this area should be considered. Since many of the materials appear to be of historical significance, an evaluation concerning disposition of them must be made. Porous materials that are judged not worthy of preservation, restoration or transfer to another media (e.g., microfiche or computer scanning) should be discarded. Where stored materials are to be preserved, restored or otherwise handled, an evaluation should be done by a professional book/records conservator. This process can be rather expensive and should be considered for conservation of irreplaceable documents that are colonized with mold. Due to the cost of book conservation, disposal or replacement of

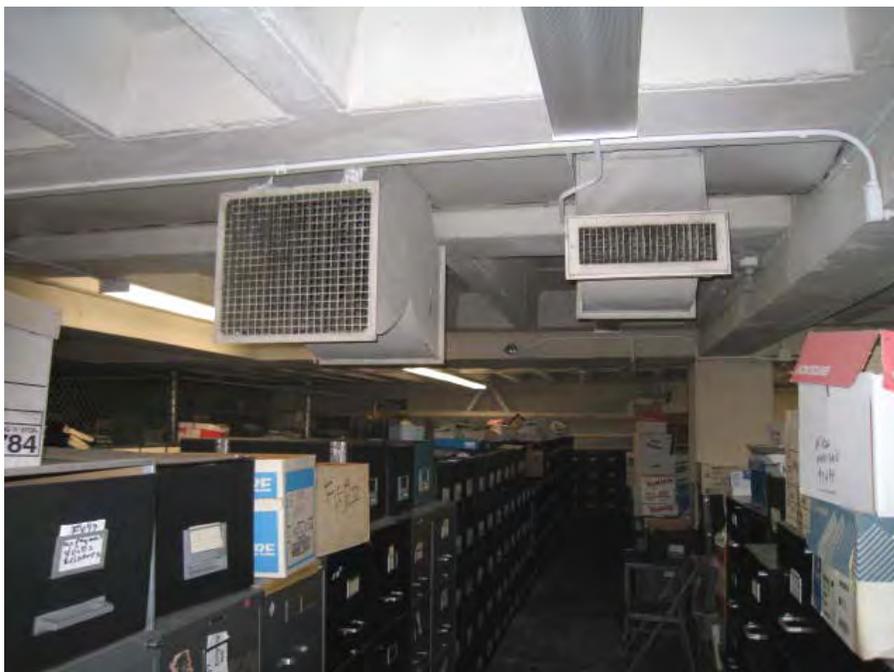
Picture 4

Fresh Air Supply And Return Vent In Records Storage Area.

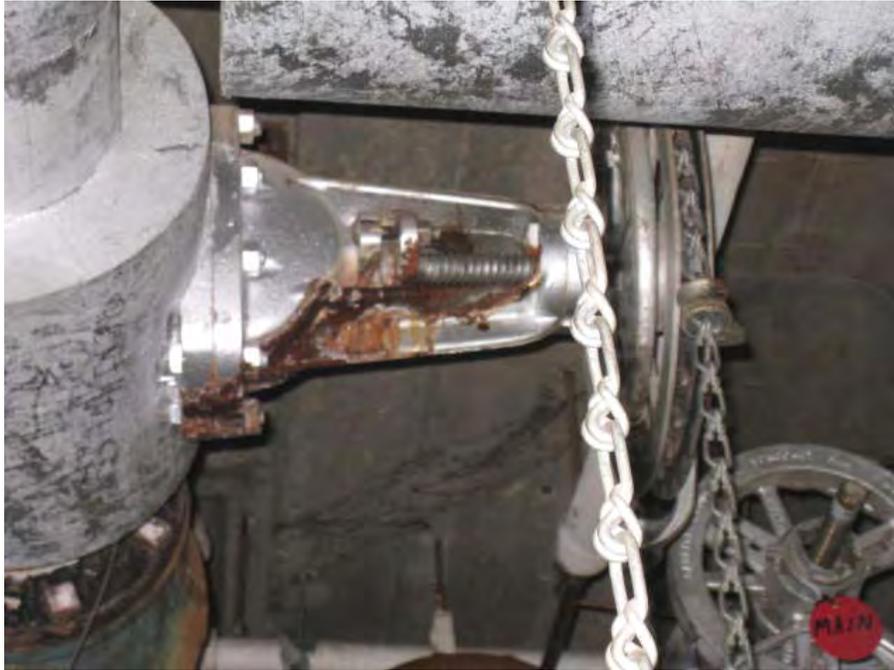
Picture 5

The likely source of moisture in this area is the building's mechanical room, which is located below the records storage room. The building does not contain a furnace. Steam is pumped into this mechanical room via piping from the UMass steam plant. The mechanical room has a number of sources for leaking water and/or steam, including a significant number of pipe breaches (Picture 5) and a sump pump cistern (Picture 6). Of note is the existence of a fan system (EB8) that appears to be an exhaust ventilation system dedicated to removing water vapor and air from the mechanical room. At the time of the IAQ assessment, this fan was found deactivated, likely due to its location with its electric exhaust vent motor in a pool of standing water (Picture 7). Without mechanical exhaust ventilation, water vapor can migrate from the mechanical room to the records storage room above.

Pipe Breach

1. Repair sources of leaking water and steam in the building's mechanical room. Eliminate sources of pooled water on the mechanical room floor.
2. Repair exhaust fan (EB8) located in the mechanical room to ensure that water vapor and air will once again be removed from the mechanical room.

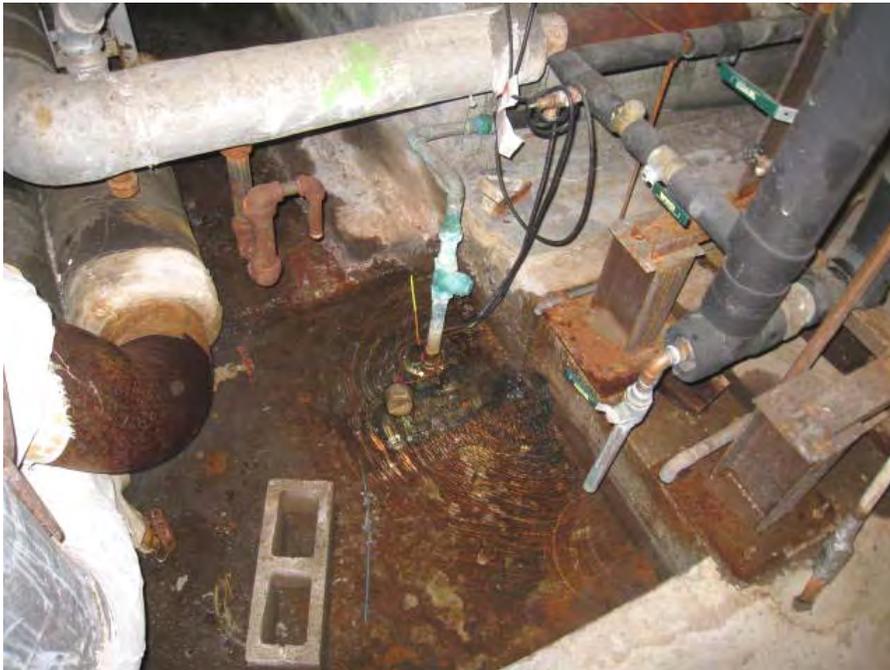
Picture 6

Sump Pump Pit Filled With Water

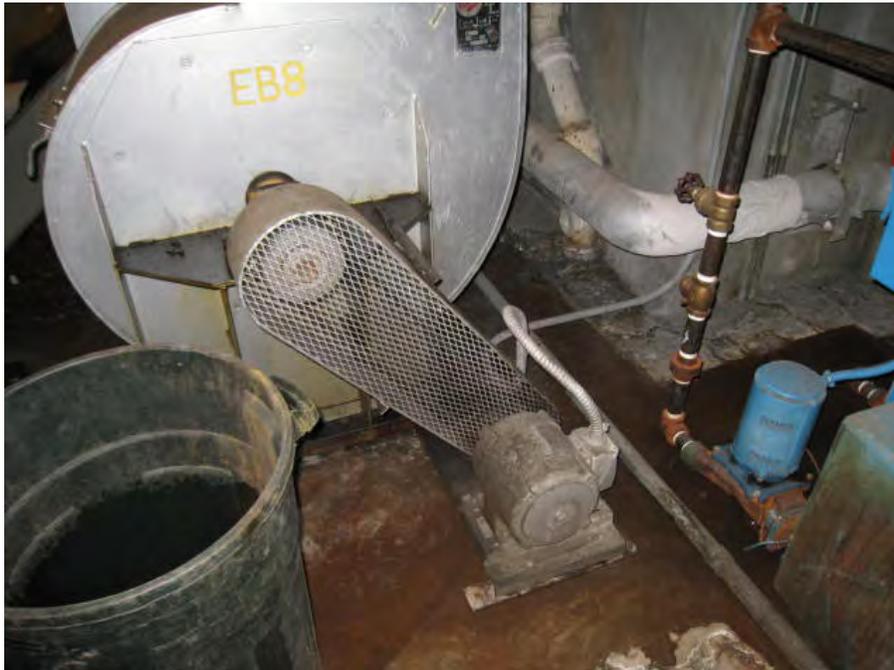
Picture 7

EB8 Exhaust Vent Motor in Standing Water

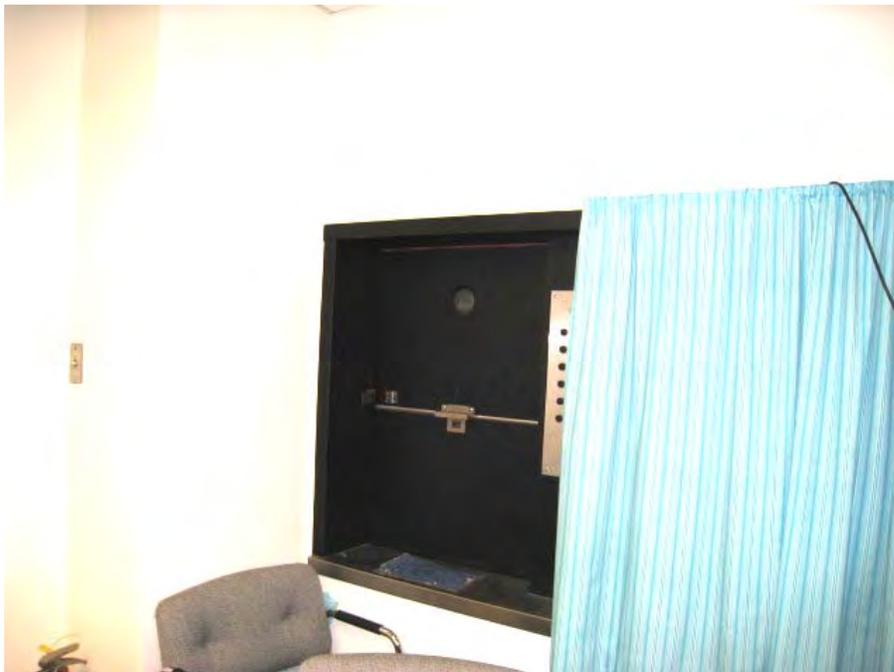
Picture 8

Several conditions observed in the building indicate that water vapor and pollutants are migrating from the records storage area to occupied areas. Air may be drawn up the elevator shafts to upper floors. In addition, the building contains a number of abandoned dumbwaiters (Picture 8), which can allow for basement air to migrate to occupied spaces on upper floors. The following concepts concerning heated air and elevators/dumbwaiters should be understood in order to explain how basement air may be impacting the upper floors:

Abandoned Dumbwaiter Door on Upper Level of Building

3. Consider permanently sealing off dumbwaiters to eliminate pathways for movement of odors, particulate matter, etc to each floor.
4. Ensure leaks are repaired and replace water damaged ceiling tiles. Examine the area above and around these areas for mold growth. Disinfect areas of water leaks with an appropriate antimicrobial.

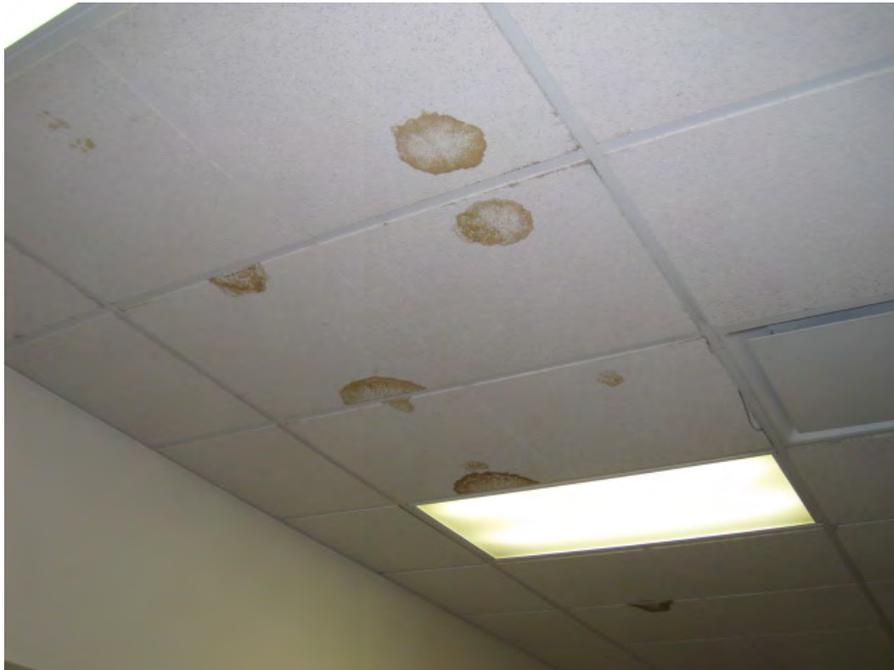
Picture 9

Water-damaged ceiling tiles were observed throughout the building (Picture 9). In some areas, water damage to ceilings and walls has caused large areas to exhibit peeling paint. Water-damaged walls and ceilings are an indication of leakage in the building, most likely from the roof. The roof should be examined and repaired/replaced to prevent additional leaks and damage to the building. Water-damaged materials should be repaired or replaced.

Water Damaged Ceiling Tiles

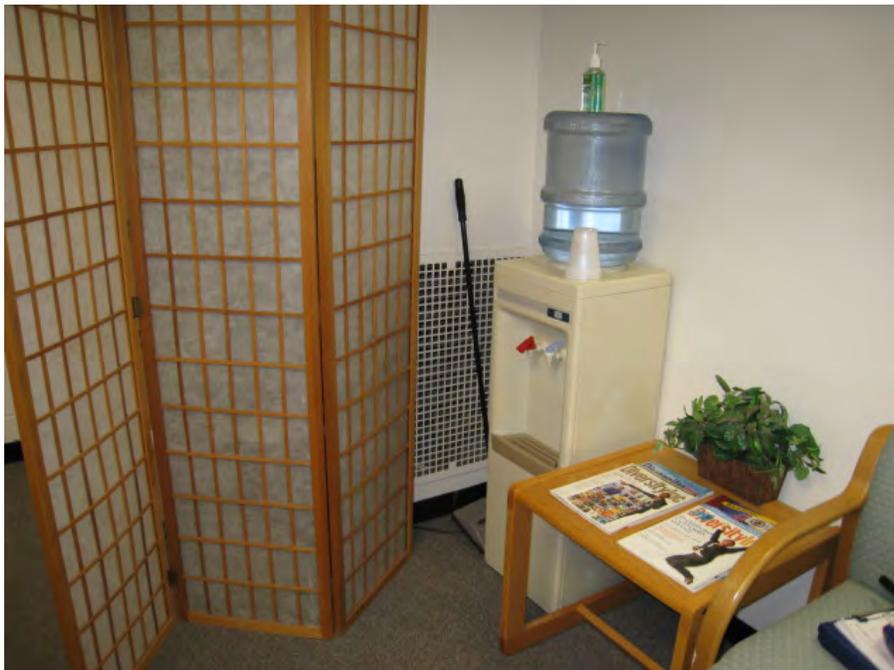
Picture 10

Water coolers were observed located over carpeted areas (Picture 10). Overflow of the water basins or spills that often occur can moisten carpeting, which can lead to mold growth. It is important that the catch basin of a water cooler be cleaned regularly as stagnant water can be a source of odors, and materials (i.e., dust) collected in the water can provide a medium for mold growth.

Water Coolers over Carpeting

5. Place water coolers located in carpeted areas on surfaces that are impervious to water, such as a rubber mat. Clean catch basins regularly.
6. Consider eliminating the practice of placing plants directly onto carpeted areas. Examine drip pans periodically for mold growth. Disinfect with an appropriate antimicrobial where necessary. In addition, plants should be located away from the air stream of ventilation sources to prevent aerosolization of mold, pollen and particulate matter.

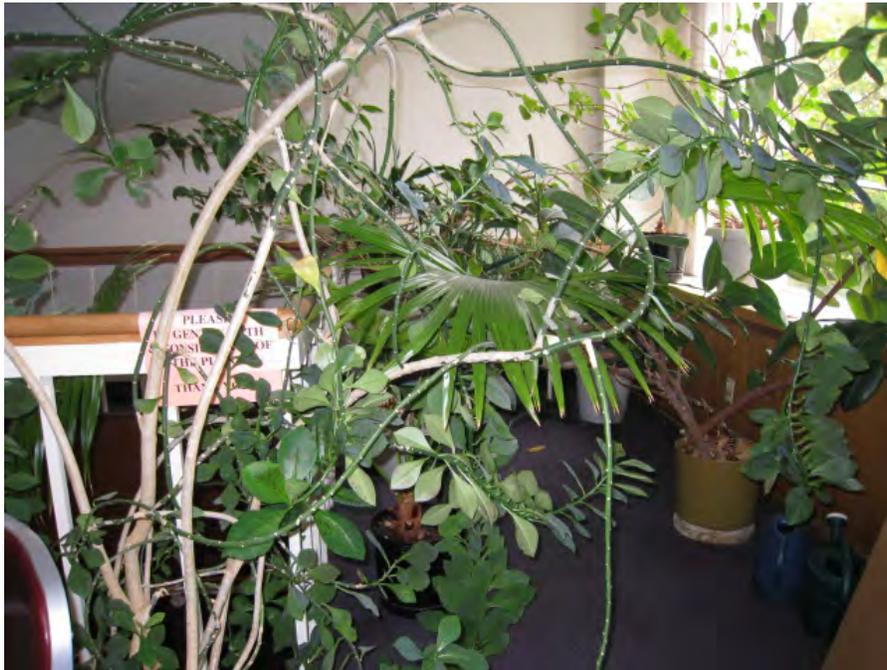
Picture 11

Several areas contained a number of plants, many of which were located on carpeting (Picture 11). Plant soil, standing water and drip pans can be a potential source of mold growth. Drip pans should be inspected periodically for mold growth and over watering should be avoided. Plants should also be located away from fresh air diffusers to prevent aerosolization of dirt, pollen or mold.

Plants on Carpeting

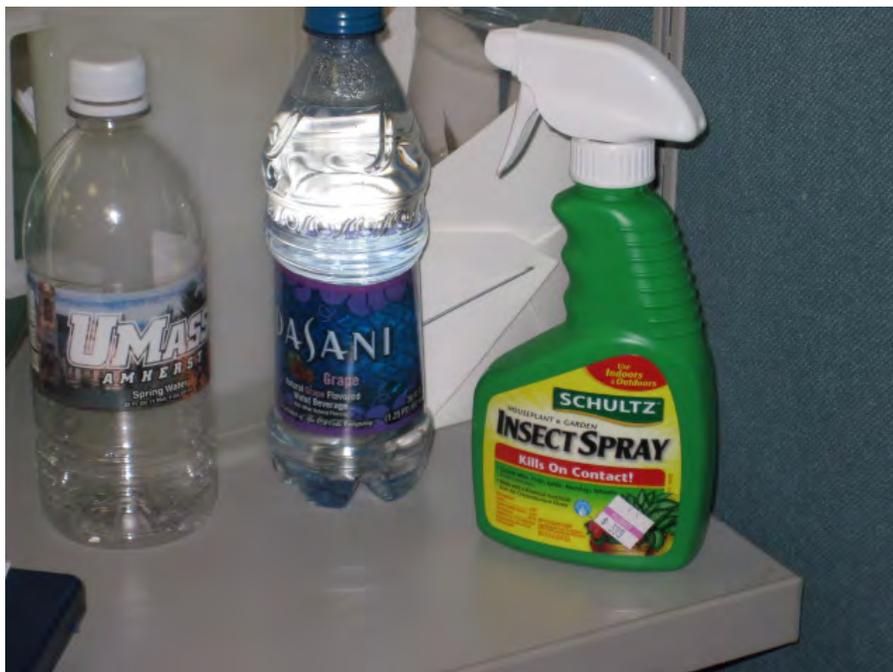
Picture 12

Insect spray was observed in one office (Picture 12). Pesticide use indoors can introduce chemicals into the indoor environment that can be sources of eye, nose and throat irritation. The principles of integrated pest management (IPM) should be considered to remove pests in buildings.

Insect Spray

- 9. Consider discontinuing use of air deodorizers and insect sprays within the building.
 - 10. Discontinue practice of obstructing ventilation components, both supply and exhaust vents. Once the system is properly balanced, air flow within the occupied space should meet comfort parameters for the majority of occupants. Consider having the systems balanced by an HVAC engineering firm every five years.

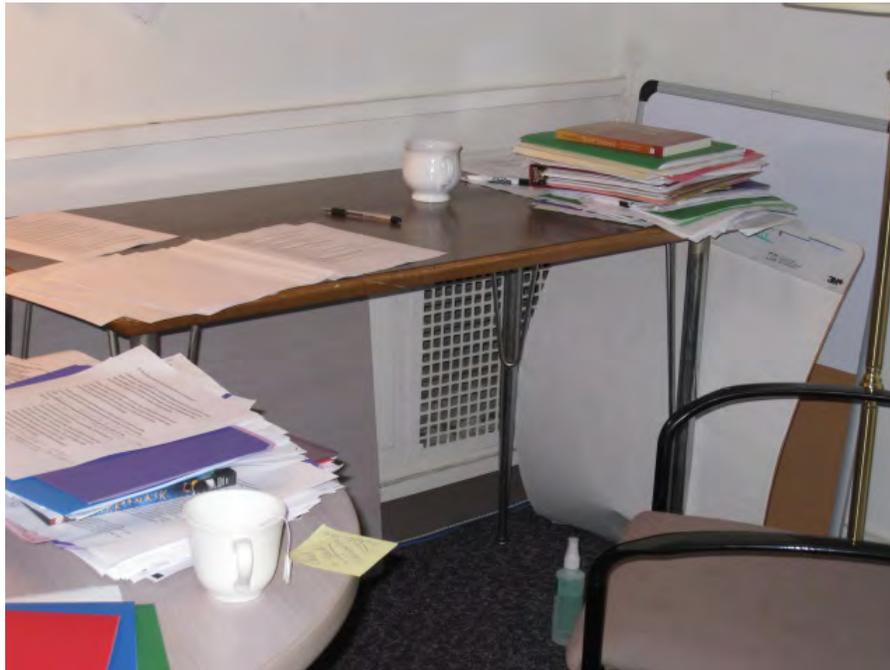
Picture 13

Several other conditions that can affect indoor air quality were noted during the assessment. Numerous exhaust vents were obstructed throughout the building by bookcases, desks, computers, as well as by materials stored on shelving (Picture 13). Occupants of the building have attempted to adjust the air flow within their space by obstructing the air diffusers in an effort to either reduce the volume of air or divert the direction of air as it enters the room (Picture 14). Additional obstructions to airflow in the building are the numerous partitions that have been installed within the building. These alterations can create an imbalance in the system, resulting in uneven heating/cooling conditions leading to occupant discomfort in other areas. A few occupants expressed concerns to BEH staff regarding black particulate matter observed within their offices. As airflow passes over the horizontal surfaces covering many air diffusers, dust which may have settled on the surface could easily become aerosolized within the occupied space. Once aerosolized, the particulates will eventually settle on horizontal surfaces below.

Blocked Air Vent

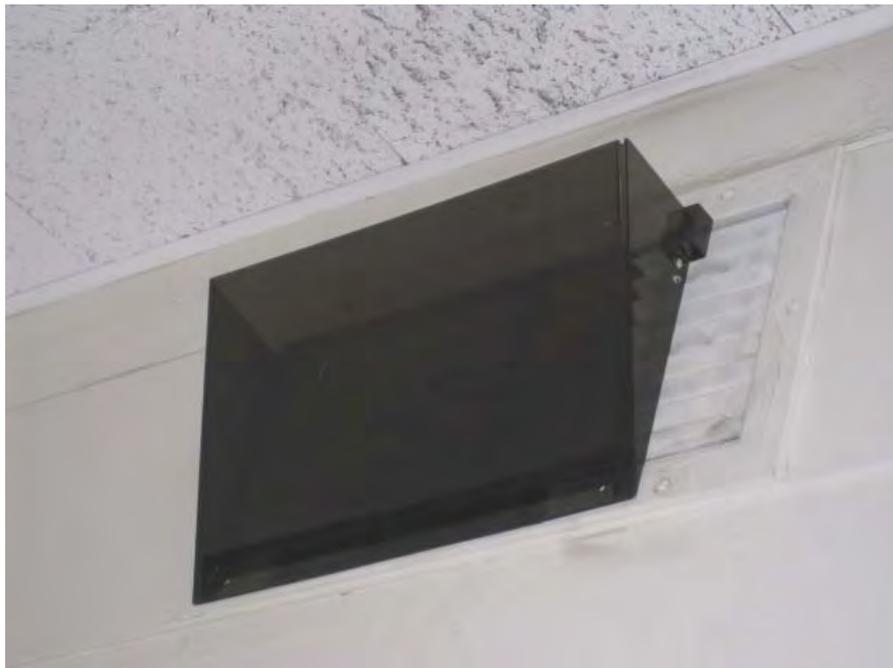
Picture 14

Vent Covered With Cardboard.

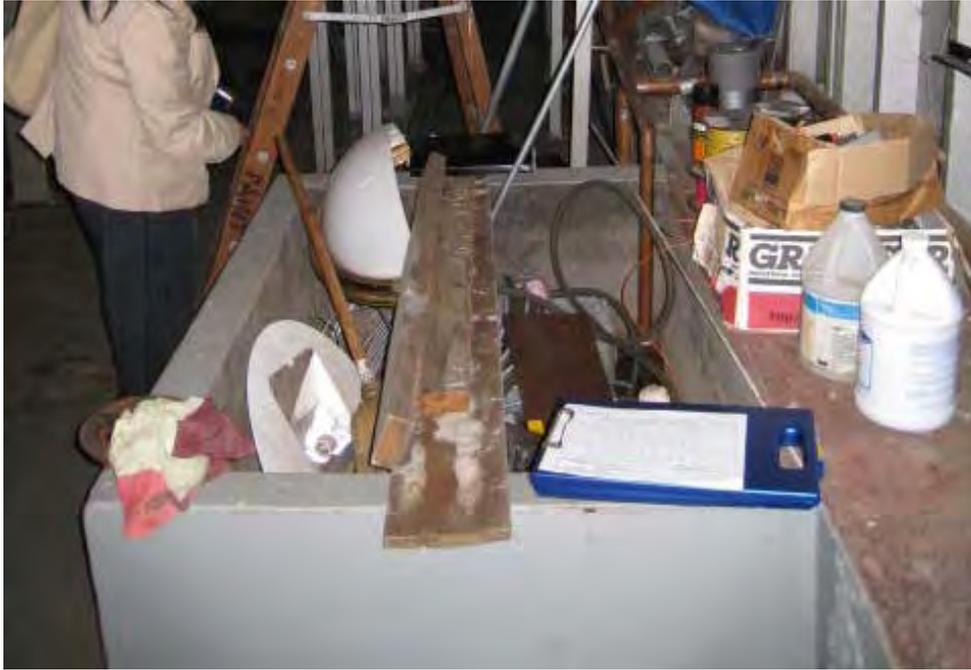
Picture 15

The HVAC system penthouse contained a large tub-like structure that was filled with debris (Picture 15). This tub structure also contained a drain. It is likely that the trap for this drain is dry, which could result in odors from the drain system to enter the HVAC mechanical room. Drain system pollutants can be irritating to the eyes, nose and throat.

Tub-Like Structure in the HVAC Penthouse Filled With Debris
