INDOOR AIR QUALITY POST-OCCUPANCY ASSESSMENT

**Commonwealth of Massachusetts
500 Main Street
Hyannis, Massachusetts**

Prepared by:
Massachusetts Department of Public Health
Bureau of Environmental Health
Indoor Air Quality Program
September 2010

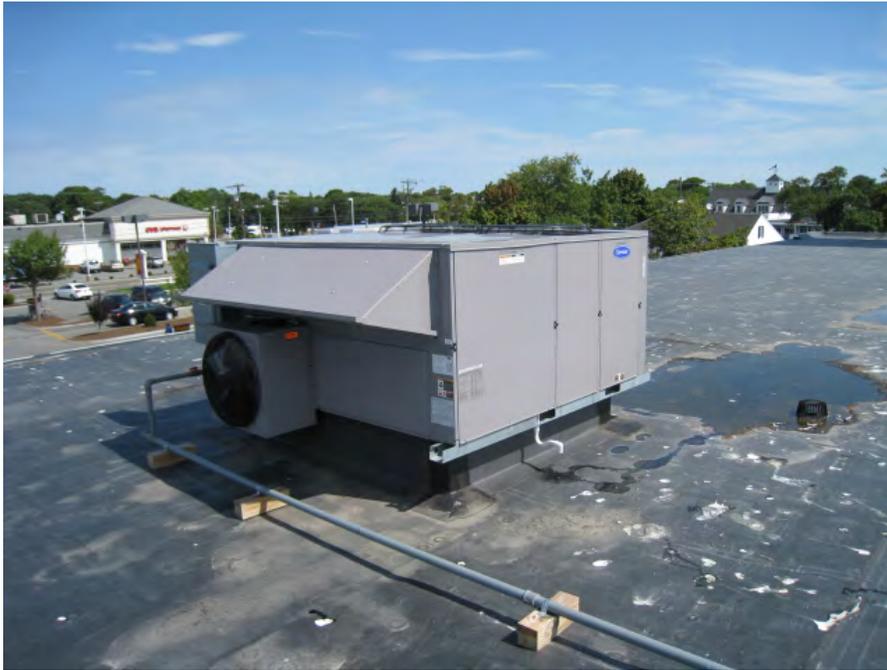
Picture 1

It can be seen from Table 1 that carbon dioxide levels were below 800 parts per million (ppm) in all areas indicating optimal air exchange at the time of testing (Table 1). Fresh air is provided by a rooftop air handling unit (AHU) (Picture 1). Fresh air is drawn into the AHU through a bank of pleated air filters (Picture 2), heated or cooled and delivered to occupied areas via ducted air diffusers (Picture 3). Return air is drawn into an above ceiling plenum and ducted back to the rooftop AHU (Picture 4).

Rooftop Air Handling Unit

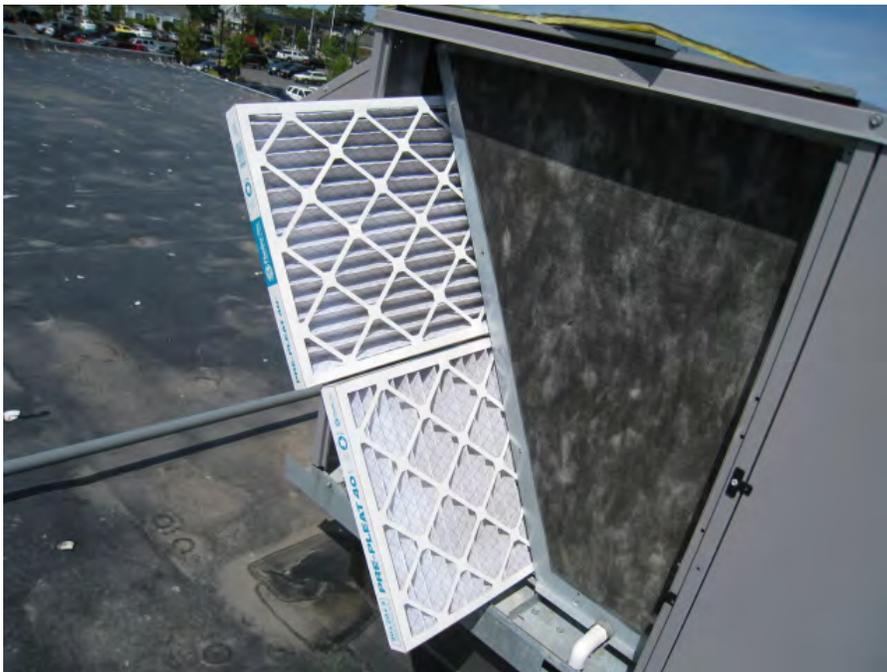
Picture 2

Bank of Pleated Air Filters Installed in Rooftop Air Handling Unit

1. Ensure repairs are made to HVAC unit in DDS area. Replace water-damaged ceiling tiles. Monitor for further leaks. If wetting of ceiling tiles recurs, report to building management for prompt remediation.
2. Change filters for air handling equipment as per the manufacturers' instructions or more frequently if needed.
3. Consider adopting a balancing schedule of every 5 years for all mechanical ventilation systems, as recommended by ventilation industrial standards (SMACNA, 1994).
4. Refer to resource manual and other related indoor air quality documents located on the MDPH's website for further building-wide evaluations and advice on maintaining public buildings. These documents are available at: <http://mass.gov/dph/iaq>.

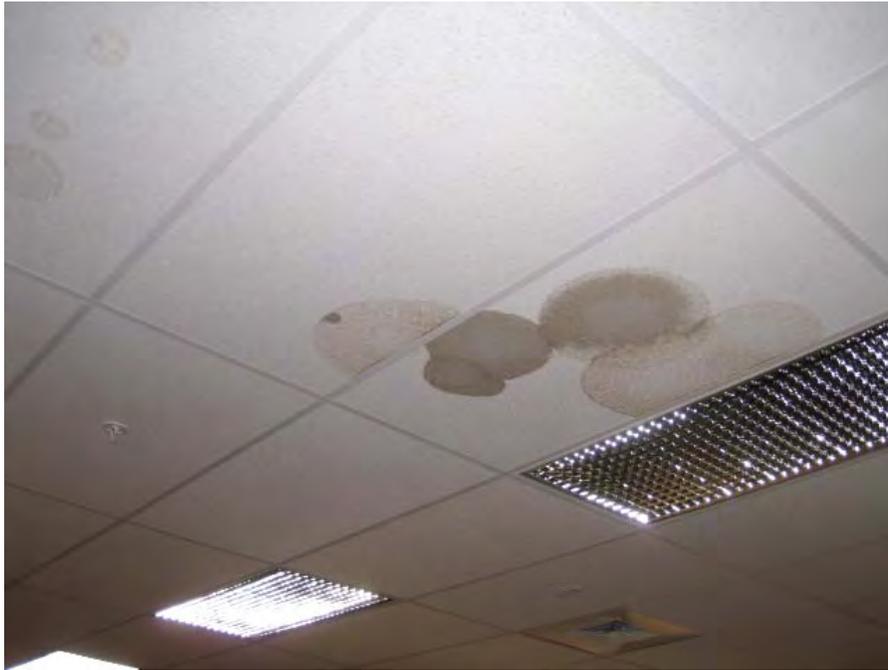
Picture 3

Water-damaged ceiling tiles were observed in the DDS work area, which can indicate leaks from the roof or plumbing system. Building management reported that tiles were damaged due to condensation from the air-conditioning system and that a service call had been placed to their HVAC vendor to investigate. Ceiling tiles should be replaced after a water leak is discovered and repaired.

Water-Damaged Ceiling Tiles in DDS Area
