INDOOR AIR QUALITY ASSESSMENT

**Career Place
Middlesex Community College
TradeCenter
100 Sylvan Road
Woburn, Massachusetts**

Prepared by:
Massachusetts Department of Public Health
Bureau of Environmental Health
Indoor Air Quality Program
June 2011

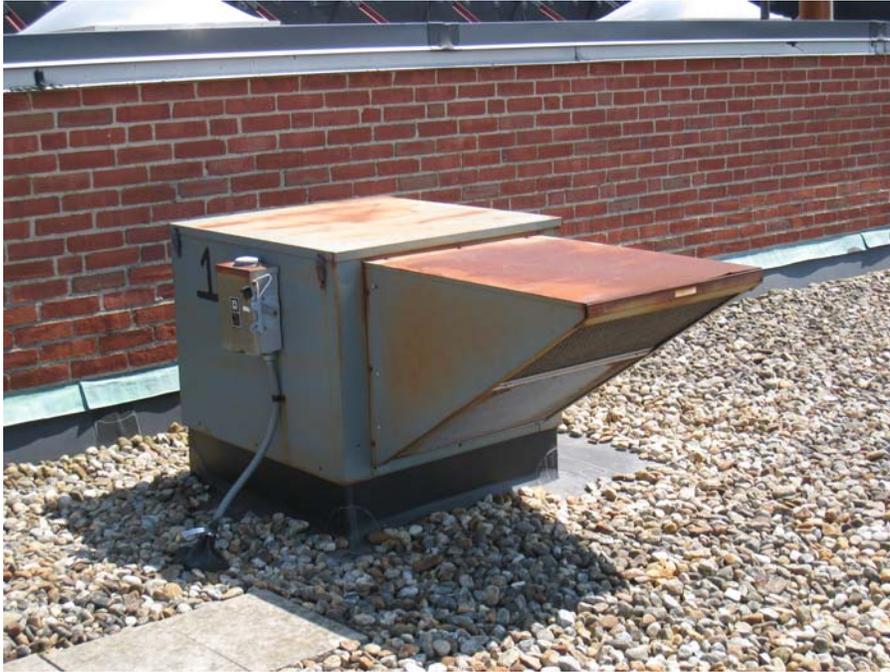
Picture 1

It can be seen from Table 1 that carbon dioxide levels were above 800 parts per million (ppm) in all areas surveyed, indicating a lack of air exchange at the time of the assessment. Fresh air ducted into the ceiling plenum via an air intake located on the buildings roof (Picture 1) is heated or cooled by the buildings chiller system (Picture 2). Heat pumps located above the suspended ceiling system draw air from the ceiling plenum and distribute it to occupied areas via ceiling-mounted air diffusers (Picture 3). In general, offices are not designed to have return vents. Offices have fresh air diffusers that pressurize the space, forcing air into hallways. Passive vents/transfer air vents located above doorways in some areas aid in the movement of air into hallways/common areas (Picture 4). Air is then drawn into the ceiling plenum by return vents in hallways and other common areas (Picture 5). Filters are installed in the return vents to aid in removing airborne particulates.

Fresh air intake

1. Increase the provision of fresh air to the CP space to dilute/reduce airborne pollutants and increase comfort.
2. Consider lowering the thermostat set point to increase occupant comfort.
3. Program thermostats to operate HVAC equipment with the fan in the *on* setting during occupied hours to increase air movement and comfort and prevent future occurrences of cooling coils from freezing.
4. Consider installing additional transfer air vents in offices lacking vents to increase movement of air.

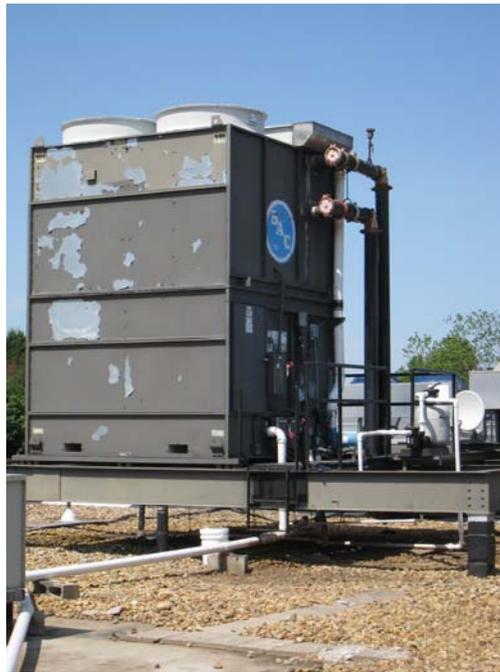
Picture 2

Cooling Tower

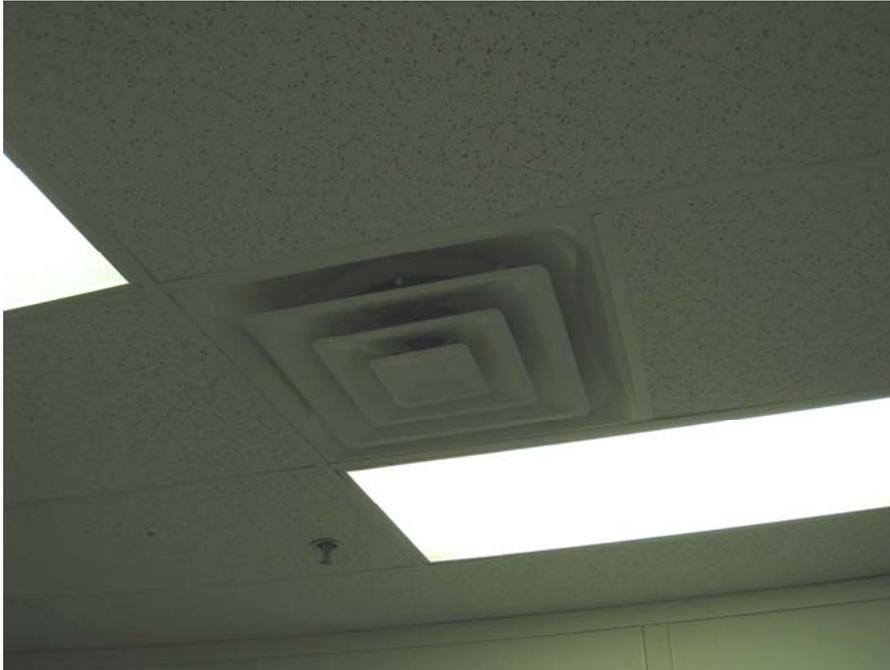
Picture 3

Supply vent

5. Change filters regularly to ensure proper filtration. Ensure filters are in place and that they fit properly.
6. Clean air diffusers, return vents and personal fans periodically of accumulated dust/debris.

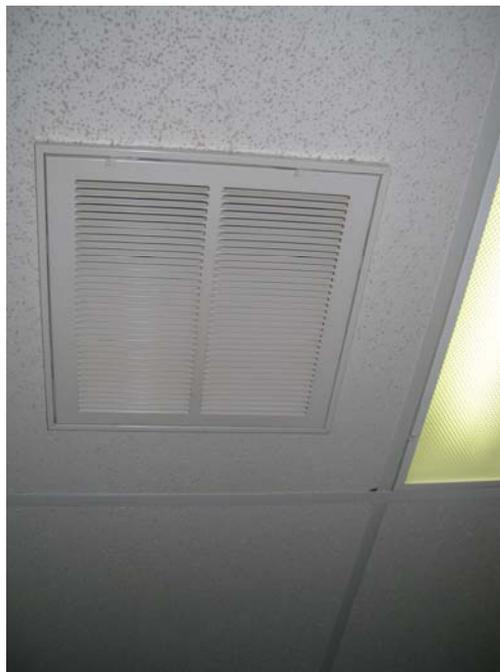
Picture 4

Return vent

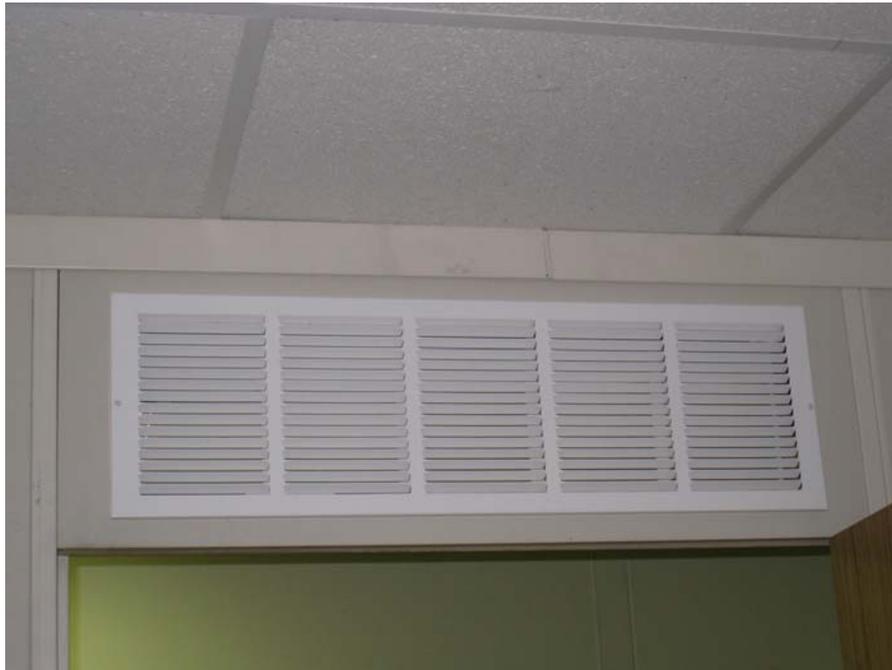
Picture 5

Passive vent above door

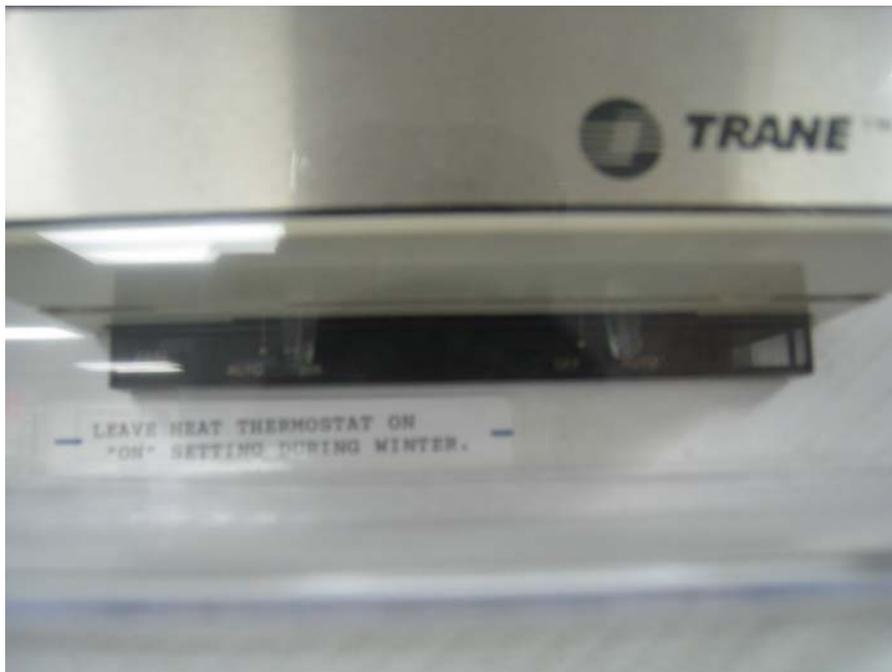
Picture 6

Digital wall-mounted thermostats control the heating, ventilation and air-conditioning system at the CP. Thermostats have fan settings of *on* and *automatic*. One thermostat was in the *automatic* setting, while two others were found in the *on* setting during the assessment (Picture 6). The automatic setting on the thermostat activates the heating, ventilation and air-conditioning (HVAC) system at a preset temperature. Once a preset temperature is reached by

the thermostat, the HVAC system is deactivated. Therefore, no mechanical ventilation is provided until the thermostat re-activates the system. MDPH recommends that thermostats be set to the *on* position during occupied periods, as this setting provides a continuous source of air circulation.

Thermostat fan set to auto

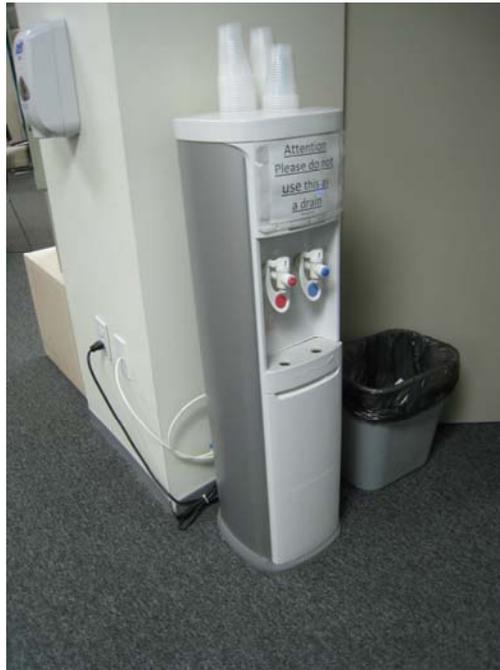
Picture 7

A water dispenser was located in a carpeted area (Picture 7); spills/leaks from such appliances can be a source of moisture in carpeting that can lead to water damage and mold growth. When possible, these units should be located in tiled areas or placed on a waterproof mat.

Water dispenser on carpeting
