# **INDOOR AIR QUALITY ASSESSMENT**

**Division of Capital Asset Management  
One Ashburton Place  
Boston, Massachusetts**

Prepared by:  
Massachusetts Department of Public Health  
Bureau of Environmental Health  
Indoor Air Quality Program  
February 2012

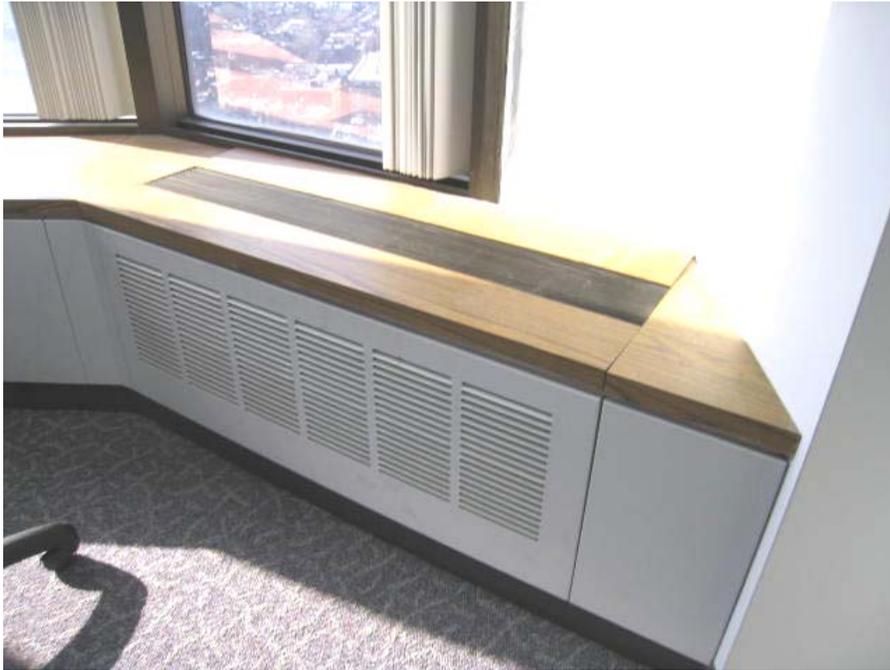
**Picture 1**

**Induction Unit in Office**

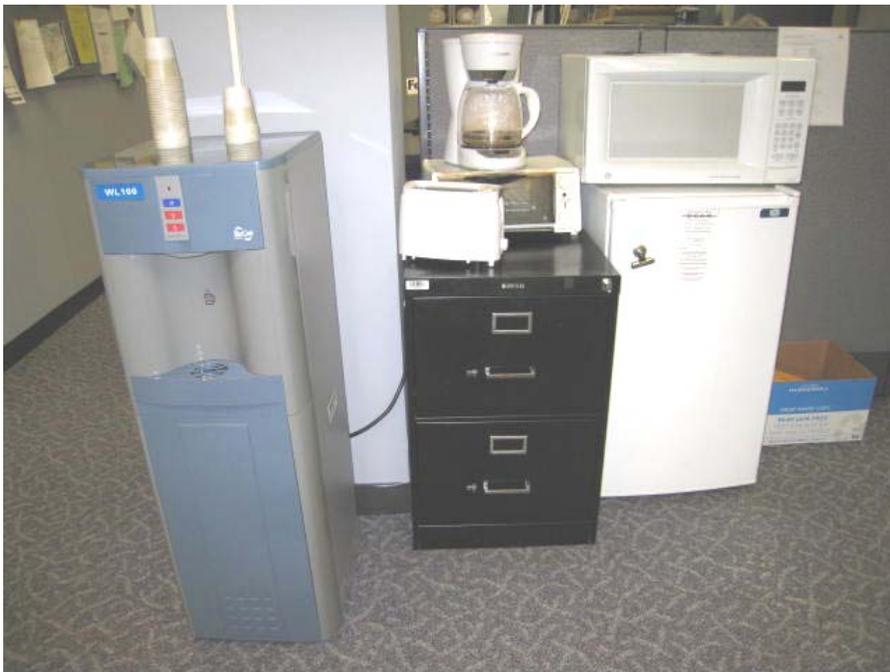
**Picture 2**

A water cooler and mini refrigerator were found located on carpeting (Picture 2). Carpeting underneath this equipment is vulnerable to water damage, which can lead to mold growth. The carpeting under this equipment should be covered by a rubber/plastic mat to prevent moistening. No signs of current water damage or moistened materials were noted in this area.

**Refrigerator and Water Dispenser on Carpet**

4. Consider outfitting water dispensers and refrigerators with a rubber/plastic mat to prevent water damage to carpeting.
5. Clean personal fans and supply/return vents periodically of accumulated dust/debris.

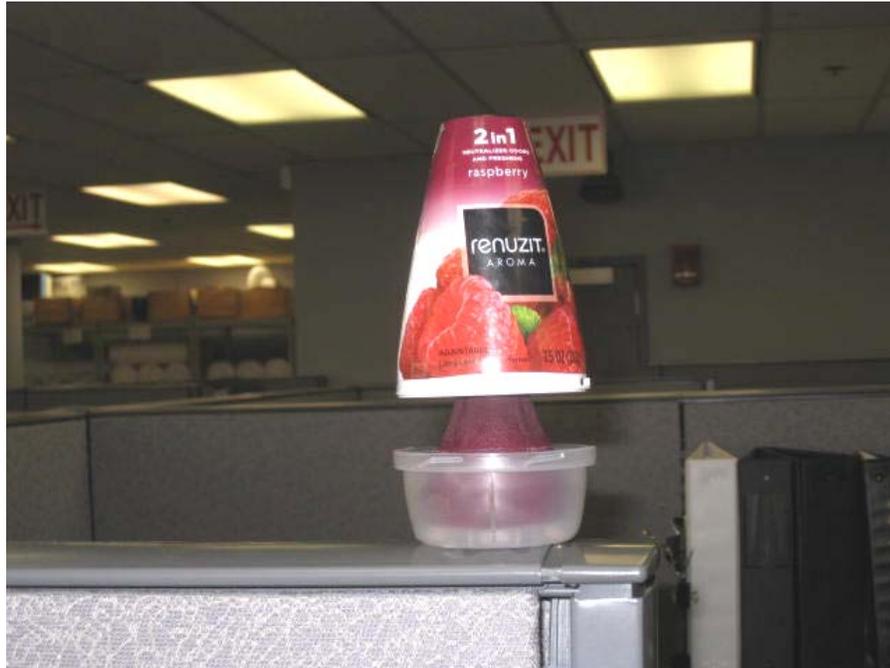
**Picture 3**

Cubicle 5 had a solid air freshener (Picture 3). Air fresheners contain chemicals that can be irritating to the eyes, nose and throat of sensitive individuals. Many air fresheners contain 1,4-dichlorobenzene, a VOC which may cause reductions in lung function (NIH, 2006). In addition, air fresheners do not remove materials causing odors, but rather mask odors which may be present in the area. Hand sanitizer was also found in the office. Hand sanitizer products may contain ethyl alcohol and/or isopropyl alcohol which are highly volatile and may be irritating to the eyes and nose, and may also contain fragrances to which some people may be sensitive (GOJO, 2007).

**Air Freshener**

1. Discontinue the use of strongly-scented air fresheners in the building, particularly around individuals who may be sensitive to them. Since the modular furniture is newly installed, it is suggested that the installation contractor be contacted to repair all sticking drawers.
