# **INDOOR AIR QUALITY LEASE RENEWAL ASSESSMENT**

**Commonwealth of Massachusetts  
Department of Revenue/Office of Environmental Law Enforcement  
218 South Main Street  
Fall River, MA**

Prepared by:  
Massachusetts Department of Public Health  
Bureau of Environmental Health  
Indoor Air Quality Program  
November 2012

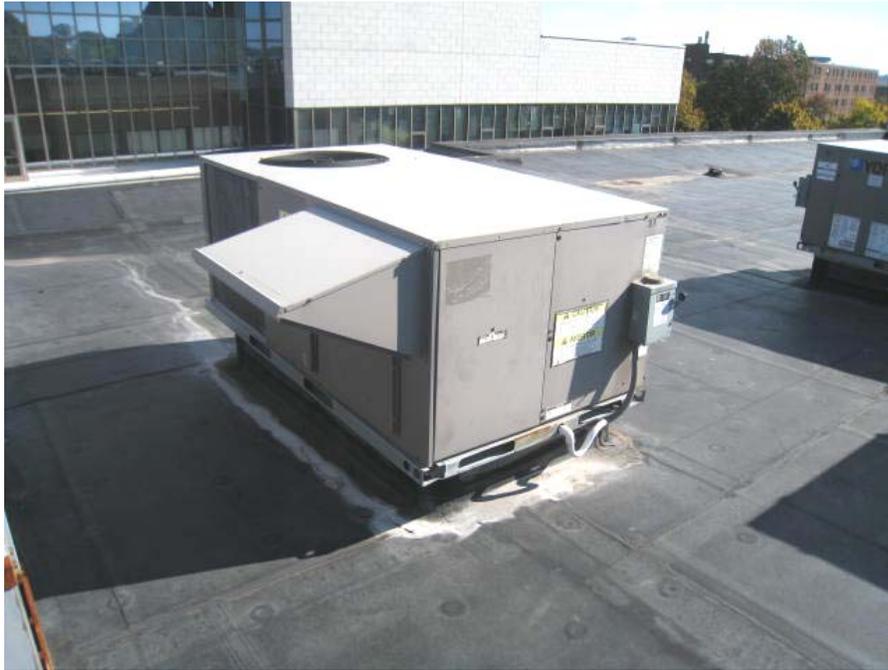
**Picture 1**

It can be seen from Table 1 that carbon dioxide levels were above 800 parts per million (ppm) in 12 of 15 areas surveyed, indicating a lack of optimal air exchange at the time of assessment. Fresh air is provided by three rooftop air-handling units (AHUs) (Picture 1). Fresh air is drawn into the AHUs through a bank of pleated air filters, heated or cooled and delivered to occupied areas via ducted air diffusers (Picture 2). Return air is drawn into ceiling-mounted vents (Picture 3) and ducted back to the rooftop AHUs.

**Rooftop air handling unit**

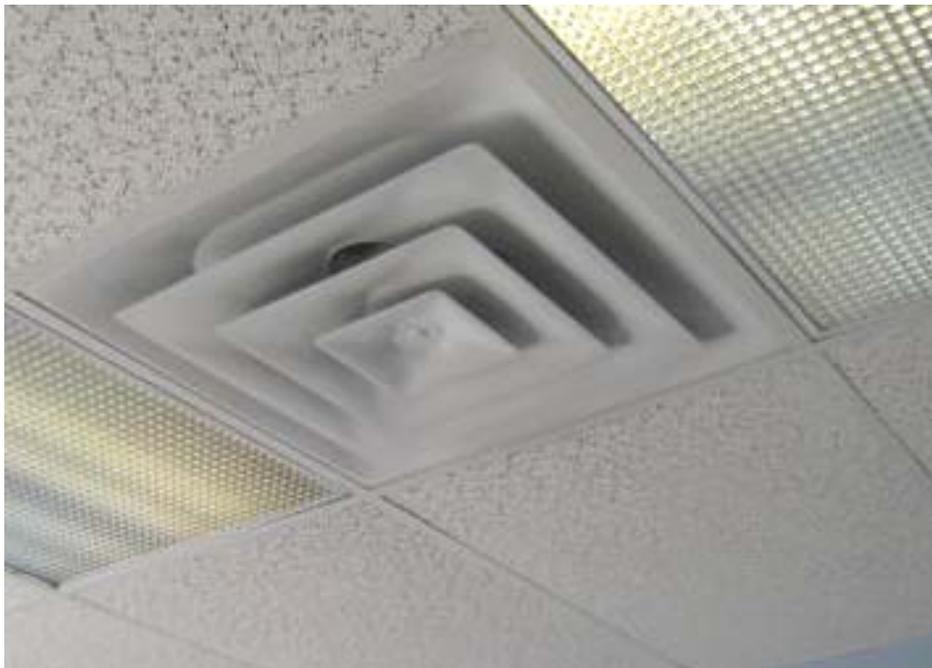
**Picture 2**

**Ceiling-mounted supply diffuser**

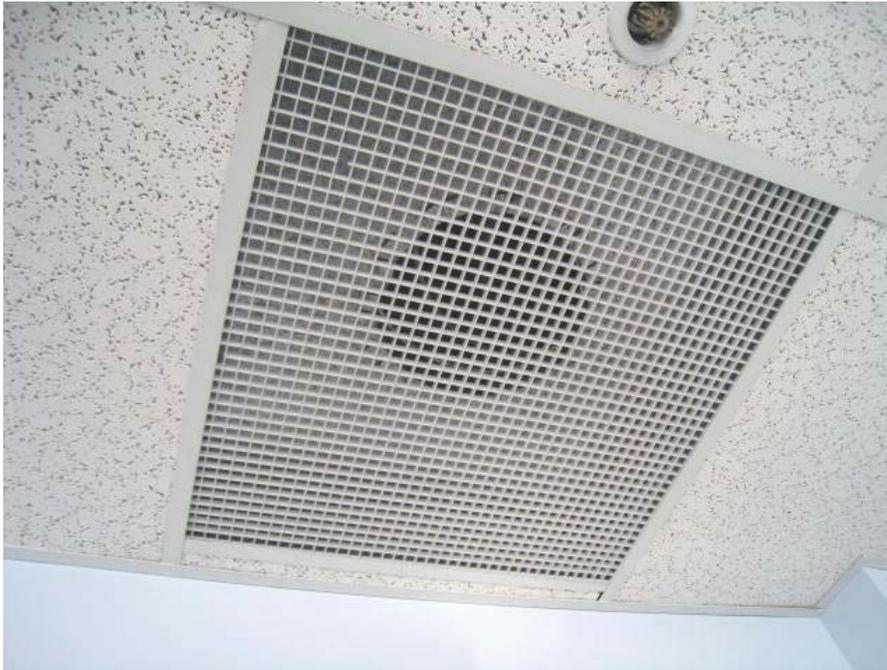
**Picture 3**

**Ceiling-mounted return vent**

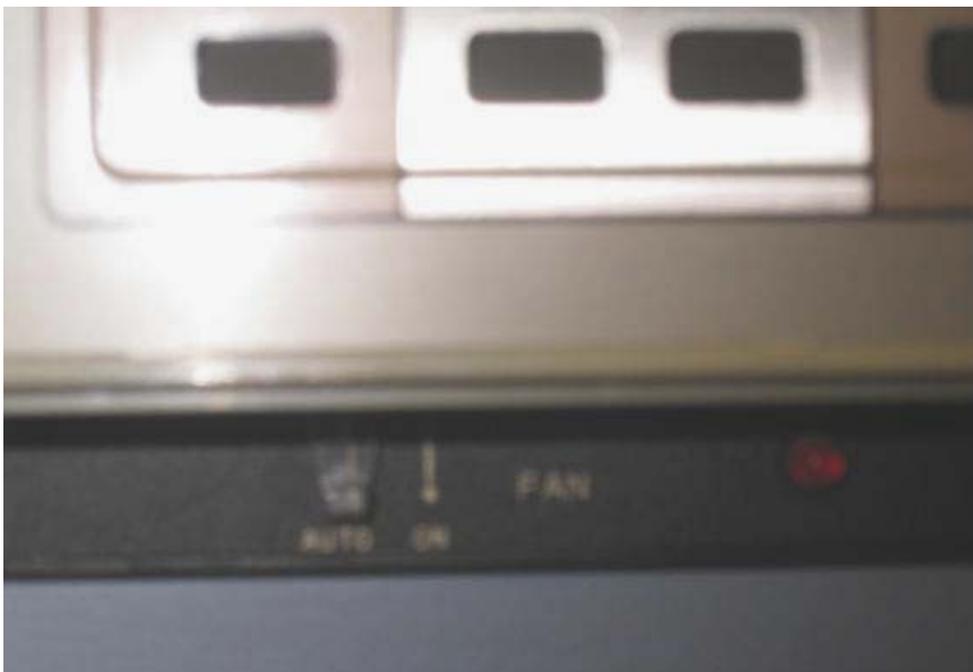
**Picture 4**

The heating, ventilating and air-conditioning (HVAC) system is controlled by digital thermostats. Thermostats examined had a fan switch with two settings, *on* and *auto* (Picture 4). When the fan is set to *on*, the system provides a continuous source of air circulation and filtration. The *automatic* setting on the thermostat activates the HVAC system to a preset temperature. Once the preset temperature is reached, the HVAC system is deactivated. Therefore, no mechanical ventilation is provided until the thermostat re-activates the system. The MDPH typically recommends that thermostats be set to the fan *on* setting during occupied

hours to provide continuous air circulation. During the assessment most of the thermostats were set to the fan *auto* setting; one thermostat was shut completely off, therefore no air circulation was being provided.

**Close-up of digital thermostat with fan in “auto” setting**

1. Ensure that all thermostats are activated and set to the fan “on” position to operate the ventilation system *continuously* in occupied areas during business hours.

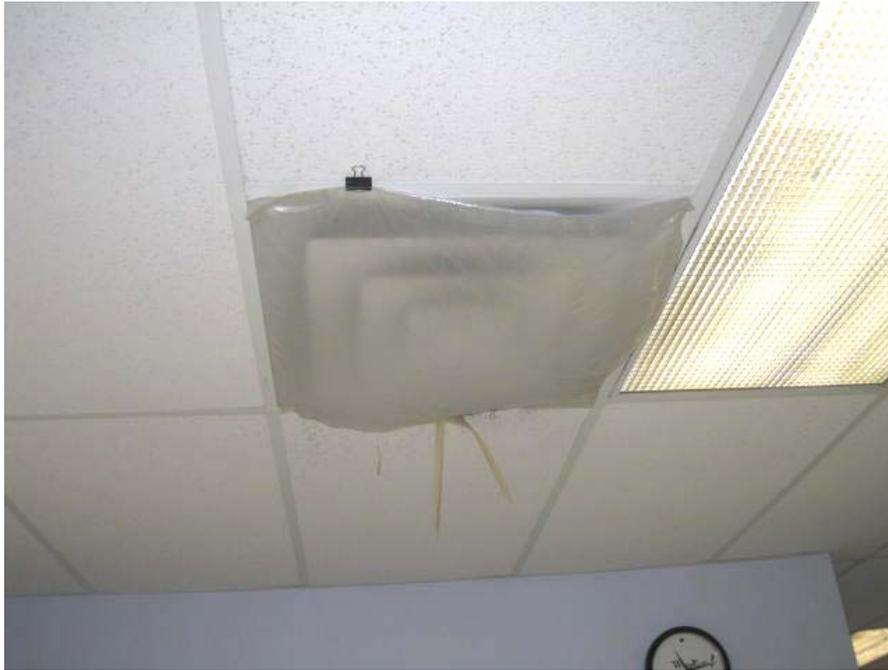
**Picture 5**

**Supply diffuser sealed with plastic**

2. Continue with plans to work with building management and HVAC vendor to examine the large conference room for better temperature/comfort control.
3. Remove plastic covering supply air diffusers. Work with HVAC vendor and/or building management to relocate diffuser or install an adjustable diffuser to improve comfort.

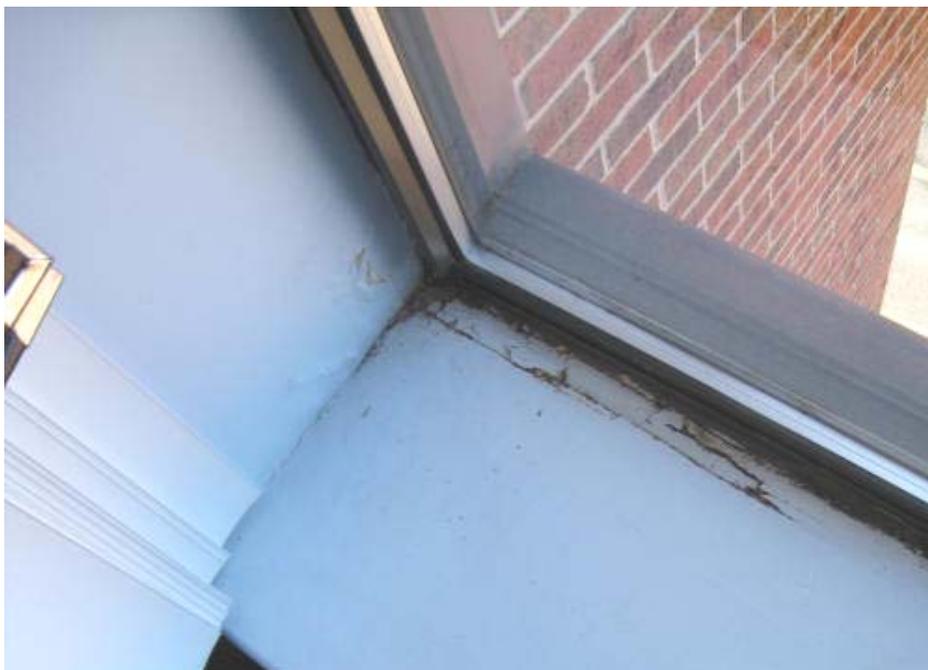
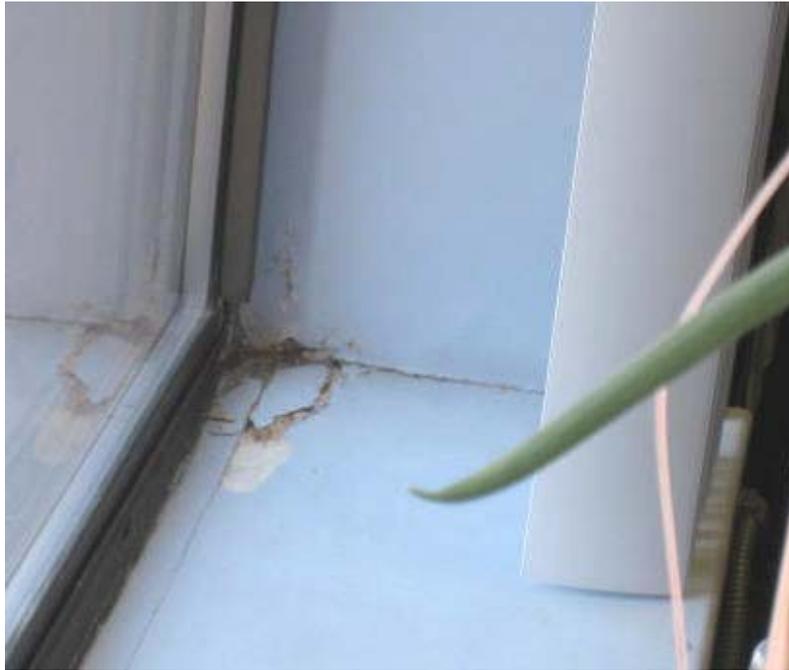
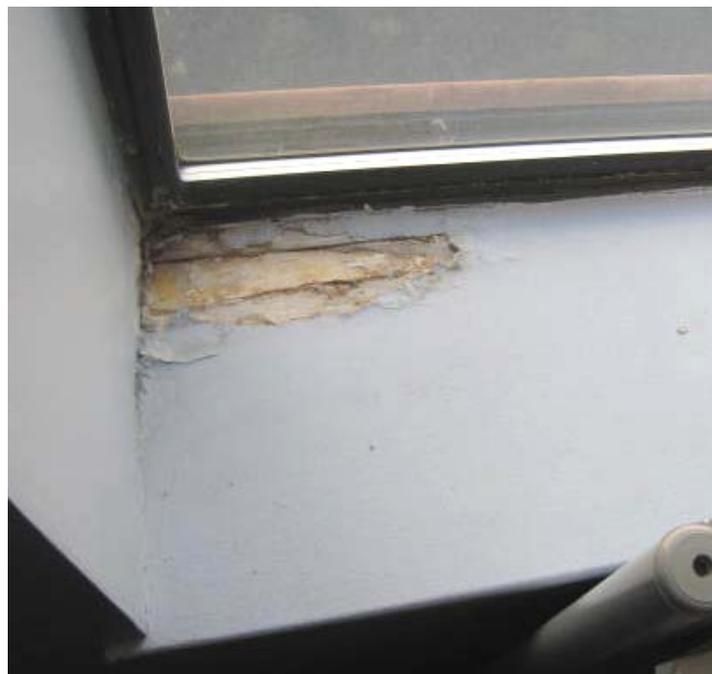
In order for building materials to support mold growth, a source of water exposure is necessary. Bubbling/peeling paint and water-damaged windowsills were observed in several areas (Pictures 6 through 8), indicating window leaks. At the time of assessment, BEH/IAQ staff conducted moisture tests in water-damaged wooden windowsills and found several to be elevated (Table 1), necessitating their removal.

**Water-damaged windowsill**

6. Ensure window leaks are repaired. Repair/replace any remaining water-damaged wooden windowsills and peeling paint. Monitor for further leaks, if leaking recurs, report to building management for prompt remediation.

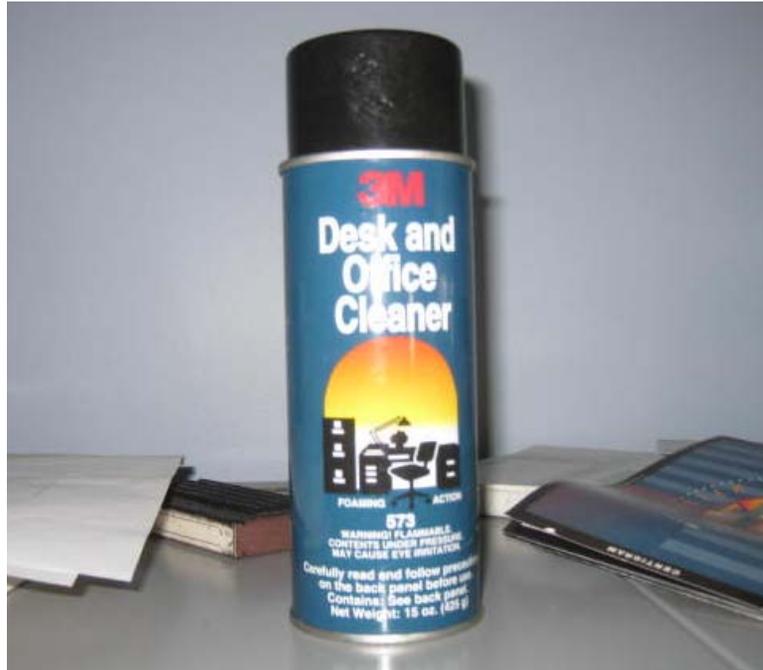
Picture 9

Lastly, DOR staff use volatile organic compound (VOC)-containing cleaning materials (Picture 9) to clean personal work areas. These materials contain several VOCs (e.g., isopropyl alcohol and monoethanolamine) that can be irritating to the eyes, nose and throat (3M, 2000).

VOC-containing spray cleaner, note warning label: flammable, causes eye irritation

8. Consider discontinuing the use of VOC-containing cleaners. Less irritating materials, (soap and water) may suffice to clean in these areas.
9. Refer to resource manual and other related indoor air quality documents located on the MDPH's website for further building-wide evaluations and advice on maintaining public buildings. These documents are available at: <http://mass.gov/dph/iaq>.
