INDOOR AIR QUALITY ASSESSMENT INCIDENT RESPONSE

**Hayden-McFadden Elementary School
361 Cedar Grove Street
New Bedford, Massachusetts**

Prepared by:
Massachusetts Department of Public Health
Bureau of Environmental Health
Indoor Air Quality Program
April 2012

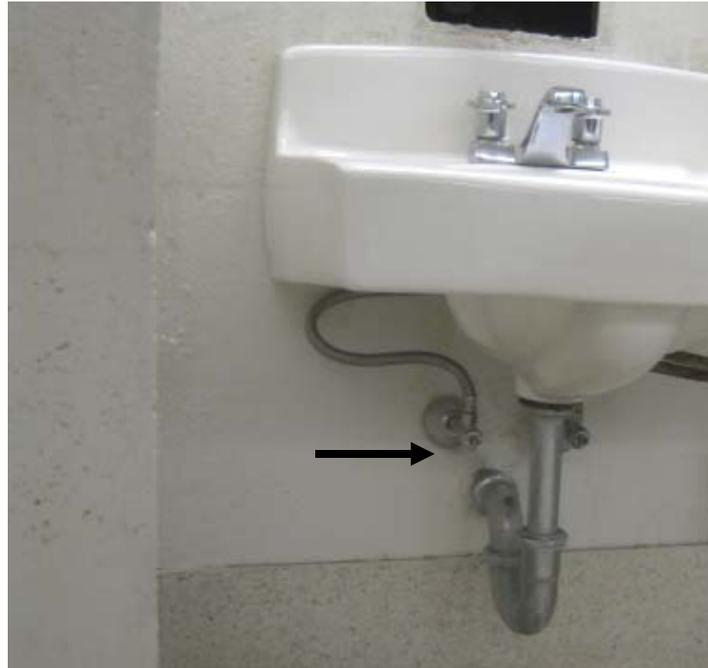
Picture 1

It was reported that at about 6:30 on the morning of March 22, 2012, the day-shift custodian noted flooding as a result of a failed sink connector in the 3rd floor boys' restroom. This caused wetting of carpeting and ceiling tiles on the 3rd floor adjacent to the restroom as well as similar materials on the 2nd and 1st floors directly below, albeit to a lesser extent. In addition, an electrical panel shorted out, creating smoke/odors in the building. As a result, all school activity was cancelled for the day.

Flexible Hose Connection (arrow) Source of Leak

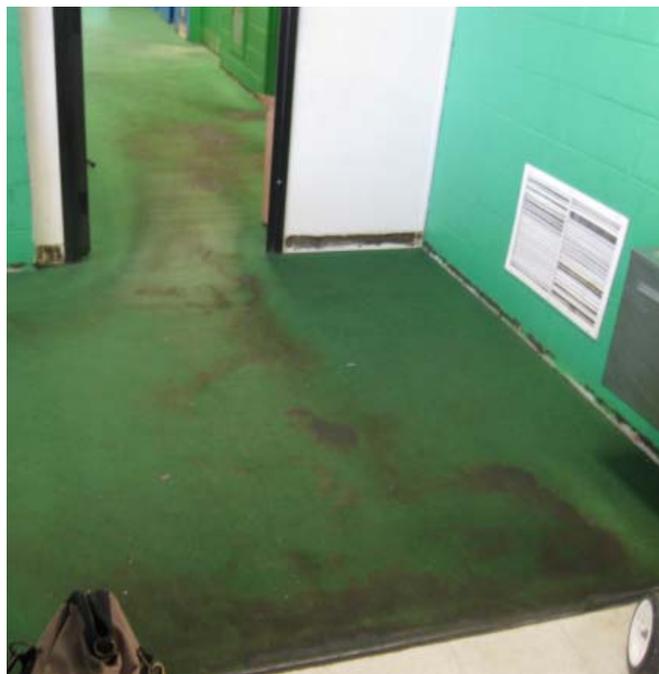
Picture 2

Carpet on all three floors evaluated by BEH staff was wet (Table 1). Due to the extent of the wet carpet and condition of the carpeting, BEH staff recommended that a professional restoration company be contacted to conduct thorough cleaning/drying efforts. Serv-Pro, a flooding remediation company, was contacted and arrived on site at approximately 4:15 PM to conduct mitigation/restoration.

It is important to note that the majority of floor surfaces in the school are covered by wall-to-wall carpeting, much of which appears to be original to the construction of the building (i.e. over 35 years old). Carpeting was observed to be worn, stained and/or damaged in several areas, particularly in hallways directly outside restrooms. At the time of the assessment, severely worn/damaged carpeting outside of the 3rd floor restroom was removed at the recommendation of BEH staff.

Wet Soiled/Worn Carpeting outside 3rd Floor Restroom

1. Remove soiled/damaged carpeting in hallway areas directly outside of restrooms.
Replace with non-porous floor covering (e.g., tile).
