# MA FACE

## Occupational Fatality Report

### Landscaper Working from a Raised Portable Work Platform Was Electrocuted When a Pole Saw Contacted Overhead Power Line - Massachusetts

Release Date: January 12, 2015  
Investigation: # 13-MA-019-01

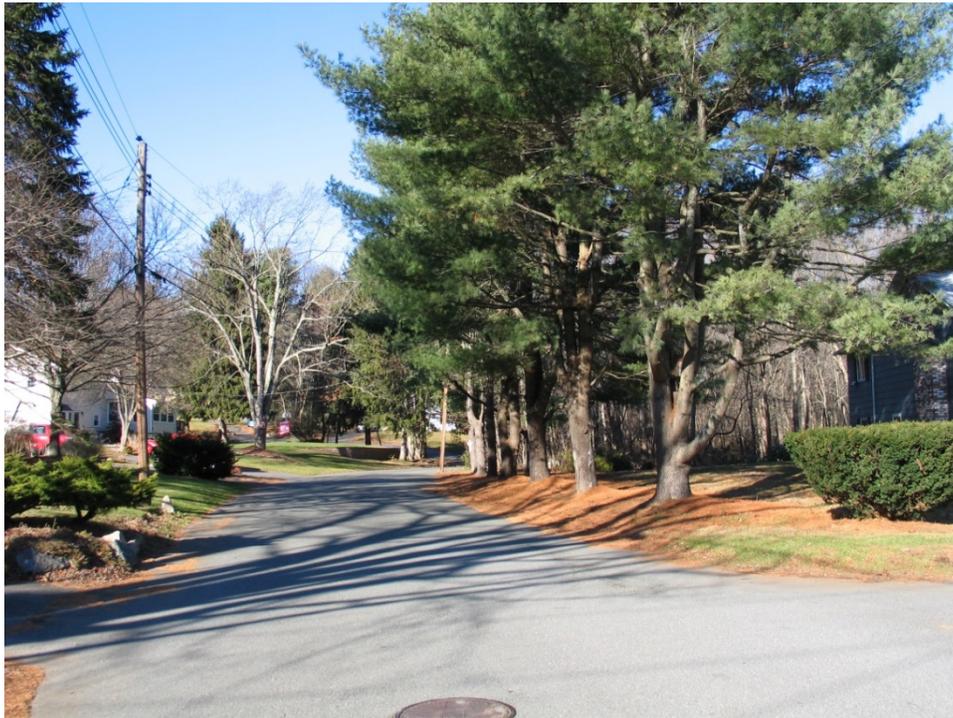
**Figure 1 – Large pine trees being trimmed at the time of the incident**

The incident occurred in a suburban residential neighborhood of single family homes. The owner of the house where the incident took place had hired the company to trim the trees that enclosed the property's side and backyards. Specifically, the scope of work was to trim branches that overhung the lawn and to raise the overall tree canopy. The house was located on a corner lot where two of the lot's property lines, the north and east property lines, abutted roadways. The northern property line that ran along the front of the house abutted a small dead-end roadway. The eastern property line that ran along the eastern side yard of the house, and was the location where the incident occurred, abutted a larger secondary roadway. Six large white pine trees growing in a line at the edge of the secondary roadway separated the roadway from the property's eastern side yard. This secondary roadway was

asphalt and ran north and south where the incident occurred (Figure 1). There were no painted roadway markings on this roadway and traffic traveled both directions.

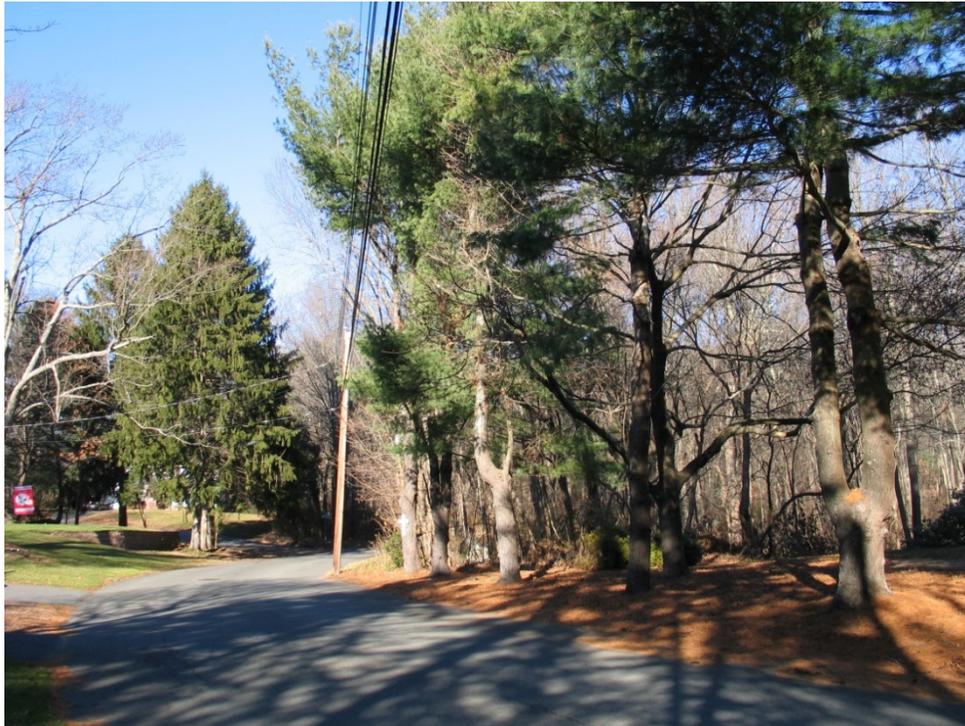
**Figure 2 – Overhead power lines involved in the incident**

Multiple utility lines including cable, telephone and a 7,900 volt overhead power line ran along the east side of the secondary roadway. These lines transitioned to the west side of the roadway approximately  $\frac{3}{4}$  of the way down the lot's eastern property line. The lines, including the overhead power line, then continued along the western side of the roadway and along the eastern edge of the property line where there was a utility pole (Figure 2).

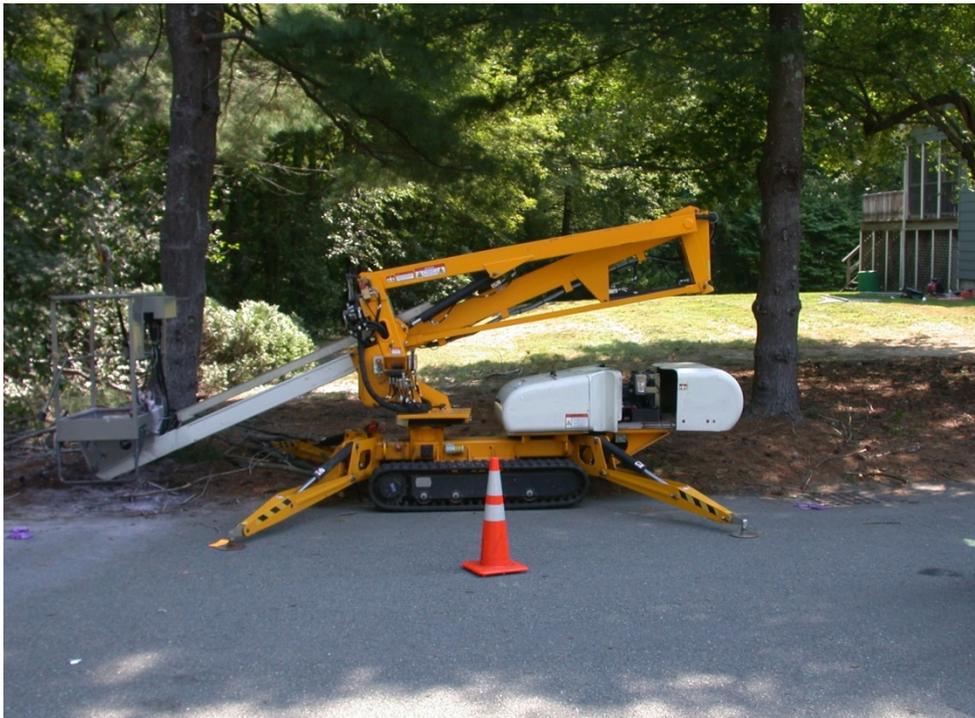
**Figure 3 – Lift being used at the time of the incident**

The equipment involved in the incident was a track mounted work platform manufactured in 2010 (Figure 3) that was being rented from a local equipment rental company. The work platform had an articulating boom, rubber tracks and four outriggers. Each outrigger extended approximately four feet. The overall dimensions with the platform and outriggers stowed were approximately four feet wide by six feet high by 13 feet long. The maximum platform height was approximately 34 feet with a maximum working height of 40 feet. The metal platform measured three feet seven inches by two feet two inches with a capacity of 500 pounds and was equipped with a metal guardrail. Fall protection, including a full body harness and a lanyard, was provided with the work platform by the rental company, although it was not being worn by the victim at the time of the incident. The lift had multiple warning decals from the manufacturer including a decal warning about the electrocution hazard when coming in contact or within close proximity of overhead power lines.

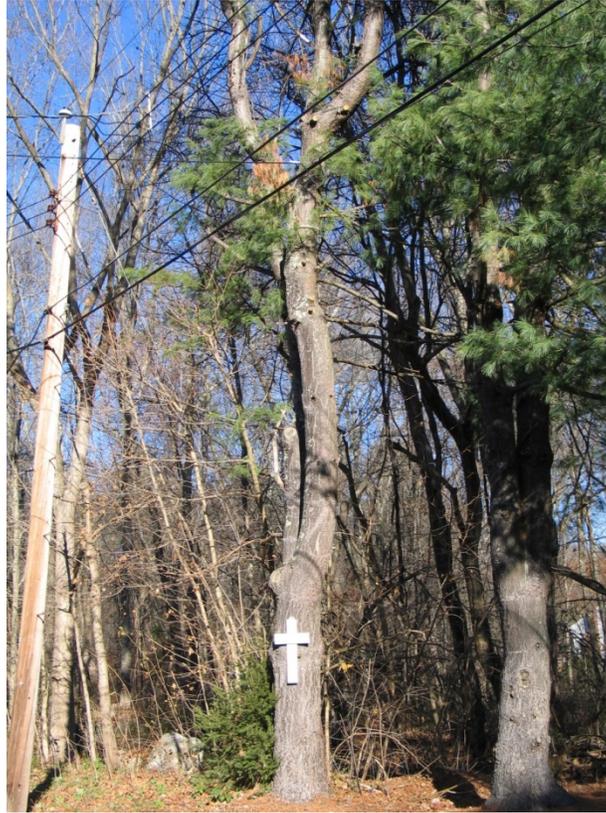
**Figure 4 – Tree being trimmed at the time of the incident**

When the co-workers arrived on site they started to clear branches that had already been pruned by the victim and that were on the ground. At some point the victim put the pole saw's base (motor and gasoline tank) on the platform's floor and the other end of the pole saw (blade) extended approximately two feet above and beyond the top of the platform's guard rail. Although not witnessed, around 9:15 a.m., while the victim was in the raised work platform and possibly repositioning the platform, the pole saw came in contact with the 7,900 volt energized overhead power line electrocuting the victim (Figure 4) and igniting his clothing.
